Oversight and Safety Issues at the PBS Michigan Service Center

*Report Number A140024/P/5/R15009
September 30, 2015*

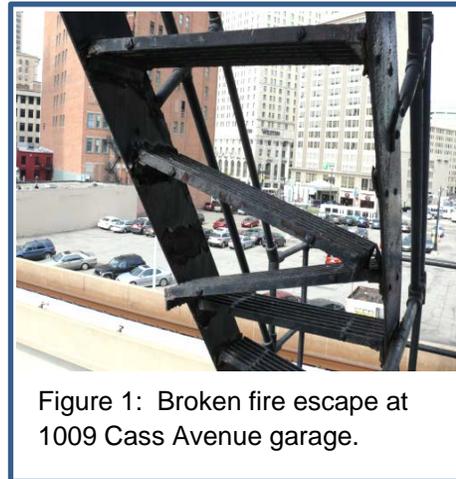
PBS originally leased the 1009 Cass Avenue garage on May 1, 2003, on the written condition that the lessor prepare the building for government occupancy and complete all items contained in the *Pre-lease Fire/Life Safety Report*, dated October 11, 2001.³ The pre-lease report, which noted several fire and safety issues, became part of the lease. We inspected the property on April 24, 2014, and found that in the 10-year period preceding our review, the lessor had either failed to comply with the pre-lease report's recommendations or had allowed any responsive repairs made to become neglected. For example, a section of the fire escape had no structural integrity: the stairs were bent, broken, or missing (see *Figure 1*). We concluded that PBS' inspections of the property did not determine if the lessor complied with the pre-lease report and did not emphasize fire or life safety issues. Further, the Detroit Leasing Office did not have the entire lease contract file, which would inhibit its ability to perform additional inspections of the property against the requirements of the lease.

Figure 1: Broken fire escape at 1009 Cass Avenue garage.

All deficiencies at the 1009 Cass Avenue and 11411 E. Jefferson locations have been corrected.

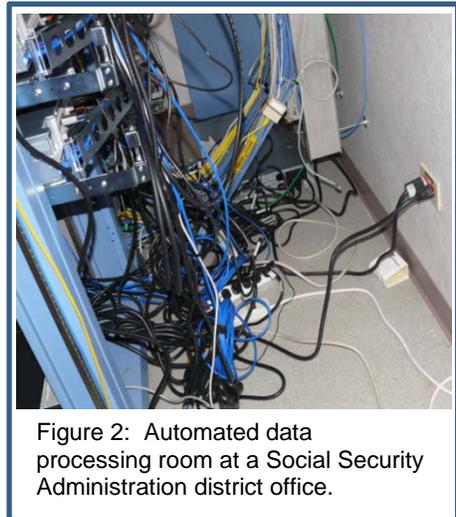
During our inspection of leased properties occupied by the Social Security Administration, we found several conditions that should have been identified during inspections of the properties. For example, our review revealed several instances of tangled wires, cabling, and power strips in the agency's automated data processing or local area network rooms, as shown in *Figure 2*. The property managers were unaware of the situation and acknowledged that they usually do not enter automated data processing rooms as part of their inspections. Once notified, the property managers agreed the situation presented a potential hazard.

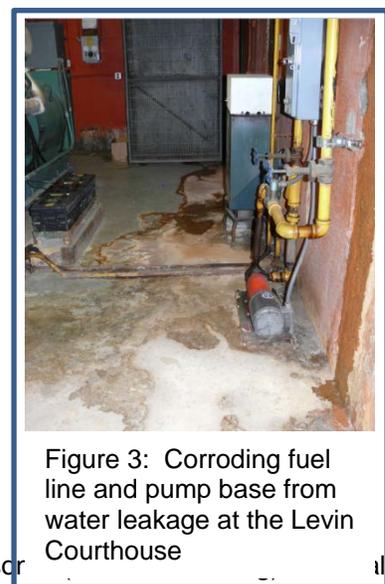
Section 27.6.4 (Corrosion Protection) of National Fire Protection Association 30 (*Flammable and Combustible Liquids Code*) maintains that above ground piping systems that are subject to external corrosion shall be suitably protected.⁹ However, at the Levin Courthouse, we found long-term water damage including damage to key emergency and fire protection systems located in the basement of the building. Specifically, the pump and motor that supply diesel fuel to the emergency generator and the engine that runs the fire pump were noticeably corroded

Figure 3: Corroding fuel line and pump base from water leakage at the Levin Courthouse

from water damage, as shown in *Figure 3*. The leaking water has also corroded the fuel lines leading to the diesel-powered emergency generator which may cause the fire system to become inoperable in the case of a fire.

We concur with the safety findings regarding the use of occupancy sensors in mechanical areas. As identified in the audit, water infiltration into the basement has been an issue for several years. A design had been completed to replace the fuel tank, pump and motor, and the emergency generator prior to the audit and is incorporated in the \$140 million prospectus project that addresses extensive electrical, mechanical, plumbing and safety issues at this historic facility. Weekly testing is performed on the emergency generator as required by the O&M contract. The corroded fuel line in the Levin basement has been replaced.

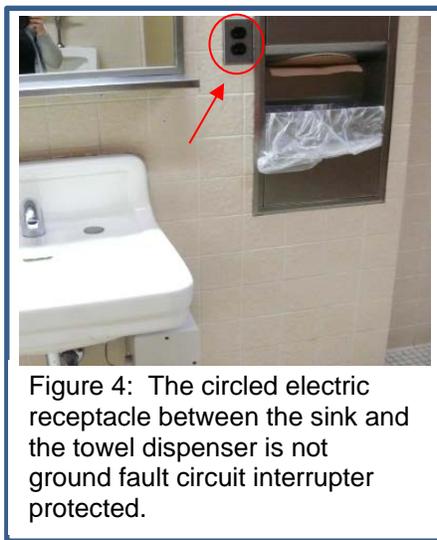
National Fire Protection Association 70 (*National Electrical Code*), sections 210.8(A)(7) and 210(8)(B)(1), maintains that all receptacles installed within 6 feet of the outside edge of a sink must be ground fault circuit interrupter protected.¹⁰ A ground fault circuit interrupter is a device that shuts off an electric circuit (or portion thereof) when it detects that current is flowing along an unintended path – possibly through water or through a person. The device is used to reduce the risk of electric shock and commonly takes the form of a receptacle that electric devices are plugged into.

Figure 4: The circled electric receptacle between the sink and the towel dispenser is not ground fault circuit interrupter protected.

Our audit revealed many examples, in buildings managed by the Michigan Service Center, of restrooms and water coolers where the use of a ground fault circuit interrupter is appropriate but is not used. For example, *Figure 4* shows an unprotected receptacle between the sink and the paper towel dispenser in a Levin Courthouse restroom.

The audit identified a lack of Ground Fault Circuit Interrupters (GFCIs) in several water cooler and restroom areas. While many safety and electrical items were identified in the 2013 MARS report for the Levin Courthouse, most deficiencies were due to the age of the electrical wiring and equipment, which will be addressed in a prospectus currently in design. Subsequent to the audit, management requested a survey to determine which areas do not have cloth wiring in place so that GFCIs could be installed in advance of the prospectus. The study determined that all areas within six feet of a water source had cloth wiring. Consequently, outlets that can be removed from service will be capped until the prospectus remedies this safety issue on a permanent basis, and new wiring and GFCIs will be installed where outlets must remain in use.

Lighting sensors in mechanical spaces have been removed, and analog switches have been added in their place. Outlets near water sources will either be capped or replaced with GFCIs.
