SIGAR 18-35 Inspection Report

Afghan Ministry of Interior Headquarters
Project: Phases 1 and 3 Experienced
Construction Deficiencies, Poor Oversight,
and Increased Costs

MARCH
2018

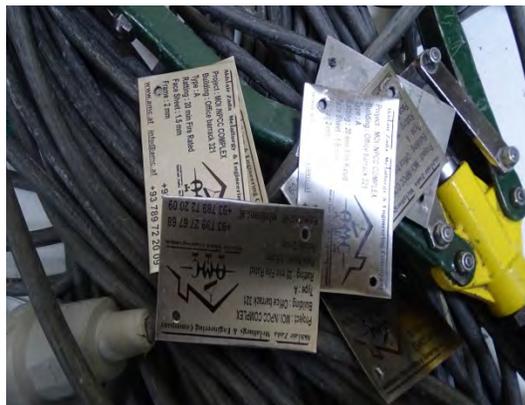
Photo 2 - Noncertified Fire Door Labels Found in MOI Headquarters Buildings

During our October 26, 2015, site visit, we observed a worker attaching manufacturer fire door labels to doors in an administration building. Two USACE officials, the Kabul officer-in-charge and the project engineer, were present when we observed this activity. Photo 2 shows some of the noncertified fire door labels we observed in one of the MOI administration buildings. As we continued our site visit, we observed that these labels were also affixed to doors in other buildings on the MOI compound. The phase 3 contract and the IBC require that fire door certification labels be affixed to doors at the manufacturing site, not at the installation site. Therefore, labeling the doors on the MOI headquarters compound violated both contract and IBC requirements. We also determined that these labels were not authentic because they displayed AMC, an Afghan company, as the manufacturer and fire rating information without the required UL, FM, or WHI certification logo. Further, we found that the labels were affixed to the face of the door instead of to the door hinge, as the contract required.

During our March and April 2016 site visits to the 21 buildings requiring fire doors, we saw that other doors had labels displaying OST and ASPIC, both Afghan manufacturing companies. These doors did not have certification labels from one of the three certifying agencies. We found that the OST labels had a UL logo, but the labels were not authentic labels approved by UL. An authentic UL label must display a "UL classified" mark, the UL product category code, and show the fire rating classification in hours. However, OST's labels did not state "UL classified," did not list the product category code, and showed the fire ratings in minutes instead of hours. We also found that the ASPIC labels did not include the logo of a certifying agency.

We also observed that a second label had been affixed to each door, indicating that the door had been "field" certified after it was installed. All three door manufacturers—OST, ASPIC, and AMC—had doors with their own

1. **Remove all manufacturer fire rating and field labels from the noncompliant doors and notify the MOI of the potential safety hazards resulting from the noncompliant doors installed throughout the headquarter compound.**
2. **Reinforce with USACE's contracting officers the importance of preparing final Contractor Performance Assessment Reports that include details from interim evaluations to ensure that any contractor performance deficiencies identified and actions taken to address those deficiencies reflect the complete history of contractor's performance over the course of the contract.**

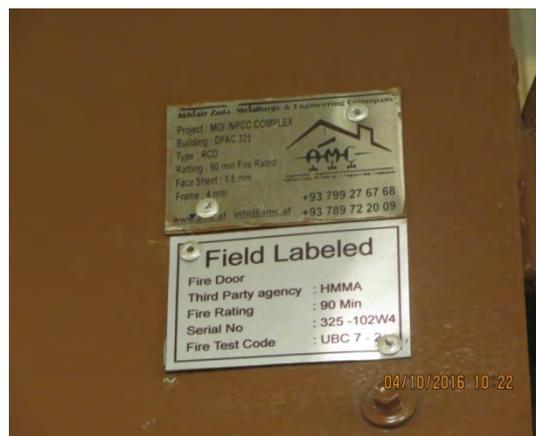
Photo 3 - Door in MOI Headquarters Dining Facility with AMC Label

label and a field label. Photo 3 shows a door that has a label from AMC, the manufacturer, and a field label. The three door manufacturers' field labels all looked identical except for a serial number and a fire rating duration. However, field labeling of fire doors can only be performed by one of the certification agencies. Based on industry standards, field labeling is never performed for doors that have not been previously certified and labeled. Instead, field labeling involves recertifying an already certified door when the existing fire door label is damaged, painted over, missing, or otherwise unacceptable to the authority having jurisdiction, or a labeled fire door approved by one of the certifying agencies has had field modifications, such as additional signage or new windows, that are outside the original scope of the fire door's certification.¹⁶

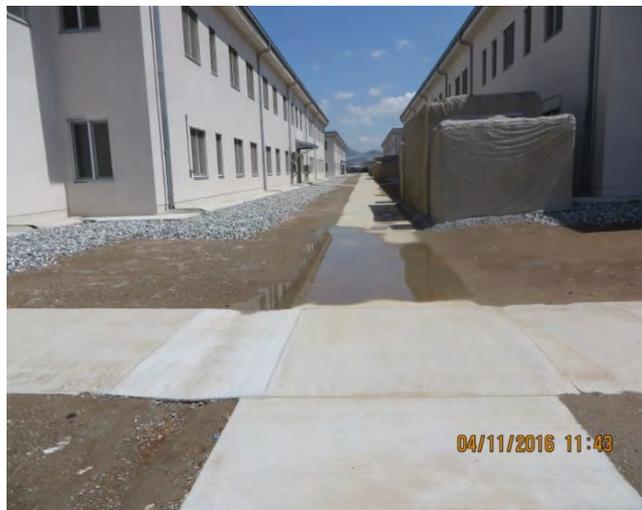
Photo 4 - Poor Grading Near an Administration Building Resulting in Pooling Water

Some project site areas were poorly compacted and graded.	The contract specifications required the ground to be compacted to a 95 percent density and graded with a 2-3 percent slope to avoid soil settlement and prevent water from pooling. We conducted soil compaction tests and found compaction ranging from 63.1 to 81.5 percent near the waste water treatment plant, the national police command center, several administration buildings (numbers 303, 306, and 312), the medical clinic building (number 319), the dining facility, the auditorium building, and the interview building. We also found that areas near the national police command center, dining facility, interview building, administration buildings, and other buildings were poorly graded, and that soil settlement had occurred, resulting in water pooling (see photo 4).

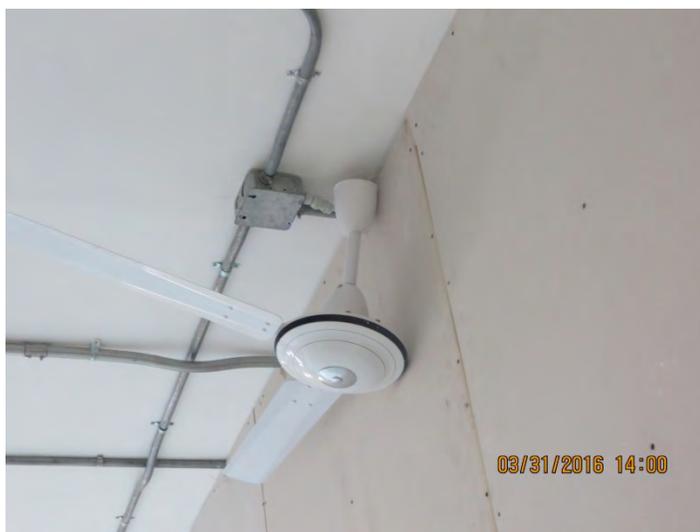
Photo 5 - Inoperable Ceiling Fan

electrical system to overload. Overloading an electrical system may cause wires to overheat and burn, creating a safety hazard. Some ceiling fans are now inoperable, and partitioned space may not be adequately heated or cooled unless additional heating, ventilation, and air conditioning units are installed. This situation is likely to persist until the partitions are removed, or the electrical system is upgraded.
