Desoto Carrier Annex, Memphis, TN: Delivery Unit Operations

AUDIT REPORT

Report Number 23-100-3-R23 | June 27, 2023

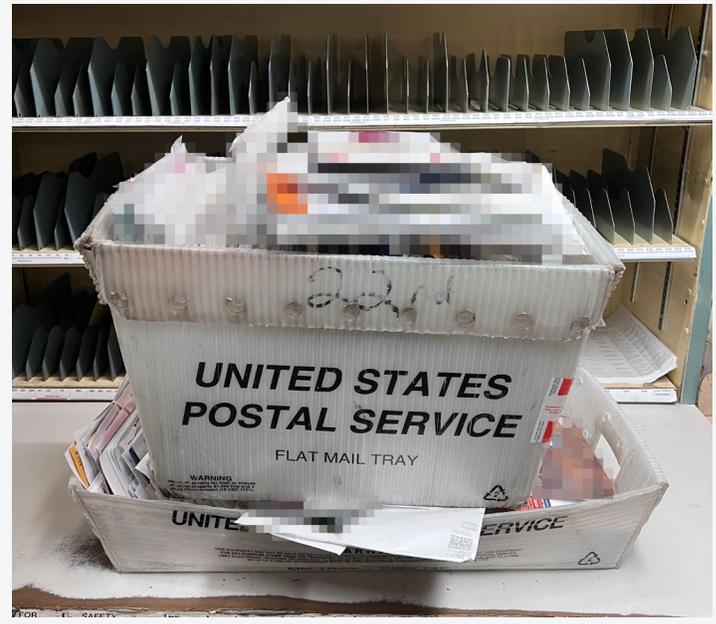
Figure 1. Delayed Mail at the Carrier Case

On the morning of May 2, 2023, we identified 2,141¹⁰ delayed mailpieces at 15 carrier cases and the workroom floor. Specifically, we identified 1,929 mailpieces at the carrier cases and 212 pieces on the workroom floor. In addition, management did not report in the Delivery Condition Visualization (DCV)¹¹ system undelivered mail carriers brought back. While they reported 254 delayed mailpieces, this represented only 11.86 percent of the delayed mail volume we identified at the unit. See Table 2 for the number of pieces for each mail type and Figures 1 and 2 for examples of delayed mail found at the carrier cases and the workroom floor.

Management should have monitored and verified that the number of delayed mailpieces in DCV was accurate. Management should have instructed carriers to report on PS Form 1571, and supervisors to report in the DCV system, the number of undelivered mailpieces brought back by carriers. Postal Service Policy¹² states that all types of First-Class Mail, Priority Mail, and Priority Express Mail are always committed for delivery on the day of receipt. In addition, management is required¹³ to report all mail in the delivery unit after the carriers have left for their street duties as either delayed or curtailed in the DCV system. Further, management must update the DCV system if volumes have changed prior to the end of the business day.

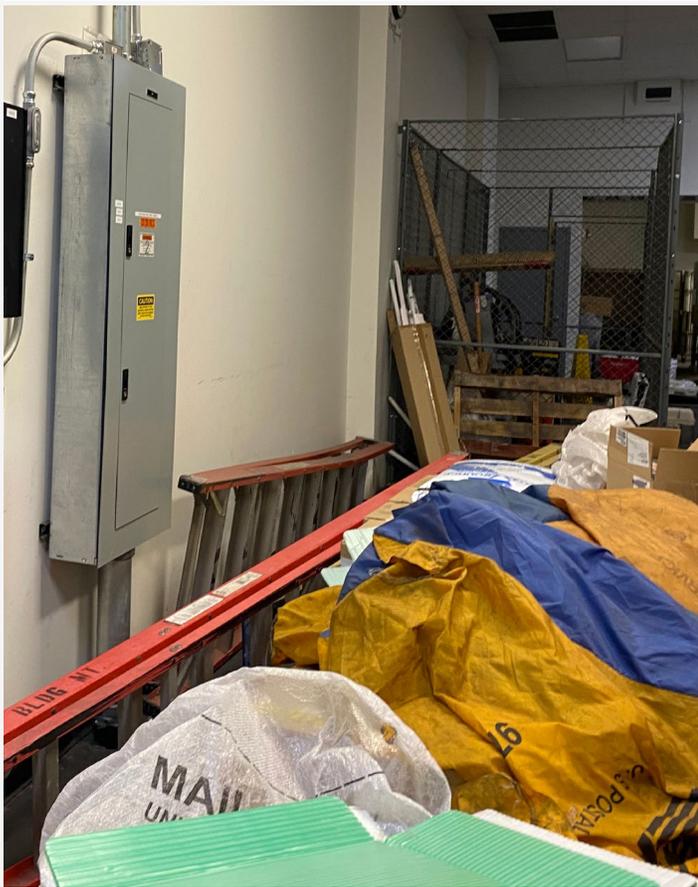
Figure 3. Blocked Electrical Panel

- Blocked electrical panel in the workroom (see Figure 3).
- Unmounted fire extinguishers in the workroom area and hallway to the offices including four fire extinguishers sitting on the floor.
- Missing annual and monthly inspections on all fire extinguishers.
- Rusted railing and crumbling concrete on the steps and landing of the Caller Service entrance (see Figure 4).

Management did not take the necessary actions to verify that property conditions issues were identified and corrected. Management stated that they were aware of some of the property conditions identified during our fieldwork and are currently taking steps to abate some of them.

Management should have provided sufficient oversight of personnel responsible for maintaining facilities, reported safety and maintenance issues as they arose, and followed up for completion. The Postal Service is required to maintain a safe environment for employees and customers. In addition, the Occupational Safety and Health Administration (OSHA) requires employers to provide a safe and healthy workplace free of recognized hazards.¹⁷

Property Conditions: Two of the eight property conditions have been abated. Work orders have been submitted for the remaining six.
