# INSPECTOR GENERAL

SEPTEMBER 24, 2025

## Audit of Storage and Maintenance of Marine Corps Prepositioned Equipment and Supplies on the U.S. Naval Ship *Dahl* in the Indo-Pacific Region

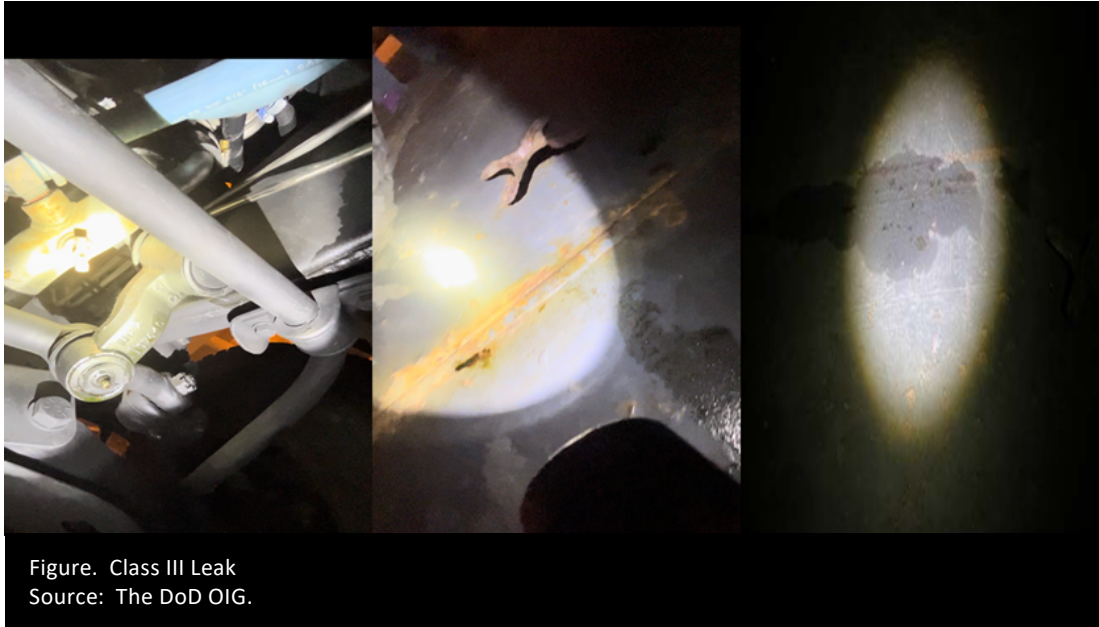
BICmd officials did not ensure that the contractors initiated service requests for five vehicles with Class III leaks aboard the USNS *Dahl*, as required by the contract. According to the contract, a service request must be created before initiating corrective maintenance repairs. Prior to our review of the prepositioned equipment in February 2024, the contractors did not document any Class III leaks related to the five vehicles during their monthly stock check in January 2024 and, therefore, did not initiate service requests for the leaks before we notified them of the leaks. The Figure shows one of the Class III leaks observed during our review.

During our review of 88 prepositioned equipment items on the USNS *Dahl*, we identified 5 vehicles that had Class III leaks. However, the contractors had not initiated service requests for the leaks before we identified the leaks during our walkthrough. The contract states that the contractors are required to create a service request when equipment needs repairs or other services. The contractors did not document any Class III leaks related to the five vehicles during their monthly stock check in January 2024, before our review of the prepositioned equipment in February 2024; therefore, the contractors did not initiate service requests for the leaks before we notified them of the leaks. After we brought the leaks to the attention of the BICmd officials and the contractors, the contractors initiated service requests for four of the five vehicles.

BICmd officials stated that the contractors did not initiate a service request for one of the five vehicles because there may have been a previous vehicle in that location that had a leak; however, BICmd officials provided no documentation to support this statement. Therefore, we recommend that the Commanding General, Marine Corps Logistics Command, direct the Commander, Blount Island Command,

After we informed BICmd officials and the contractors of the Class III leaks, the contractors initiated service requests for four of the five vehicles that had Class III leaks. However, we could not verify that the contractors initiated a service request for one vehicle that had a Class III leak. Specifically, the leak was not annotated on the SASU form, and there was no record of an open or closed service request. BICmd officials stated that the reason no records were found for this Class III leak could be because that vehicle may have been moved during the exercise, and the leak was from a different vehicle. BICmd officials did not provide any supporting documents to show that the leak came from a different vehicle and not from our sampled vehicle, or to show that they rechecked the vehicle.

to determine whether any vehicles aboard the USNS *Dahl* have Class III leaks and, if so, require the contractors to take appropriate corrective maintenance actions. In addition, we recommend that the Commanding General, Marine Corps Logistics Command, direct the Commander, Blount Island Command, to determine why the contractor did not identify maintenance issues, such as Class III leaks, and develop and implement a solution.
