Memorandum from the Office of the Inspector General

**REQUEST FOR MANAGEMENT DECISION – EVALUATION 2016-15359 – ACTIONS
TAKEN TO ADDRESS RISKS RELATED TO COAL PLANT DUCTWORK**

ACTIONS TAKEN TO ADDRESS RISKS RELATED TO COAL PLANT DUCTWORK

Evaluation 2016-15359
July 28, 2016

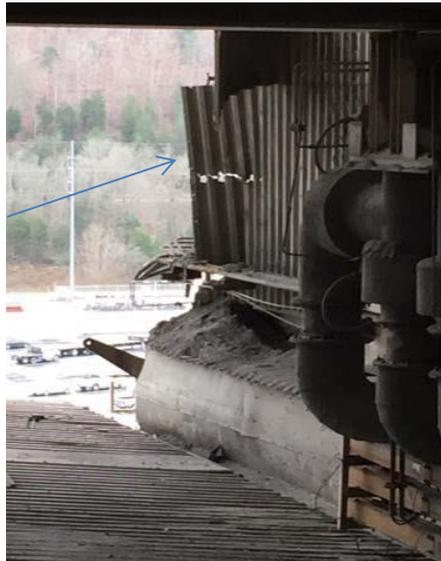
- **Falling Lagging:** Flue gas ductwork lagging is the finishing material used to cover insulation surrounding the duct. As shown in Illustration 1, flue gas leaks in the ductwork may cause deterioration resulting in visibly distressed lagging panels as well as locations where the lagging is hanging loosely or has completely fallen away from the duct. Loose lagging presents a safety concern for personnel working in the area due to its potential to fall to areas below. According to TVA Safety Operations personnel, loose lagging could be considered a safety hazard under OSHA's General Duty Clause, which mandates employers provide employees a place of employment "free from recognized hazards that are causing or are likely to cause death or serious physical harm."

Illustration 1
Loose Lagging on SCR Box,
Bull Run Fossil Plant,
December 2015

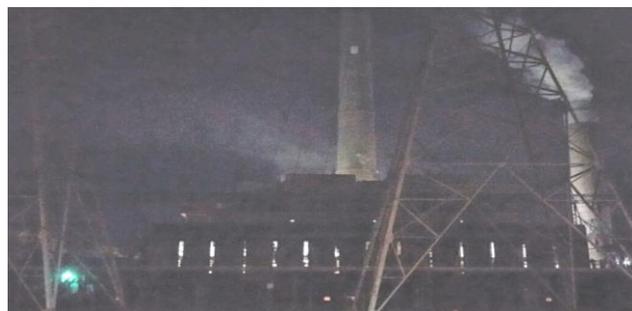
- **Flue Gas Exposure:** (See Illustration 2.) Flue gas is comprised of SO_2 , NO_x , and ash particles, which are subject to OSHA regulations for toxic and hazardous substances in the workplace. Applicable OSHA standards for SO_2 , NO_x , and ash particle levels are set for 8 hours of exposure and are to be measured by taking samples from impacted areas. According to OSHA, if air contaminated with harmful dust and gases cannot be controlled by engineering controls, appropriate respirators shall be used.

Illustration 2
Haze from Flue Gas Leaks
(Left of Stack Emissions),
Bull Run Fossil Plant,
March 2015

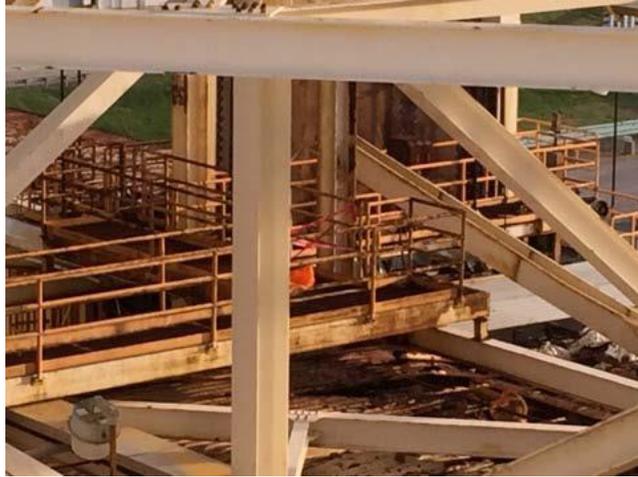
- **Compromised Grating:** Grating is an industrial flooring material made of metal. As such, it is susceptible to acidic compounds that can leak from ductwork, corroding the surface, as shown in Illustration 3. Corrosion may compromise structural integrity of the grating.

Illustration 3
Corroded Grating Near
Flue Gas Ductwork,
Cumberland Fossil Plant,
January 2016

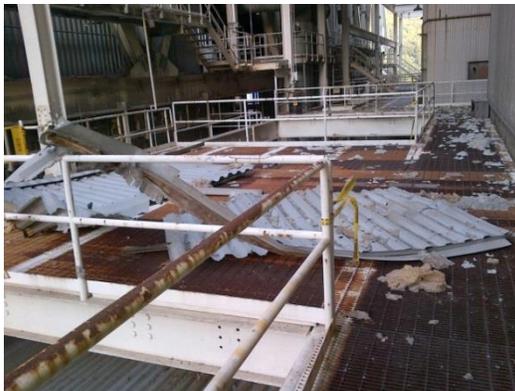
In addition, TVA's Safety Manual indicates every employee is responsible for knowing the hazards associated with his or her job and reporting each injury and near-miss accident.¹⁵ We reviewed documented recordable injuries and near misses and found no documented recordable injuries or near misses resulting from ductwork. However, we were provided examples of near misses at Bull Run that were not recorded, possibly due to an employee's fear of reprimand. An example of an unrecorded near miss due to fallen lagging at Bull Run is shown in Illustration 4.

Illustration 4
Fallen Lagging on a
Grated Walkway,
Bull Run Fossil Plant
