REQUEST FOR FINAL ACTION – EVALUATION 2019-15644 – NUCLEAR ARC FLASH PROTECTION

NUCLEAR ARC FLASH PROTECTION

Evaluation 2019-15644
July 13, 2020

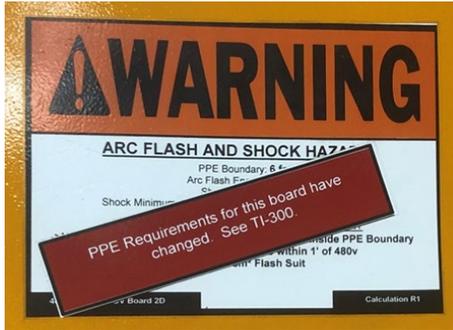
Illustration 2: Example of Label with Outdated Information at Browns Ferry

24 (22 percent) were unlabeled—16 at Browns Ferry, 4 at Sequoyah and 4 at Watts Bar. We also observed work locations at Browns Ferry that had arc flash labels marked out with a notice to consult a calculation that we determined to be obsolete (see Illustration 2). We were provided evidence dating back to 2018 that Browns Ferry was aware of over 130 missing arc flash labels. When we visited the plant in December 2019, plant management indicated there was no plan to post and/or update the labels.

TVA Management's Comments – TVA management agreed with the recommendation and will update postings on electrical boards as needed following the arc flash value revisions to NPG-SPP-18.4.9. See Appendix B for TVA's complete response.
