OFFICE OF INSPECTOR GENERAL

AUDIT OF USAID/WEST BANK AND GAZA CONSTRUCTION PROGRAMS

AUDIT REPORT NO. 8-294-16-001-P
FEBRUARY 22, 2016

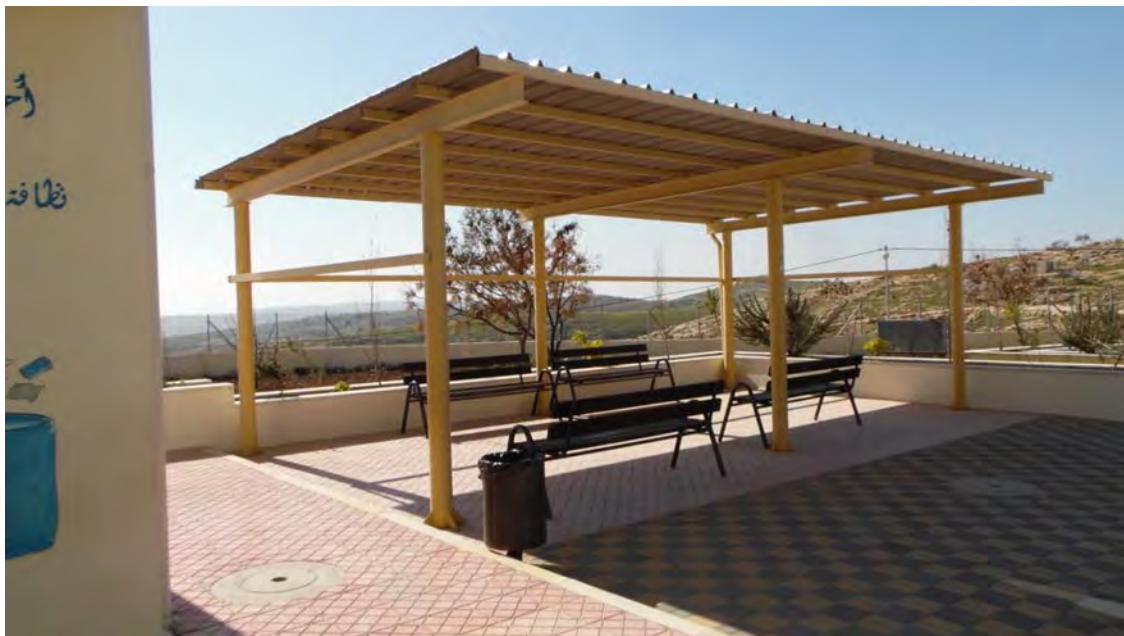
This shade area at Al Buweib Coeducational School was paid for by USAID. (Photo by RIG/Frankfurt, January 29, 2015)

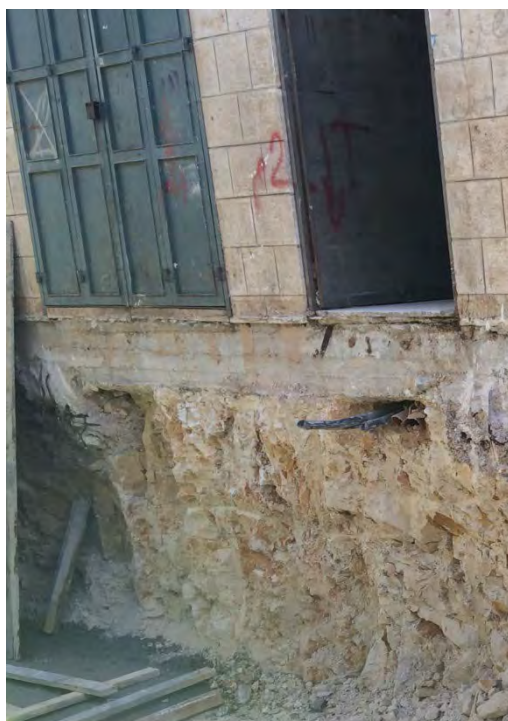
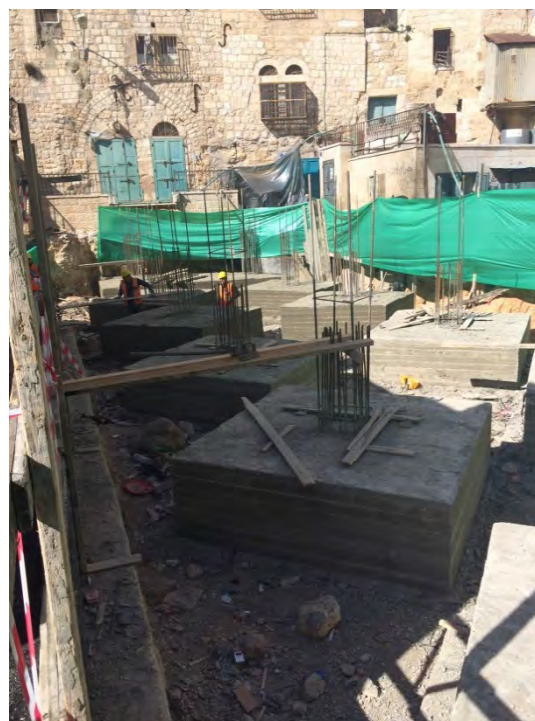
For example, the mission is renovating the Old Market in Bethlehem for more than \$2 million. This project is implemented through a cooperative agreement with American Near East Refugee Aid (ANERA), and the site is not subject to oversight provided by an A&E firm hired by the mission. Instead, ANERA's engineers supervised the excavation, steel construction, and other work, and ANERA hired an A&E firm to support them. The construction staff did not seem to understand steel construction, however, and neither mission staff nor staff from ANERA knew which building standards were used. This substantially increased the risk that the quality of the work will be poor. In another example at this site, workers were excavating beneath a building, which could cause it to collapse.

USAID is paying for renovations of the Old Market in Bethlehem. The work includes excavating under an existing building, left, and building foundations (right) for large, metal shade structures. (Photos by RIG/Frankfurt, February 3, 2015)
