INSPECTOR GENERAL

JUNE 2, 2017

U.S.-Controlled and -Occupied Military Facilities Inspection – Camp Lemonnier, Djibouti

Our objective was to inspect U.S. military-occupied facilities at Camp Lemonnier, Djibouti, to verify compliance with DoD health and safety policies and standards regarding electrical and fire protection systems.

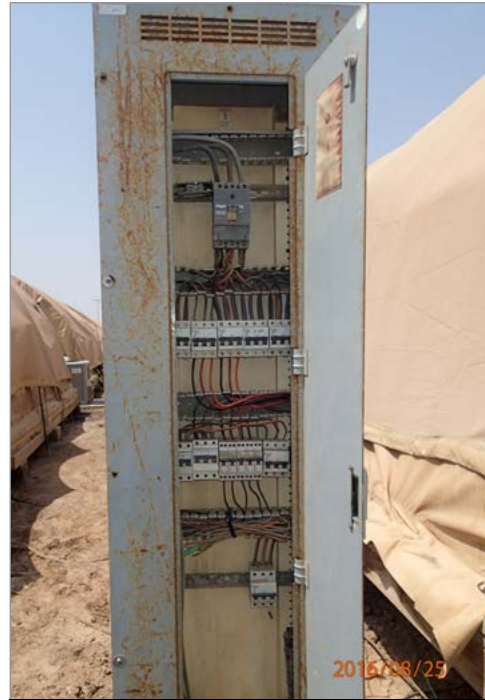
Electrical equipment installation and maintenance at Camp Lemonnier was not being performed in a manner consistent with NFPA standards. We found electrical panels installed outdoors that were not designed for outdoor conditions. The surge tents, which were temporary sleeping quarters, were powered by a nearby electrical panel, which was placed outdoors. The panel (Figure 2) was not protected from the environment and significantly degraded. The vents on the panel allowed dust and water to penetrate the panel, which could energize the panel exterior and shock personnel or start a fire. In addition, there was no front panel cover to prevent contact with the internal energized parts.

Figure 2. Electrical panel environmental degradation (Deficiency No. CLD-EL-160902-020)

- At building 111, an outdoor Electrical Panel built for use indoors is continually degrading due to it being placed in direct contact with the elements; openings allow for the infiltration of water and it has no dead-front protecting the internal components. This creates a shock and explosion hazard. Deficiency: CLD-EL-160902-020.

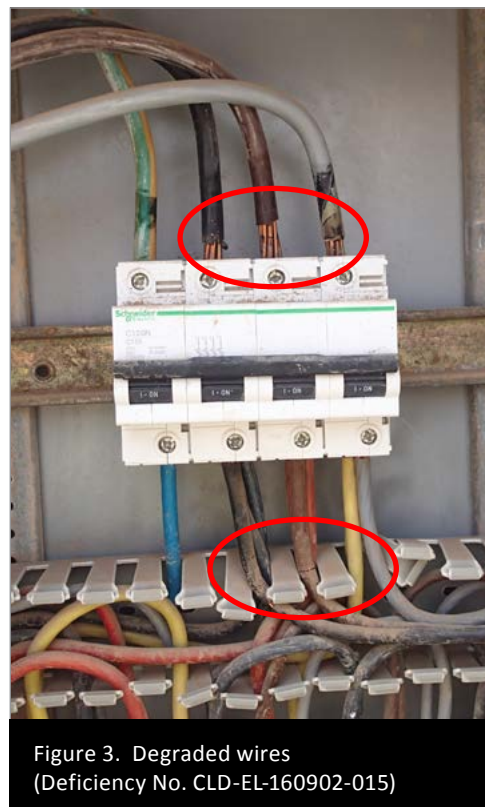
In another panel, we found scorched, cracked, and receding insulation on wires, which were signs of the wires overheating (Figure 3). Because the wire size was not rated for as high of a load as the circuit breaker, the wires were failing before the panel breakers tripped and stopped the flow of electricity. Wires that fail by overheating could cause an arc flash. An arc flash occurs when a flashover of electric current leaves its intended path and travels through the air from one conductor to another. The results are often violent and when a human is in close proximity to the arc flash, serious injury, and even death can occur.

Figure 3. Degraded wires (Deficiency No. CLD-EL-160902-015)

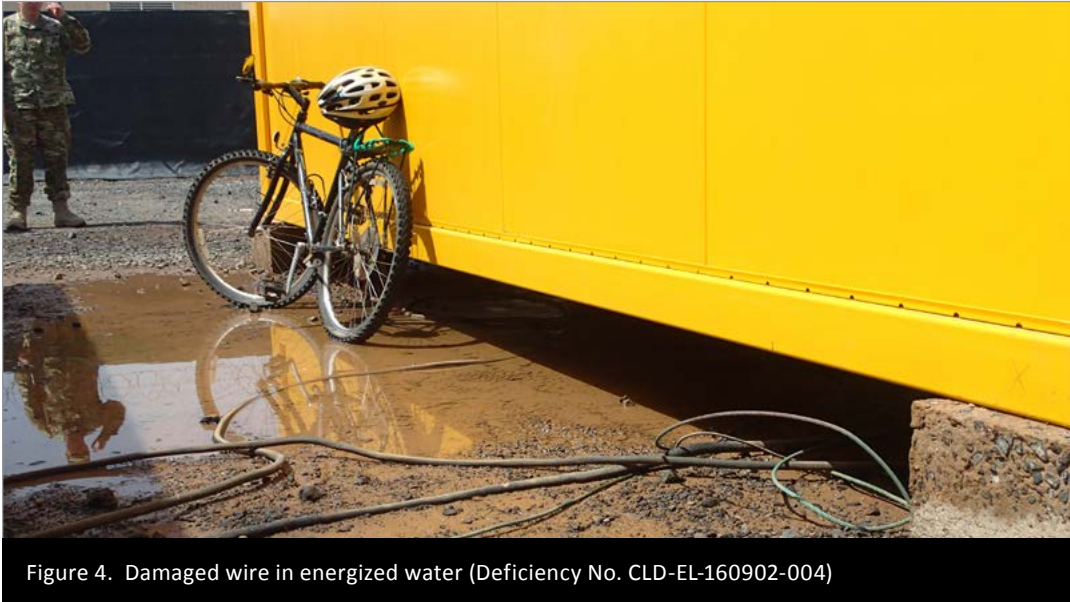
We documented 25 occurrences of unprotected large feeder wires. Buildings and air conditioning units were powered by large feeder wires, which were routed above ground without protection from foot, bicycle, and vehicle traffic. Traffic over wires causes the insulation to break or wear away, thus exposing the metal wire. Worn insulation may result in shock and electrocution. A wire with damaged insulation and submerged in water (Figure 4) was discovered between containerized working units. We observed the wire smoking and making crackling noises, which is evidence of broken insulation and energized water.

Figure 4. Damaged wire in energized water (Deficiency No. CLD-EL-160902-004)

- We found unprotected conductors laying on the ground vulnerable to abrasion by foot traffic. This is a systemic issue with 25 occurrences in the following 17 buildings; 313C, 313D, 925, 230, 111, 305, 427, 100, 453, 420E, 101, 102, 211, S6, S53, 630 and 130. This constitutes a severe shock/electrocution hazard to the warfighter should they come in contact with the exposed wiring. This is a base wide concern. Deficiency: CDL-EL-160902-004.

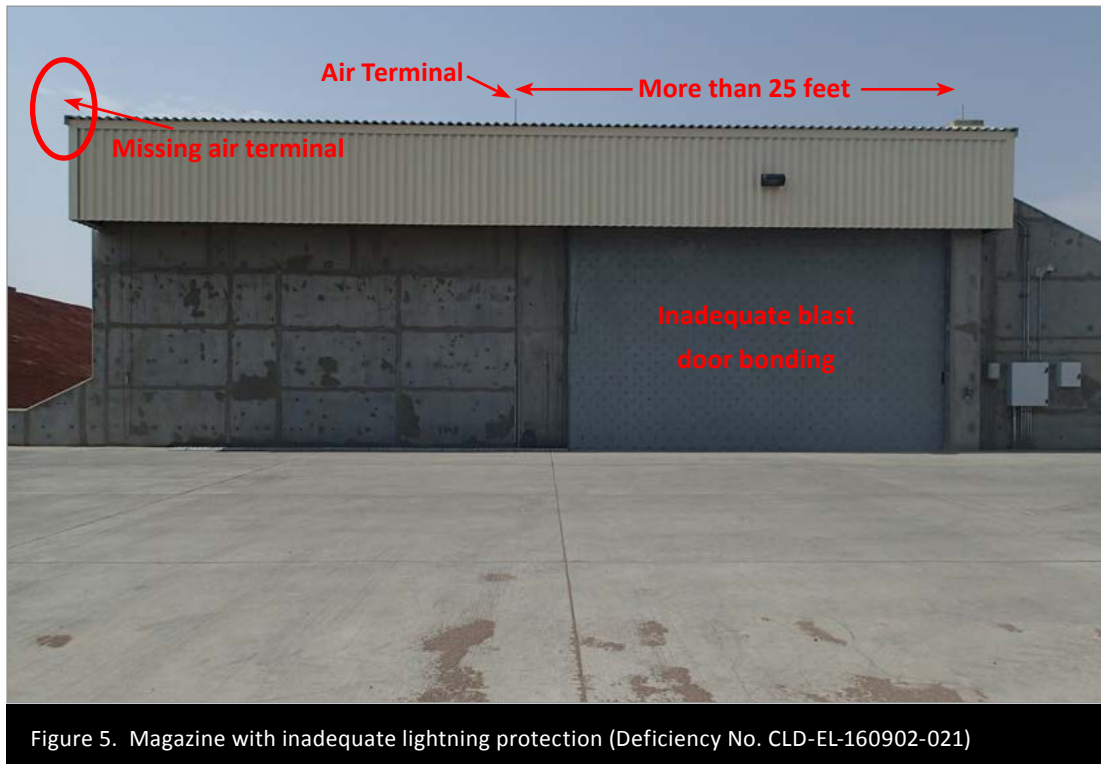
All four of the newly built, high-explosive magazines in the munition storage area had deficient lightning protection systems and lacked bonding of conductive fixtures (Figure 5). Without adequate lightning protection and bonding, lightning could strike a high-explosive magazine, create arcing, and transfer electricity through the conductors to electrocute personnel or explode ordnance. The distances between air terminals, also known as lightning rods or strike termination devices, was greater than the maximum allowed 25 feet. Each magazine has only two air terminals, which did not fully protect the structure. All of the magazines were missing the air terminals required on each of the rear vents.

- All four of the Igloo (High Explosive Magazines), Buildings 1050, 1060, 1070 and 1080 have air terminals with too large a separation distance; also there are missing air terminals on the left side of each Igloo and on the rear vent on top of each Igloo. This presents a significant and immediate risk of explosion during adverse weather. Deficiency: CLD-EL-160902-021.
- All four of the Igloo (High Explosive Magazines), Buildings 1050, 1060, 1070 and 1080 have a lack of, or improper bonding with their metal doors, metal frames, and fence gates. This presents a significant and immediate risk of explosion during adverse weather. Deficiency: CLD-EL-160902-022.

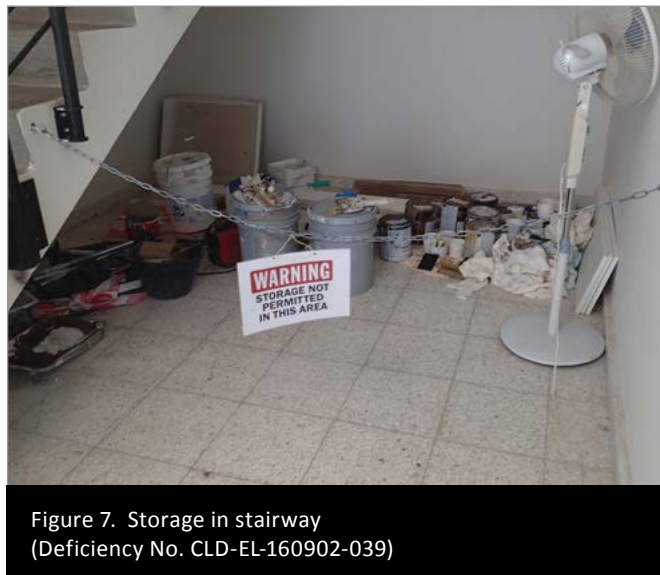
We found seven buildings with blocked exits, four of which had egress stairs blocked or were being used as storage. In building 737, there was a sign posted warning that storage is not allowed; however, there was storage present in the area (Figure 7). Potentially combustible materials, such as paint, brushes, and rags, stored in stairways could compromise the tenability of the exit enclosure and put lives at risk.

Figure 7. Storage in stairway
(Deficiency No. CLD-EL-160902-039)

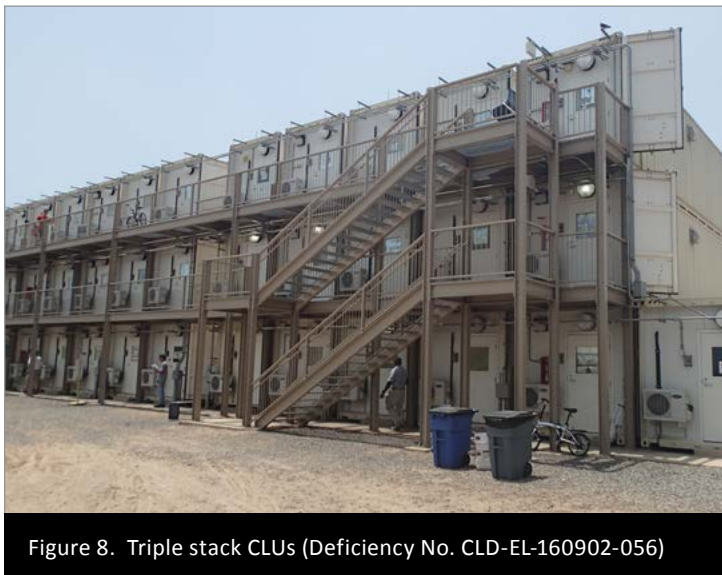
Figure 8. Triple stack CLUs (Deficiency No. CLD-EL-160902-056)

We found occupied containerized living units (CLUs) stacked three stories high with fire alarm systems that were not working and may not activate the sprinkler system. Figure 8 is a photograph of triple stacked CLUs. A CLU is a nonpermanent type of construction that UFC 1-201-01, section 3-3.1.5.1, limits stacking to four stories. However,

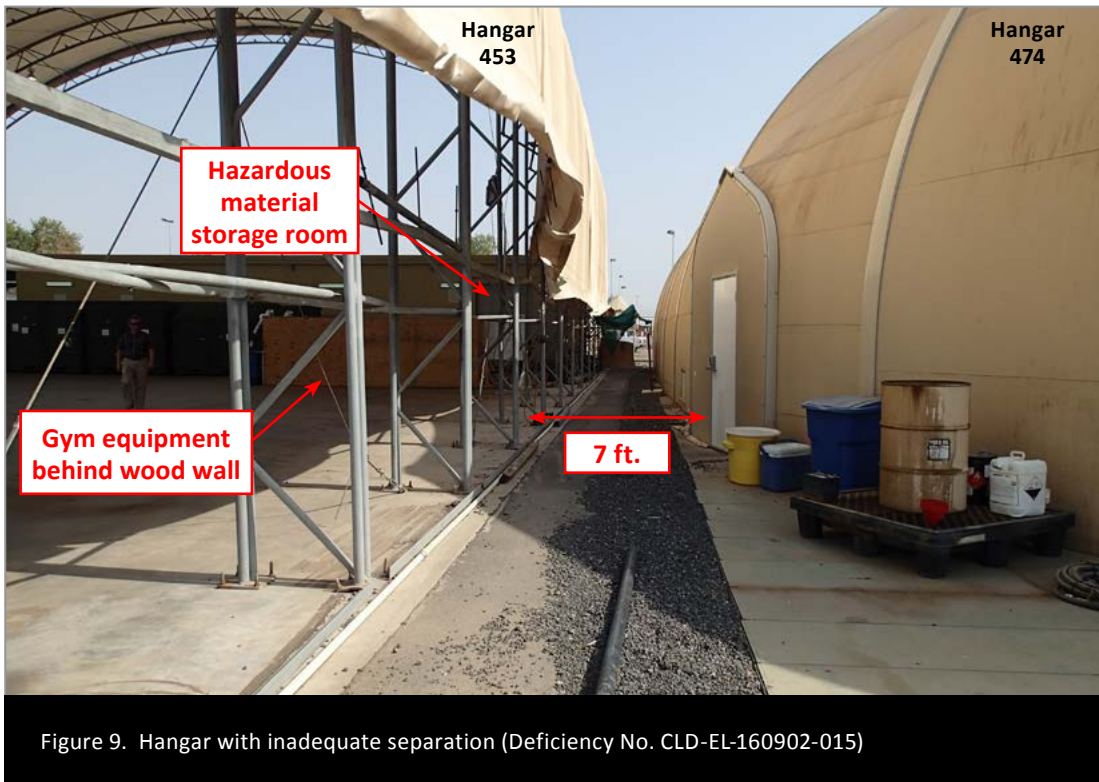
Two 13,000 square foot hangars (453 and 474) had inadequate separation. The distance between the two hangars was 7 feet (Figure 9). The UFC 1-201-01, “Non-Permanent DoD Facilities in Support of Military Operations,” requires hangars this size that are not separated by at least 50 feet to have fire protection as called for by UFC 3-600-01, “Fire Protection Engineering For Facilities.” Further, neither of the aircraft hangars had fire suppression systems and associated fire alarm as required by UFC 4-211-01N, “Aircraft Maintenance Hangars: Type I, Type II and Type III,” section 3-10. In hangar 474, we observed that an office had been constructed without code-required, fire-rated walls and doors. Fire-rated walls and doors prevent the risk of injury to occupants by allowing them ample time to escape during a fire.
