INSPECTOR GENERAL

JULY 20, 2017

Followup on DoD OIG Report No. DODIG-2015-013, "Military Housing Inspections – Republic of Korea," October 28, 2014

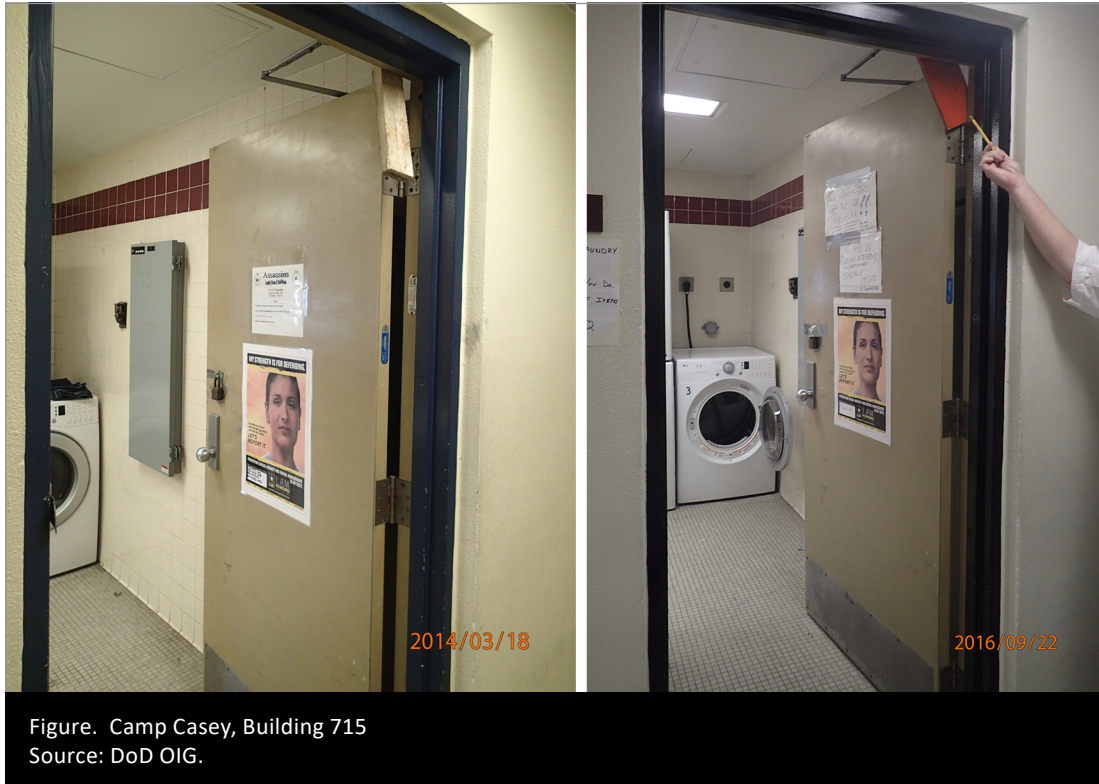
Figure. Camp Casey, Building 715
Source: DoD OIG.

Despite the efforts of the Army and Air Force to identify the root causes for the deficiencies identified in 2014, the deficiencies continued to exist in 2016. For example, in 2014, we identified a systemic concern with non-compliant corridor doors, exit stair doors, and laundry room doors. Stair fire doors are required to be fire-rated, should not be propped open, and should have well-functioning door closers, as required by NFPA 101.⁴ The intent is to protect the means of egress and allow building occupants time to evacuate safely. If fire doors are blocked or wedged open, they will not function as designed to protect the building and its occupants. In Report No. DODIG-2015-013, we identified a laundry room door in a barracks building at Camp Casey, as propped open and improperly fire-rated. During our 2016 followup inspection, we identified the deficiency continued to exist, despite being reported as corrected. See the figure.

⁴ The Life Safety Code Handbook (NFPA 101) has several applicable sections depending on the classification and type of building. For example, NFPA 101, section 29.3.6.2.3., states, “[d]oors that open onto exit access corridors shall be self-closing and self-latching.” Also, section 8.3.4.1., states, “[e]very opening in a fire barrier shall be protected to limit the spread of fire and restrict the movement of smoke from one side of the fire barrier to the other.”
