# INSPECTOR GENERAL

AUGUST 13, 2020

## Followup Audit on Recommendations to Correct Building Deficiencies at the Naval Station Great Lakes Fire Station

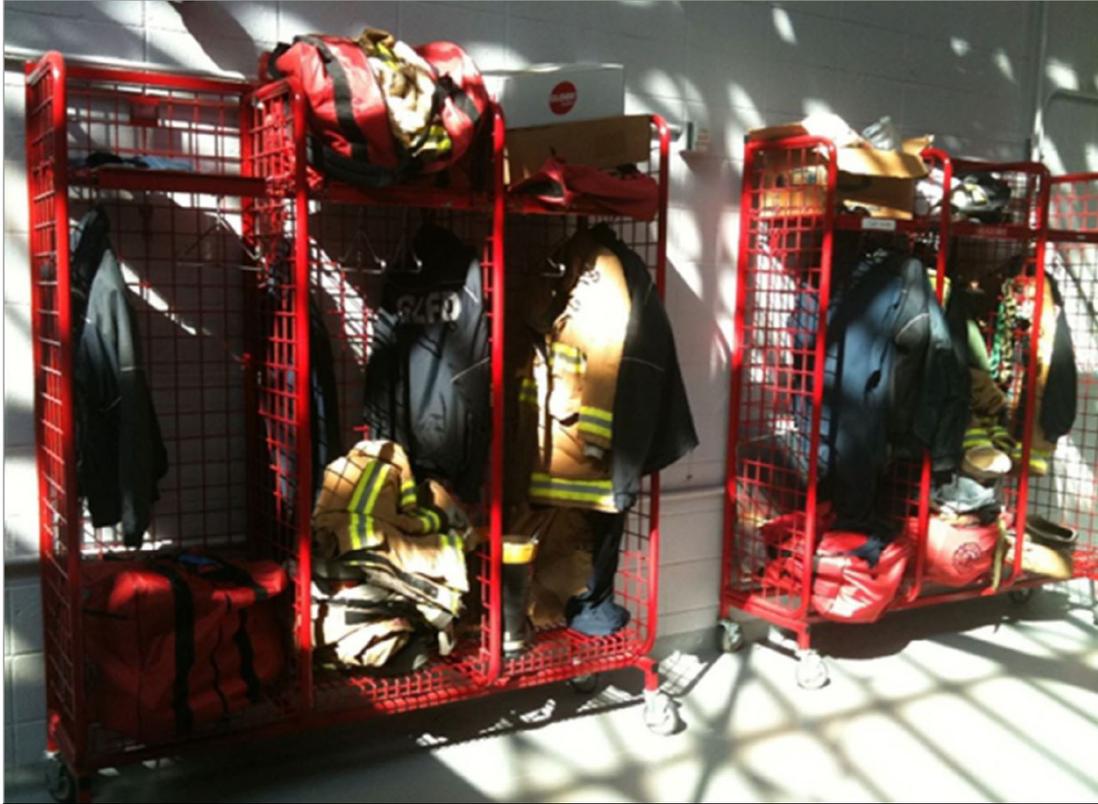
- Personal protective equipment (PPE) was not stored in a negatively pressurized room and was exposed to sunlight, which could cause the PPE to deteriorate or damage and potentially expose firefighters to gaseous emissions.<sup>9</sup>

Figure 3. Storage of PPE Exposed to Sunlight Before a Dedicated PPE Storage Room Was Added  
Source: The DoD OIG.

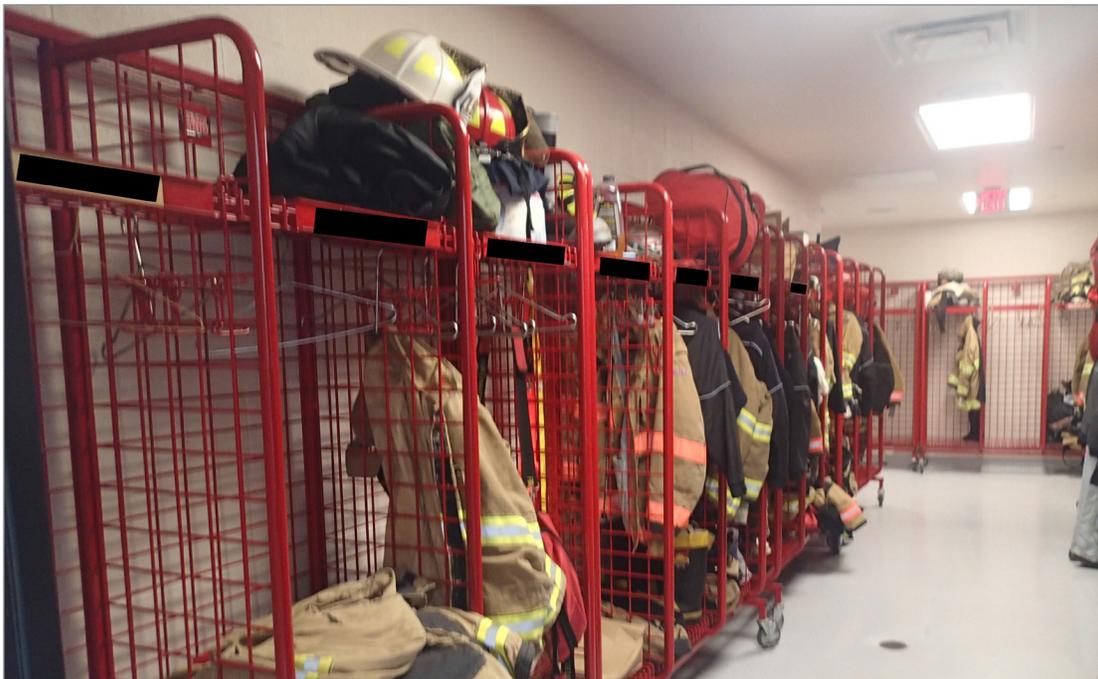
Figure 4. The New PPE Storage Room at Building 106  
Source: The DoD OIG.

The new rooms complied with UFC 4-730-10 because all three rooms were negatively pressurized, and the PPE storage and laundry rooms had dedicated exhaust systems vented to the outside, among other UFC requirements. In addition, the PPE gear was no longer exposed to sunlight, as identified by Report No. DODIG-2012-132. Therefore, these deficiencies were corrected.

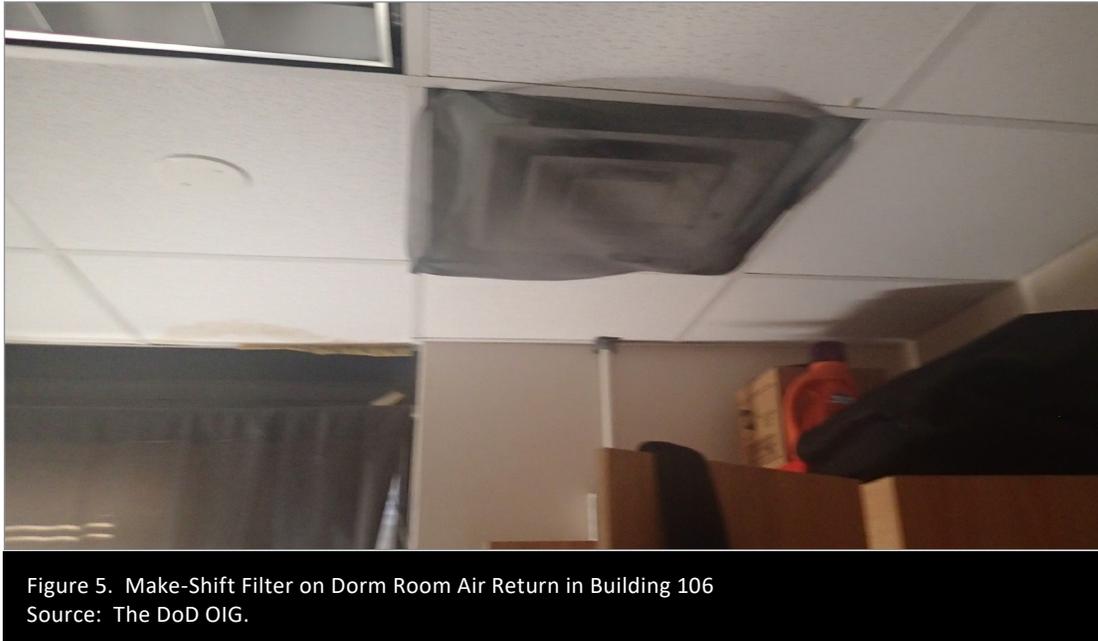
In addition, PWD Great Lakes officials did not correct the additional HVAC deficiency specific to the second floor dorm areas that NAVFAC Midwest officials identified in their management comments to Report No. DODIG-2012-132. To address this deficiency, PWD Great Lakes officials installed a door vent to aid in air flow; however, this did not correct the air flow concerns. The HVAC system for the firefighter dorm rooms remains one of the firefighters' top concerns. In 2019, there were 17 HVAC-related work orders, and during our building inspection, we identified additional evidence of continuous HVAC issues, such as dirty air diffusers, fans, humidifiers, and dehumidifiers. The NSGL firefighters stated that their air ducts are dirty, so they installed make-shift filters on the air returns to prevent dust and debris from entering the room. Therefore, this deficiency still requires corrective actions. PWD Great Lakes officials submitted a service request to replace the air handler unit at building 106, with a projected start date in FY 2021. See Figure 5 for the make-shift filter in the dorm rooms.

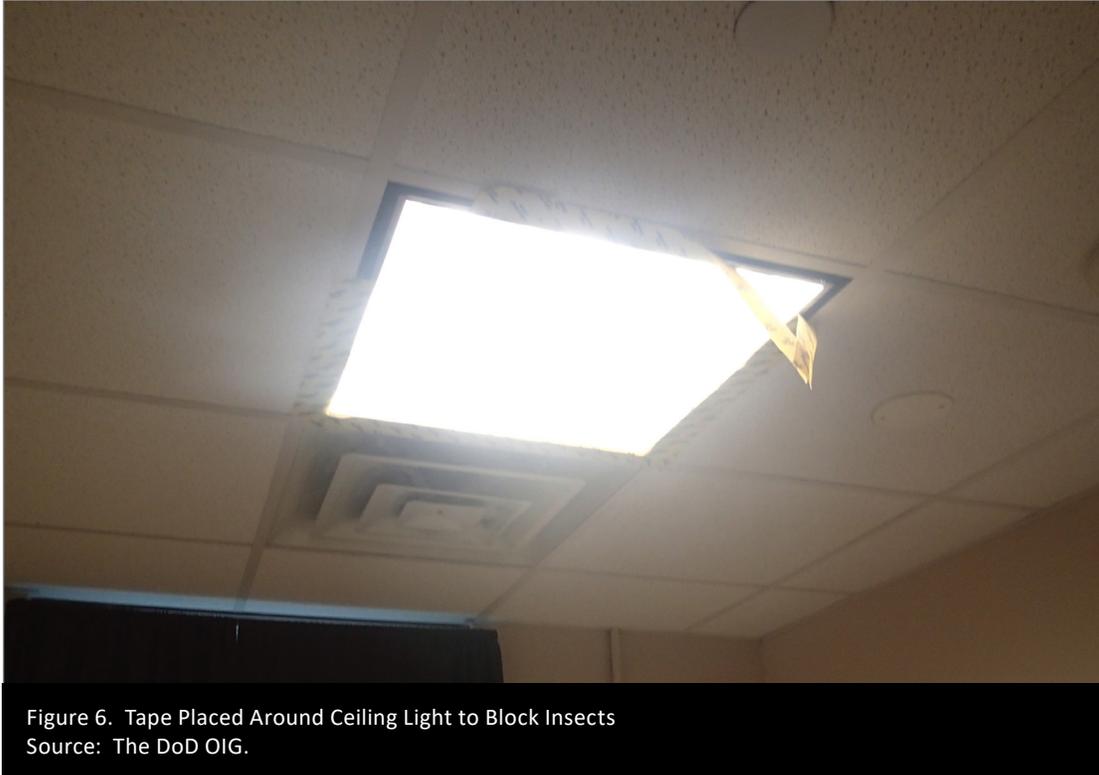
Figure 6. Tape Placed Around Ceiling Light to Block Insects  
Source: The DoD OIG.

While NAVFAC officials awarded a facility service contract for pest control services, pests remain a concern at building 106, as evidenced by the statements from NSGL firefighters and the ongoing actions by firefighters that we observed, including taping gaps in the ceiling tiles to prevent pests from entering their rooms.<sup>24</sup>

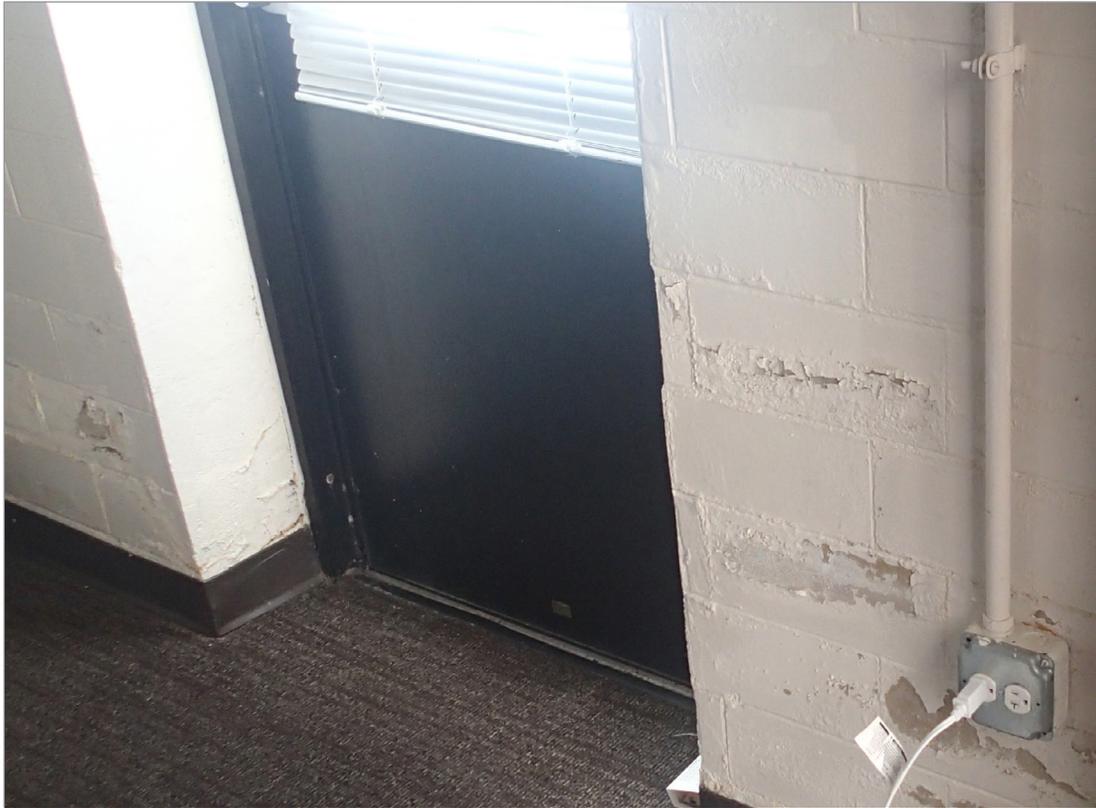
PWD Great Lakes officials did not correct the blistering paint deficiency that NAVFAC Midwest officials identified in their management comments to Report No. DODIG-2012-132. To correct this deficiency, PWD Great Lakes officials repainted the walls in room 121; however, when we inspected the facility, the paint was beginning to peel off again. According to the assigned NSGL Fire Department building monitor, the paint on the walls in room 121 is a constant issue. He explained that, according to PWD Great Lakes officials, the bricks used to build the walls have a glaze on them which causes the paint to bubble and eventually peel off. See Figure 7 on the next page for the blistering paint in room 121.

Figure 7. Peeling Wall Paint in Room 121  
Source: The DoD OIG.

While PWD Great Lakes officials addressed the deficiency by repainting the walls of room 121, this deficiency still requires corrective actions because the paint that they used continues to result in paint peeling off the wall. Therefore, this deficiency still requires corrective action. As of March 2020, PWD Great Lakes officials could not provide documentation to support any planned actions to address the blistering paint.

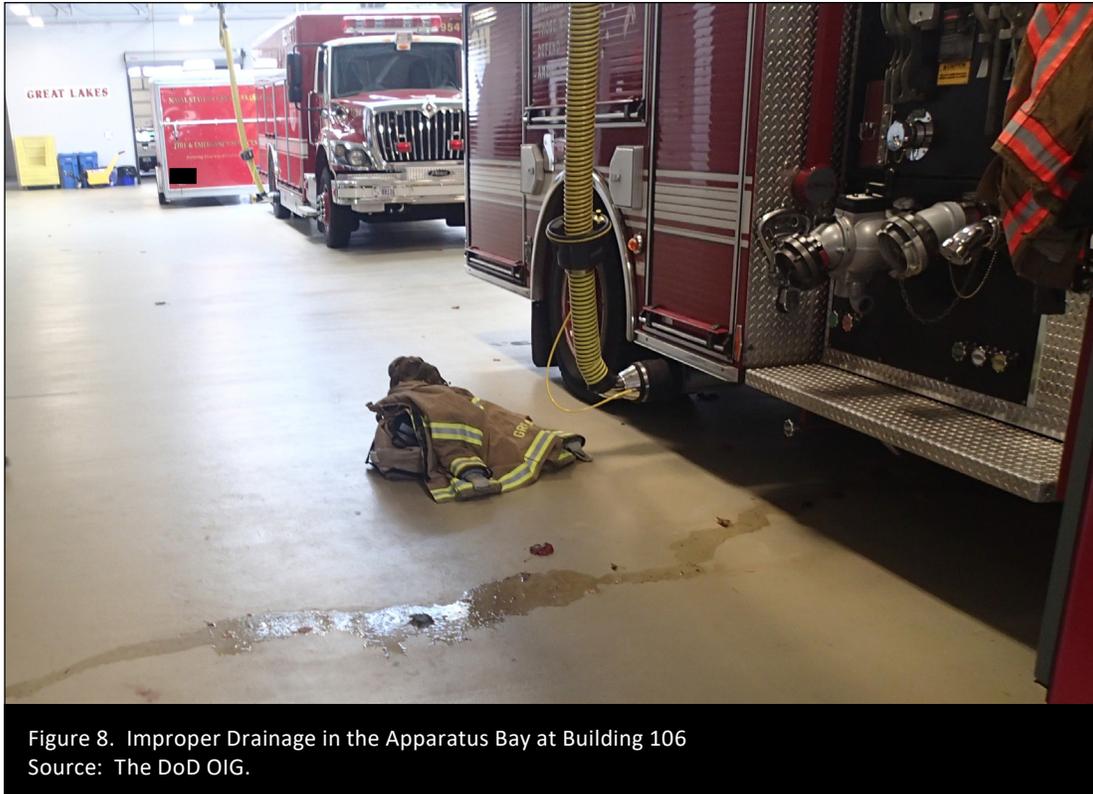
The apparatus bay floor drains were not properly installed in accordance with UFC 4-730-10. Floor drains are required to be parallel to the centerline of each vehicle parked inside the apparatus bay. However, the slope of the floor installed in the main apparatus bay in building 106 was designed to drain from one side of the bay to the other. Therefore, when water drained, it created potential slip and fall hazards as it crossed a passageway inside the apparatus bay. The assigned NSGL Fire Department building monitor submitted a service request to install proper floor drains in the apparatus bays on January 11, 2020; however, as of March 2020, it has not been completed. See Figure 8 on the next page for improper water drainage through a passageway inside the apparatus bay.

Figure 8. Improper Drainage in the Apparatus Bay at Building 106  
Source: The DoD OIG.

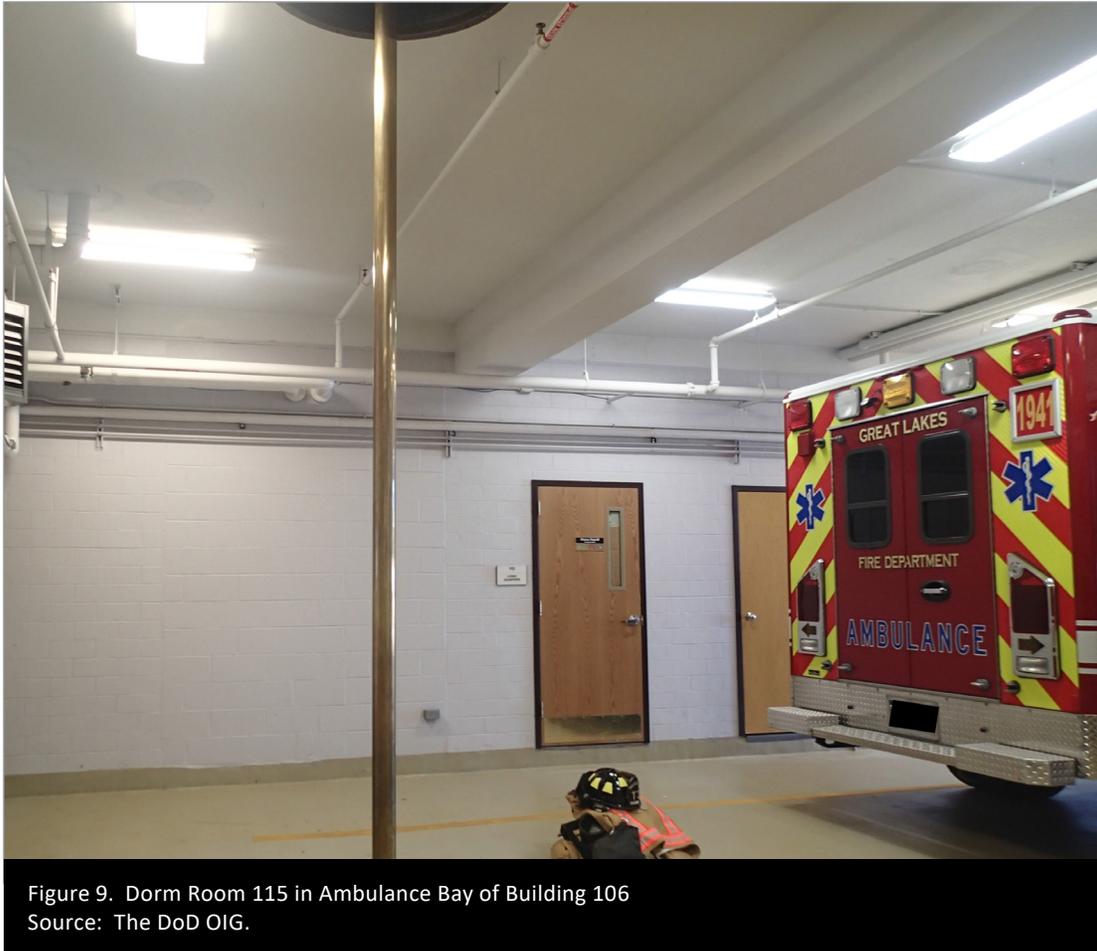
Figure 9. Dorm Room 115 in Ambulance Bay of Building 106  
Source: The DoD OIG.

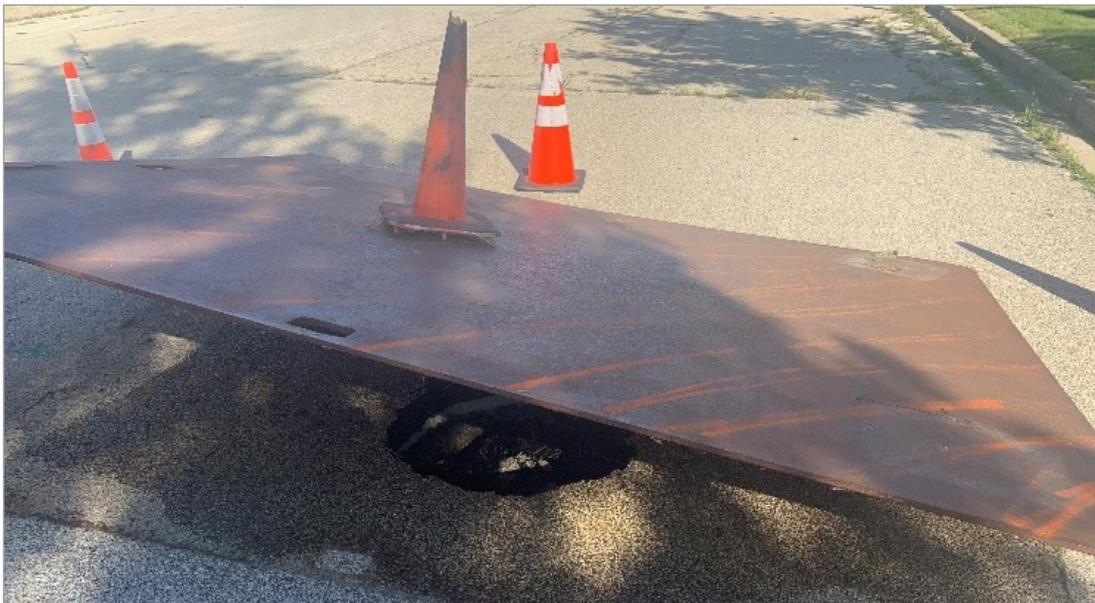
During our inspection of building 106 in September 2019, we identified a sinkhole in the parking lot to the south of the facility. According to the NSGL PWO, the sinkhole found outside of building 106 resulted from storm water eroding surrounding soil due to a collapsed storm drain. The NSGL PWO stated that the installation's storm drainage structures were constructed of brick, which eventually erode and collapse, eliminating their ability to carry storm water and clogging the storm water pipes. See Figure 10 for a picture of the sinkhole that is located outside of building 106.

Figure 10. A Sinkhole Located Outside of Building 106  
Source: The DoD OIG.

In January 2020, PWD Great Lakes officials stated that they fixed the sinkhole by digging out the collapsed material, refilling the hole, and then resurfacing the area. In addition, according to the assigned NSGL Fire Department building monitor, another project was completed nearby to add drainage for that drain. However, the NSGL PWO stated that the sinkhole issue was broader than the area surrounding the building. As previously stated, the storm drains on the main side of the installation were constructed of brick, rather than concrete, which eventually collapse, eliminating the ability to carry storm water. In addition, the PWO stated that he was unable to maintain a comprehensive set of drawings identifying where the storm drains, pipes, and outfalls were located on the installation.<sup>39</sup> He stated that the storm water outfalls were not properly maintained and resulted in backups, collapsed drains, and localized flooding.
