OIG

AUD-MERO-17-44

June 2017

Management Assistance Report: Building Deficiencies Identified at U.S. Embassy Kabul, Afghanistan Need Prompt Attention

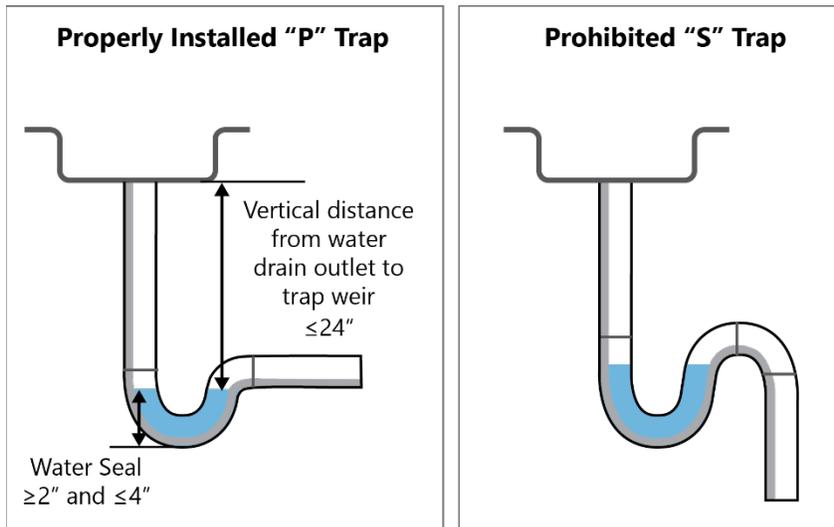
Figure 3: Properly Installed "P" Trap versus Prohibited "S" Trap

After completing an assessment of plumbing systems, PAE reported that incorrect water-seal traps had been installed beneath fixtures in SDA-1. Specifically, they found that the contractor had installed "S" traps, rather than the more appropriate "P" traps throughout the building. USACE engineers reviewed the assessment completed by PAE and concurred that there were issues with the design and/or installation of plumbing systems. The purpose of a trap is to prevent sewer gases, and possibly vermin, from coming into the building; more specifically, when water sits in the trap, sewer gases stay out. The S traps that were used in SDA-1 do not accomplish this goal. In fact, the International Plumbing Code (Chapter 10, Section 1002.3) prohibits the use of "S" traps because they are not properly vented and have the potential to siphon water out of the trap as water flows down the drain. If enough water is siphoned out of an "S" trap, it can break the water seal and allow sewer gases to come into the residence. In contrast, on a properly installed "P" trap, there is a vent at the same place the drain turns downwards, which breaks the siphon. The vent prevents water from getting sucked out of the trap. Figure 3 compares these two types of traps.

Section 901.2 of the International Plumbing Code requires that plumbing fixtures be properly vented, but the code allows for the use of a variety of methods to vent plumbing fixtures and traps. Circuit venting is one method that is widely used in the plumbing industry. The principle of circuit venting is that the flow of drainage through pipes should never exceed a half-full condition. Thus, the air for venting the fixtures circulates in the top half of the horizontal drain pipe, thereby preventing pressure differentials from affecting the connected fixtures. However, according to PAE, the use of "S" traps in SDA-1 means that plumbing fixtures throughout the building routinely exceed the half-full condition, causing improper drainage and backed-up drains throughout the building. When plumbing systems are not properly vented, a number of problems can occur, including the following:

These problems that are commonly associated with improper venting are consistent with the problems that PAE has observed in SDA-1. Further, according to PAE, sewer gas seeping into apartments is not just malodorous; it also contains methane, which in sufficient quantities can explode. It may also contain pathogens that can cause illness.

Caddell acknowledged that not all plumbing fixtures had been installed according to code. However, they disagreed with the number of plumbing issues reported. During the meeting, embassy facility managers discussed the difficulties with maintenance and the increase in plumbing-related work orders. A number of possible strategies regarding how to address the identified deficiencies were discussed. Caddell estimated that a fix would take as long as 9 months and may require residents to vacate their apartments while necessary repairs and renovations are executed. OBO concluded that the plumbing installation was subject to “poor interpretation and execution of the plumbing code.” Despite its acknowledgement that not all plumbing fixtures had been installed according to code, Caddell maintained that OBO engineers responsible for QA signed off on the installation.

OBO concluded that “failure in quality control is evident” and that the current as-built condition is not compliant and is unacceptable to OBO. In a follow-up meeting, OBO reported that plumbing deficiencies in SDA-1 will be addressed through a phased plan to identify and address all plumbing deficiencies. According to OBO, the plan will include a total of seven phases and will take approximately 8 months to implement. However, the plan does not explicitly state that Caddell will be held responsible for addressing all identified deficiencies but notes that in phase 4 of the plan, a meeting will be held with stakeholders to determine responsibility for resolving the identified issues. Although OBO stated that some issues may be design errors, which would not be Caddell’s responsibility, it also indicated that Caddell will be held responsible for any installation mistakes. However, if these repairs are not conducted under the terms of Caddell’s 1-year warranty, the costs to OBO could be significant.

Recommendation 1: OIG recommends that the Bureau of Overseas Buildings Operations have a qualified professional experienced in the installation of plumbing systems conduct a full inspection, analysis, and recommissioning of waste and vent plumbing systems in the Staff Diplomatic Apartment-1. This inspection should include a comprehensive review of all submittals, plans, and specifications, as well as all installation methods and materials.

Recommendation 2: OIG recommends that the Bureau of Overseas Buildings Operations implement actions to replace and correct all plumbing installations in the Staff Diplomatic Apartment-1 found not to conform to the contract requirements.

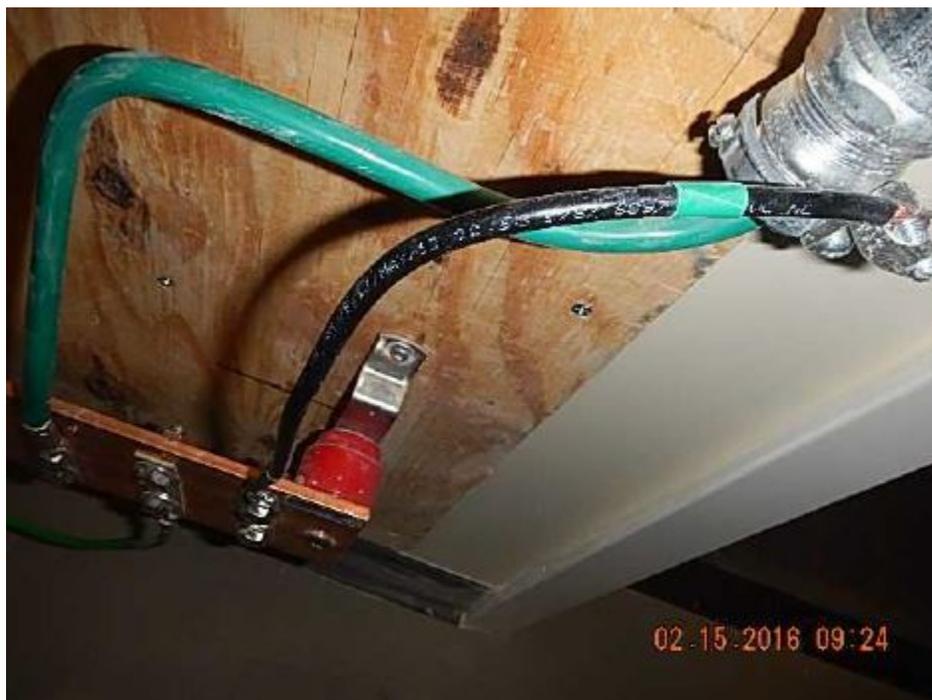
In multiple locations throughout the NOX and SDA-1, USACE identified equipment grounding conductors that were not properly identified and labeled in accordance with the NEC. NEC 2008 Article 250.119 states that individually covered or insulated equipment grounding conductors must have a continuous outer finish that is either green or green with one or more yellow stripes. This is important because the improper identification of the grounding conductor could result in the conductor being mistaken for a phased conductor (a "hot" conductor with current running on it). Improper identification of grounding conductors can result in maintenance mistakes or even electric shock if maintenance workers mistake a hot conductor for a grounded conductor. Nevertheless, USACE identified instances, as shown in Figure 4, when black conductors were used as equipment grounding conductors and were labeled with a single piece of green tape.

Figure 4: Improper black conductor in NOX labeled with small piece of green tape.

Recommendation 3: OIG recommends that the Bureau of Overseas Buildings Operations have a qualified professional experienced in the installation of electrical systems conduct a full inspection, analysis, and recommissioning of electrical systems in both the New Office Annex and Staff Diplomatic Apartment-1. This inspection should include a comprehensive review of all submittals, plans, and specifications, as well as all installation methods and materials.

Recommendation 4: OIG recommends that the Bureau of Overseas Buildings Operations implement actions to replace and correct all electrical system installations in the New Office Annex and Staff Diplomatic Apartment-1 found not to conform to the contract requirements.

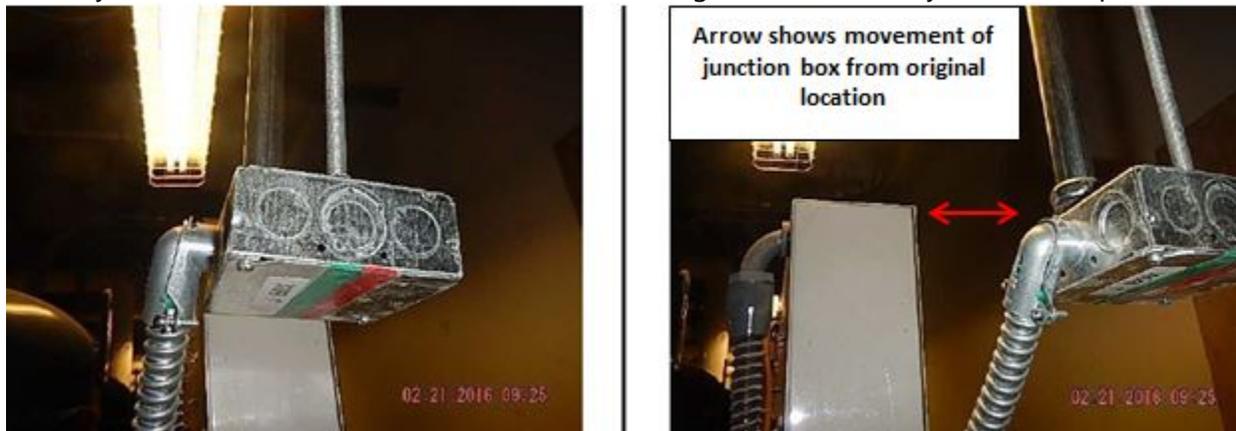
As shown in Figure 5, USACE electricians found multiple locations where junction boxes suspended from the ceiling were not secured properly. According to NEC 2008 Article 300.11, raceways, cable assemblies, boxes, cabinets, and fittings shall be securely fastened in place.

Figure 5: Junction box suspended from the ceiling is not secured properly.
Source: Photo taken by Task Force POWER on February 21, 2016.

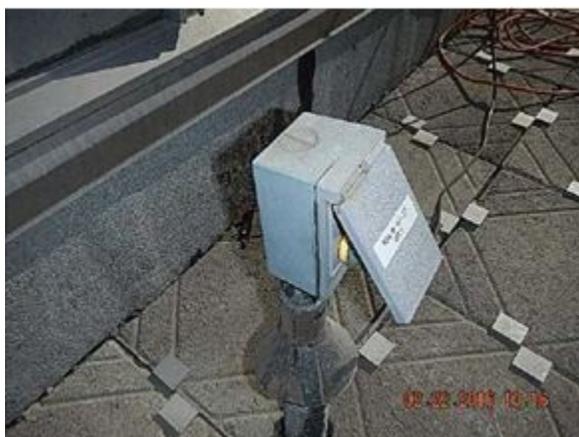
In multiple locations in the NOX and SDA-1, Task Force POWER identified instances of conduit not rated for wet locations that were nonetheless installed outdoors and without proper weatherproof fittings. As stated in NEC 2008 Article 314.15 and 406.8(B)(2), a receptacle installed in a wet location must have an enclosure that is listed for use in a wet location or that is weatherproof. Failure to properly protect receptacles during wet weather may result in connected devices experiencing a trip fault or maintenance personnel receiving an electrical shock. Figure 6 shows an unattended plugged-in device without a waterproof enclosure.

Figure 6: Unattended, plugged-in device without a waterproof enclosure in SDA-1.
Source: Photo taken by Task Force POWER on February 22, 2016, and verified by OIG on November 1, 2016.

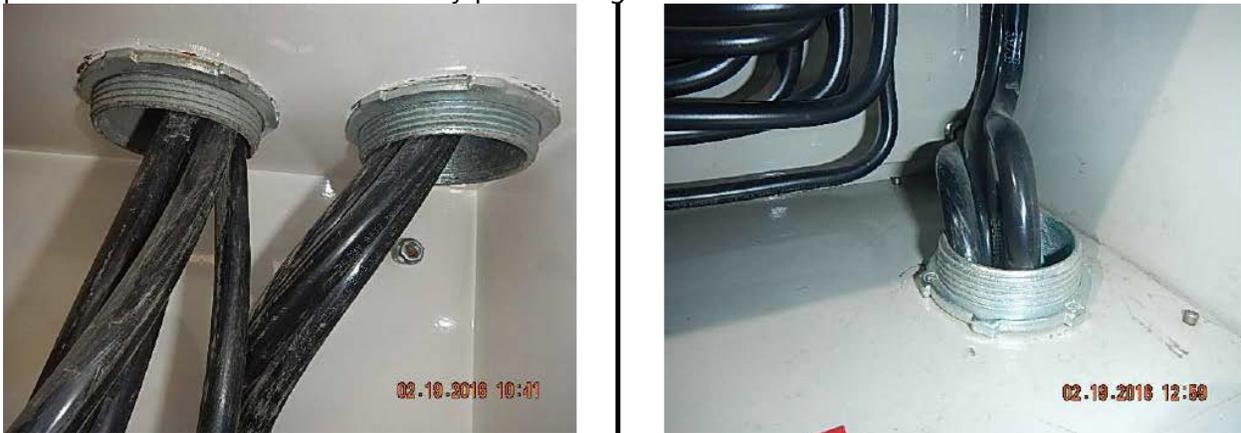
According to NEC 2008 Article 300.4(G), where raceways contain 4 AWG, or larger, insulated circuit conductors and these conductors enter a cabinet, box, enclosure, or raceway (an enclosed

channel), the conductors must be protected by a substantial fitting that provides a smoothly rounded insulating surface. Otherwise, when it is pulled over the sharp edges of an unprotected connector, the conductor may be damaged, possibly resulting in a catastrophic short circuit or equipment failure. As shown in Figure 7, Task Force POWER found that not all conductors were protected from abrasion where they pass through metal.

Figure 7: Unprotected raceways in NOX.

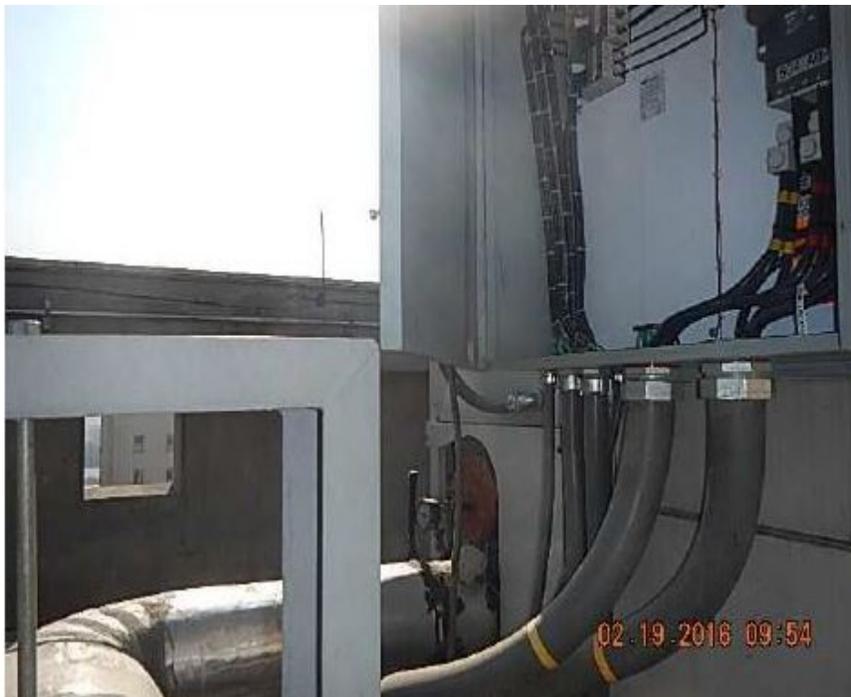
In multiple locations in the NOX and SDA-1, electrical equipment does not have adequate work space for maintenance. NEC 2008 Articles 110.32 and 110.26 require that all doors and hinged panels be able to open to at least a 90-degree angle and that sufficient access and working space be provided and maintained around all electrical equipment to permit ready and safe O&M of such equipment. Figure 8 shows an obstructed electrical panel on the NOX rooftop.

Figure 8: Obstructed electrical panel on NOX rooftop.

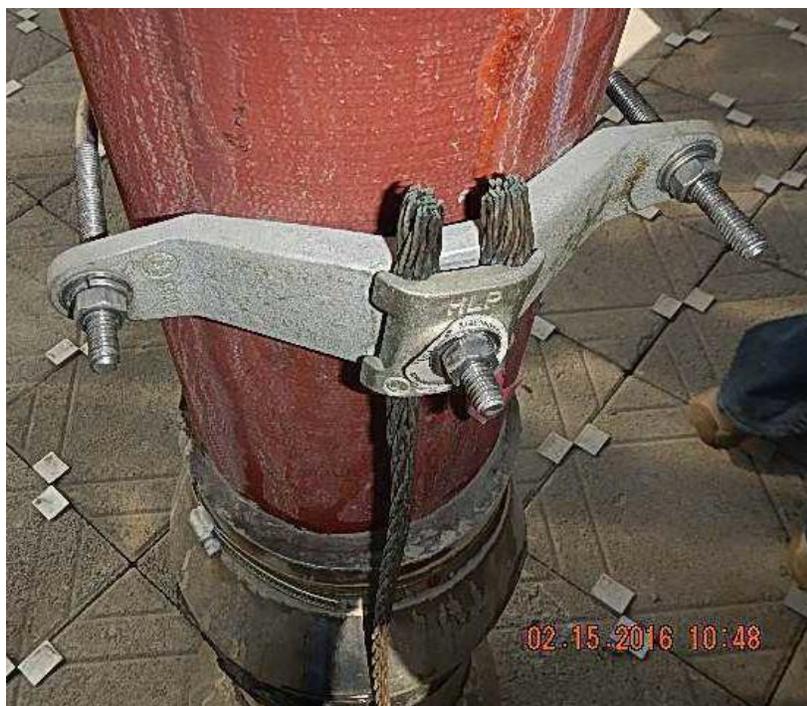
Task Force POWER found that non-conductive coatings (such as paint) were present on equipment. According to NEC 2008 Article 250.12, non-conductive coatings on equipment to be grounded must be removed to ensure good electrical connectivity. If non-conductive coatings are not removed from the equipment prior to installation of bonding clamps to pipes, good electrical connectivity is compromised.

Figure 9: Paint compromises electrical connection with bonding clamp.

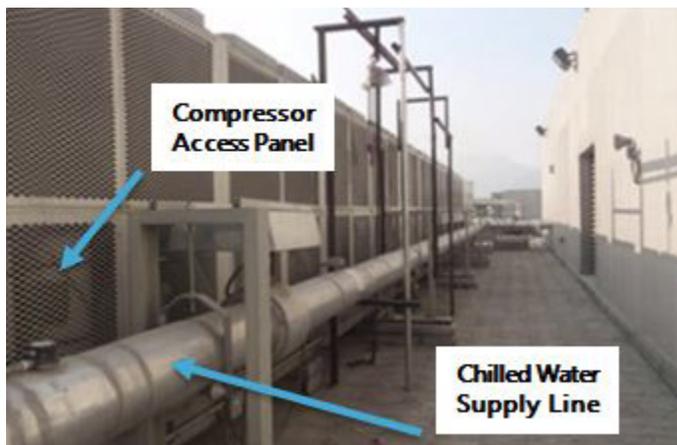
The chilled water supply pipe on the rooftop of the NOX is placed too close to the chiller, restricting access to the compressors for maintenance. The main chiller supply line is installed roughly 18 inches in front of the compressor access panels. The manufacturer recommends a clearance of 42 inches, and the contract drawings show that the supply line should have been installed 50 inches from the chiller. As a result of the installation, access to the compressors for O&M is significantly impaired. As shown in Figure 10, the supply line runs the entire length of the chiller, making it difficult to access the compressors for repair or maintenance.

Figure 10: Chilled water line on NOX rooftop.
Source: Photo taken by USACE on February 15, 2016, and verified by OIG on April 9, 2017.

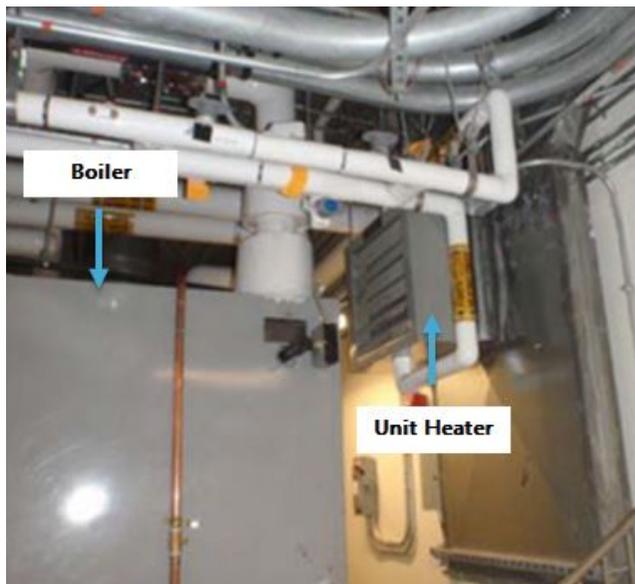
The hot water unit heater in the mechanical room on the 7th floor of the NOX is installed too close to boiler box 7-2. Contract drawings show the boiler should have adequate clearance on all sides to allow for routine maintenance. However, as shown in Figure 11, access to the boiler is obstructed by the placement of the unit heater.

Figure 11: Boiler in 7th floor mechanical room of the NOX.
Source: Photo taken by USACE on February 15, 2016, and verified by OIG on April 9, 2017.

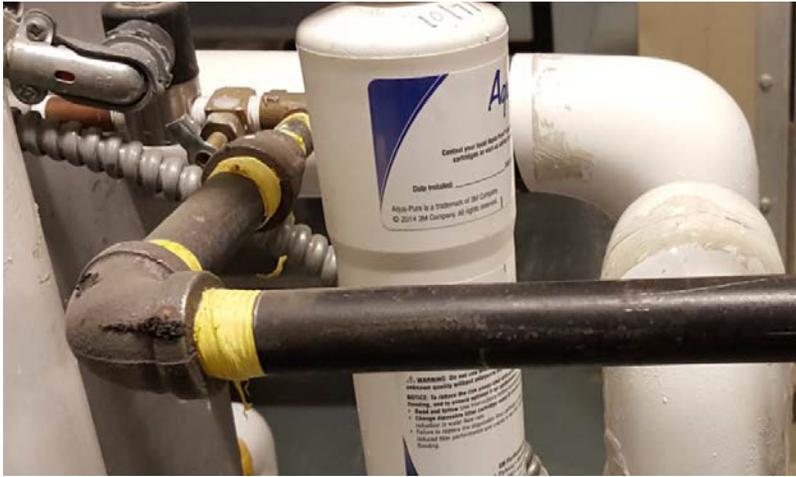
OIG found that dielectric fittings were not installed consistently throughout the NOX and SDA-1. Division 15 of the contract specifications requires that dielectric fittings be used to connect piping materials made of different metals. Typically, in a dielectric fitting, a non-conducting washer, usually made of rubber, prevents two dissimilar metals from interacting and helps to prevent accelerated corrosion. USACE and OIG found that dielectric fittings were used as required by the contract specifications in some cases, but not in others. Figure 12 shows piping used in HVAC systems in SDA-1 with no dielectric fittings between black iron and brass connections.

Figure 12: Piping used in HVAC systems in SDA-1 installed without dielectric fittings.
Source: Photo taken by OIG on May 2, 2017.

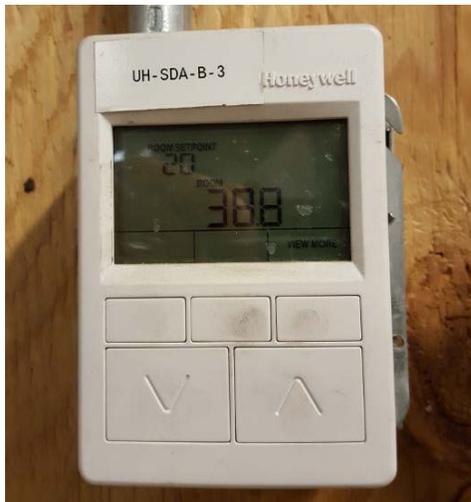
According to PAE, the air temperature in the boiler room in SDA-1 consistently exceeds 100 degrees Fahrenheit. Industry experts state that temperatures higher than 80 degrees Fahrenheit are not consistent with standard engineering practice and may compromise boiler efficiency. While the equipment in the boiler room is currently functioning properly, the elevated air temperatures in the boiler room may result in shortened life-cycles of the equipment over the long term.

Figure 13: Thermostat in SDA-1 boiler room displaying temperature of 38.8° Celsius (101.8° Fahrenheit).
Source: Photo taken by OIG on May 2, 2017.

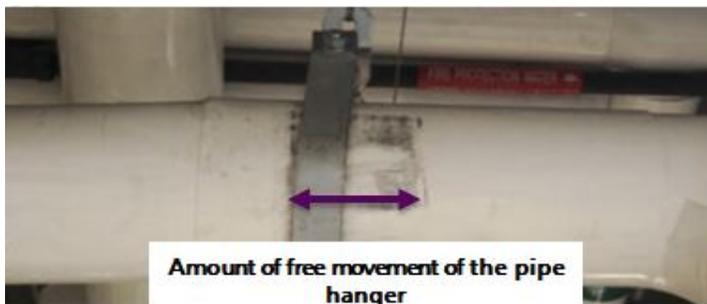
Both the NOX and SDA-1 rooftop mechanical equipment rooms have numerous improperly installed pipe hangers. USACE observed pipe hangers, such as the one shown in Figure 14, that are very loose and can be moved by hand. (USACE only inspected exposed piping but, because of the extensive amount of piping installed in the buildings, surmised that it is likely that non-exposed pipes may also have the same deficiency.) These improper installations create serious risks to life, health, and safety because of the high probability of significant seismic events occurring in Kabul. Even without a seismic event, it is possible that overloaded pipe hangers could eventually fail. This could lead to pipes breaking and releasing 160–180°F water from the hot water hydronic system.

Figure 14: Improper pipe hanger installation.

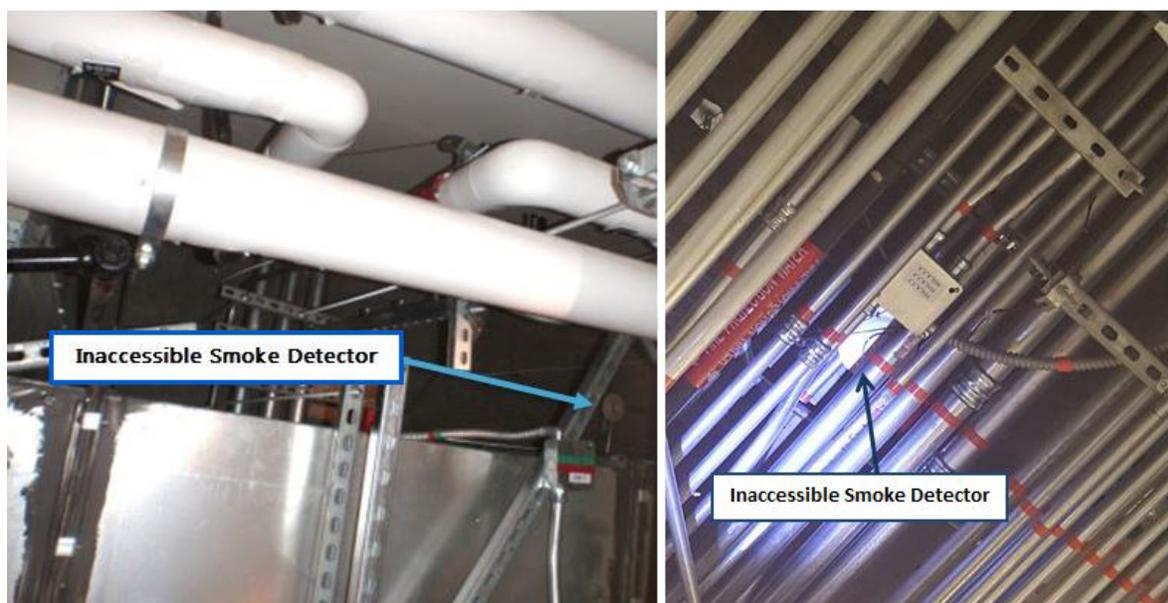
he found to be inaccessible (which were similar to the smoke detectors in Figure 15) be relocated before he would sign off on fire safety.²⁴ However, in February 2016, following substantial completion and occupancy of both the NOX and SDA-1, USACE mechanical engineers identified additional smoke detectors in the mechanical rooms of both buildings that were blocked by HVAC and electrical equipment and thus were inaccessible for maintenance. One year later, in February 2017, OIG also observed a number of smoke detectors in mechanical rooms in the NOX that had not been relocated and remained inaccessible for maintenance. PAE estimated that approximately 10 to 15 smoke detectors in the NOX do not comply with NFPA 72 because they are inaccessible for maintenance.

Figure 15: Smoke Detectors in NOX inaccessible for testing and maintenance.

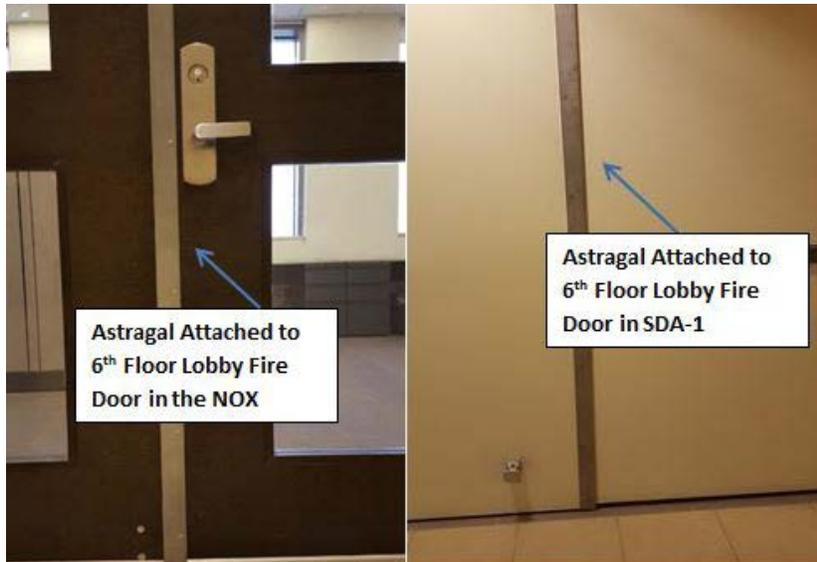
Figure 16: SDA-1 and NOX fire-safety doors with astragal modifications.
Source: Photos taken by OIG December 28, 2016, and January 3, 2017.

It is unclear, however, whether the astragals attached to the fire doors in SDA-1 and the NOX were part of the original fire-rated assembly or if they were added later. According to documents provided by Caddell for SDA-1 ("Integrated Door System," Section 08170 for Hardware), none of the integrated door systems for SDA-1 provided by the manufacturer (Adamsrite) included astragals as part of the original hardware. Embassy Kabul's fire department chief and deputy fire chief both noted that, based on the materials used and the installation, it appeared as though the astragals in both buildings were not part of the original door assembly and had been added later. According to the fire department chief, any modifications to the doors and frames (including astragals that are not part of the original hardware) are a violation of NFPA code.²⁵ If an astragal was not part of the original fire-rated assembly, the modification effectively decertifies the fire door.²⁶

²⁶ According to NFPA 80, 5.1.5.1, in cases where a field modification to a fire door or a fire door assembly is desired, the laboratory with which the product or component is being modified is listed shall be contacted through the manufacturer and a written or graphic description of the modifications shall be presented to that laboratory.

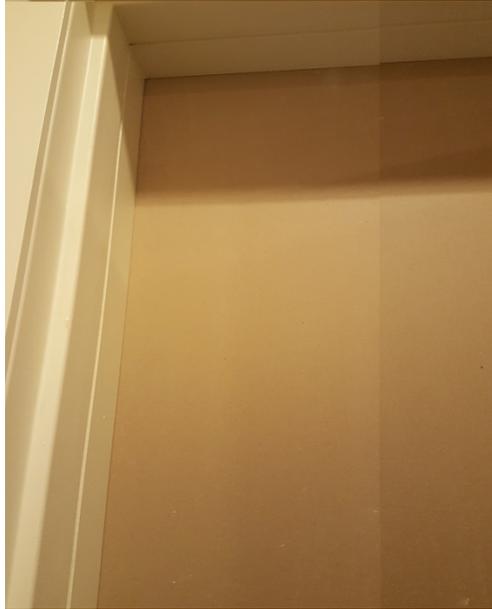
However, during inspections of several apartments in SDA-1, OIG found that none of the frames contained the mandatory Underwriter Laboratories fire-rating labels certifying that the frames are fire rated as required by NFPA.²⁸

Figure 17: Door connecting two suites in SDA-1 not labeled as having a fire-rated frame.
Source: Photo taken by OIG December 28, 2016.

OIG was unable to obtain documentation from Caddell or OBO that the lobby and suite connector doors were installed consistent with contract specifications and per NFPA fire code standards.²⁹ In addition, OIG sought, but did not receive, clarification on the fire-safety status of the elevator lobby fire doors and the efficiency suite connector door frames from OBO's fire safety director. Given the potential life-safety issues involved, OIG is concerned about the lack of documentation establishing that the doors in question meet fire code standards.

OIG Recommendation 13: OIG recommends that the Bureau of Overseas Buildings Operations implement actions to replace and correct all elevator lobby doors and efficiency suite connector doors in the New Office Annex and Staff Diplomatic Apartment-1 found not to conform to the contract requirements or National Fire Protection Association standards.

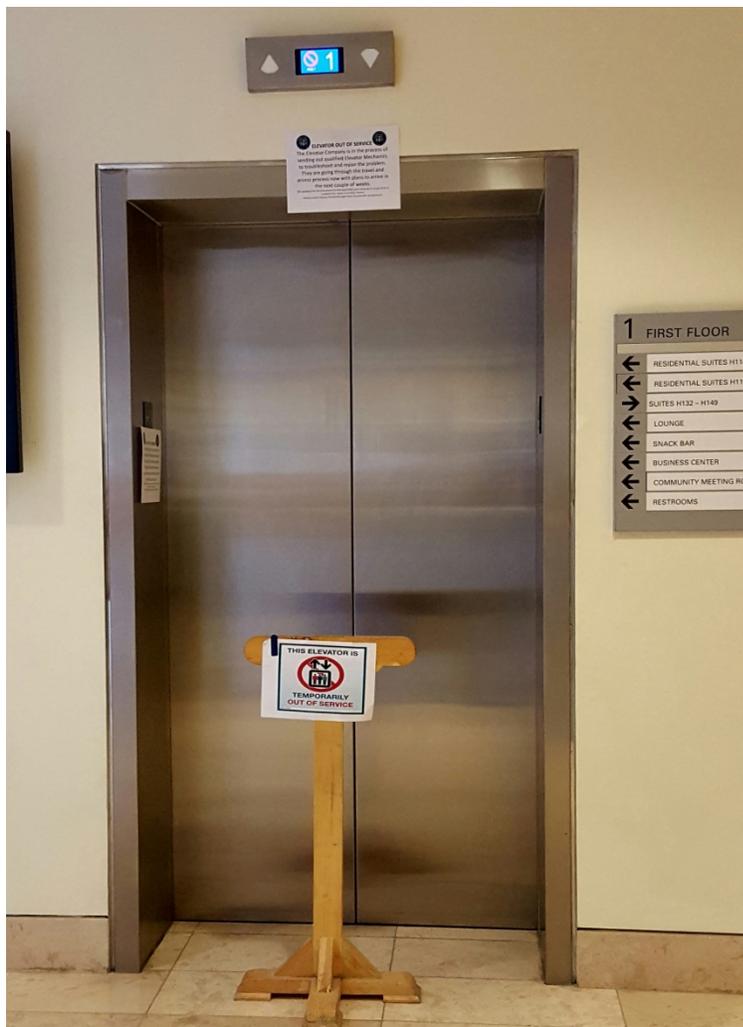
service calls, OBO purchased an extended warranty on the NOX and SDA-1 elevators that covers elevator maintenance through January 18, 2018.³⁴ Despite the fact that the elevators were never fully certified prior to substantial completion, the cost for this extended warranty is being borne by OBO. Embassy facilities managers reported that they were not sure whether the extended warranty was a more cost-effective option for the U.S. Government but felt it was the most practical means to allow embassy facilities staff to control the service process, given the large number of ongoing complaints about elevators in both buildings. However, according to OBO's elevator specialist, the extended warranty was determined to be a more cost-effective alternative to having embassy facilities staff take over the maintenance of the elevators. Further, although the terms of the extended warranty state that no elevator shall be out of service for more than 24 hours, in April and May 2017, one of the three elevators in SDA-1 was out of service for more than 6 weeks.

Figure 18: In April and May 2017, one of the three elevators in SDA-1 was out of service for more than 6 weeks.
