# INSPECTOR GENERAL

(U) Evaluation of Army Pre-Positioned Equipment Issued in Response to Ukraine and the NATO Defense Forces

#### (U) February 27, 2023

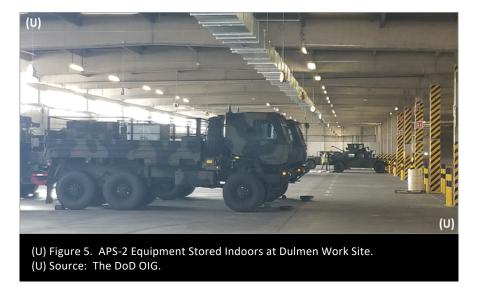
- (U) The lack of 405 AFSB exercise tracks contributed to the 405 AFSB issuing equipment to the 1 ABCT that was non-FMC. An AFSBn-Mannheim official stated that there was no exercise track at either Dulmen Work Site or Coleman Work Site to carry out this vehicle exercise requirement. We physically observed that neither site has an exercise track.

- (U) A maintenance and a support operations officer from the Mannheim battalion stated that, because of the lack of a dedicated exercise track, APS-2 contractor personnel are unable to exercise vehicles, per the exercise requirements in the vehicle technical manuals. An AFSBn maintenance official stated that many equipment faults that render vehicles non-FMC often go undetected because the vehicles do not receive required exercise. A senior AFSBn contracting officer's representative stated that many APS-2 vehicle faults are caused by the COSIS cycle, and mission capability will not improve without regular exercise of APS-2 equipment.

(U) We recommend that the Commander of the 405 Army Field Support Brigade, in coordination with the Commander of the Army Materiel Command, identify and implement ways to exercise APS-2 equipment, in accordance with care of supplies in storage and Technical Manual 38-470 requirements.

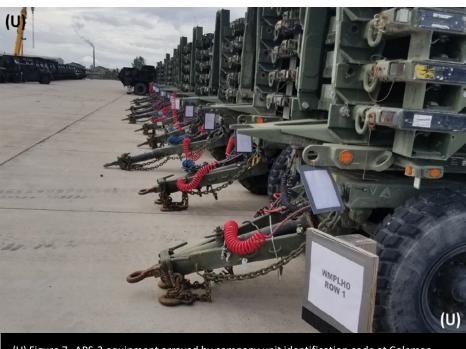
(U) According to the 1 ABCT officials, the lack of equipment in the proper combat configuration limited the speed of the issuance of numerous vehicles used by the 1 ABCT, including M109A6 Paladin Howitzers, LMTVs, M1 Abrams Tanks, Joint Light Tactical Vehicles, and M88 recovery vehicles. ATP 3-35.1 states that configuration of APS equipment at the handover area includes installing batteries, replacing fuel, uploading weapon systems and sensitive items, and making quick fix repairs. However, multiple 1 ABCT officials stated that much of the APS-2 equipment issued to the 1 ABCT was not configured for combat at the handover area.<sup>18</sup>

(CUI) A 1 ABCT maintenance official stated that a lack of APS-2 vehicles configured for combat at the handover area was a challenge for the 1 ABCT, as many issued vehicles did not have the necessary secondary items to ensure that they worked properly. The 1 ABCT maintenance official said that, for example, over 60 percent of the M88 recovery vehicles issued to the 1 ABCT did not have all of their required secondary equipment in the vehicle, and that the 1 ABCT had to remove parts from multiple M88 recovery vehicles to create working M88s.

(U) Figure 7. APS-2 equipment arrayed by company unit identification code at Coleman Work Site, Germany.

- (U) We recommend that the Commander of the Army Sustainment Command:
  - a. (U) Update Army Techniques Publication 3-35.1 to include requirements that Army pre-positioned stocks be configured for transport at the APS storage site and update procedures that Army pre-positioned stocks be configured for combat at the equipment configuration and handover area.

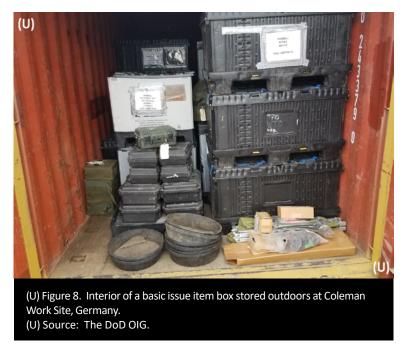
> (U) The type of equipment configuration at the APS storage sites has ramifications for how quickly the APS-2 equipment can be transported to a handover area. An AFSBn-Germany official stated that AFSBn personnel at the APS-2 sites store equipment in configure for combat format due to guidance from the AMC, and therefore personnel at APS-2 sites store basic issue items and components of end items alongside their associated vehicles (Figure 8).19

(U) AR 190-51 states that communications and electronic equipment, tool sets, night vision devices, and other high-value optical equipment require double barrier protection when not in use, including during transit. AR 190-51 further states that units must secure these items within two locked and secured containers or structures.<sup>20</sup> To meet these requirements, an AFSBn-Mannheim official stated that APS-2 sites should store APS-2 equipment in a configuration for transportation status, as opposed to a configured for combat status. This official stated that 405 AFSB personnel install communications systems in the vehicles at the storage sites as part of configure for combat, but then personnel must uninstall communications systems and pack them separately for transporting when it is time to transport them to the handover area.
