# **EVALUATION OF SECURITY FEATURES OF THE STEWART LEE UDALL U.S. DEPARTMENT OF THE INTERIOR BUILDING**

Subject: Final Report – Evaluation of Security Features of the Stewart Lee Udall  
U.S. Department of the Interior Building (REVISED)  
Report No. ER-EV-PMB-0005-2014

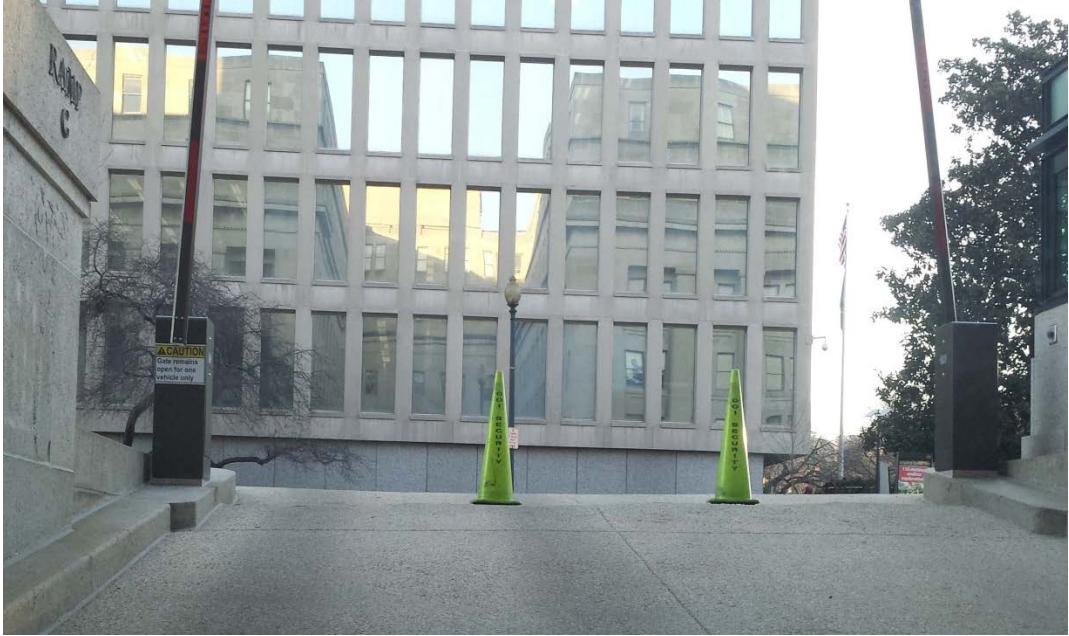
During our fieldwork, we observed 25 instances of these plastic cones being used in place of the bollards (see Figure 1). In addition, OIG staff at the Udall Building noted several occurrences of bollard malfunction and cone use after our fieldwork ended. While other security features, such as the unarmed guard and the card readers, are still in place during a bollard malfunction, plastic cones clearly cannot provide the same level of protection that a functional bollard system does against a vehicle attempting to forcibly enter the garage, and are woefully inadequate as risk mitigation. We noted this issue in our 2009 management advisory, where we stated: “The current use of an unarmed security guard and plastic traffic cones to secure this entrance is inadequate, and indicates either remarkable complacency or a complete disregard for security concerns.”

Figure 1. View of street from garage ramp C, showing traffic cones blocking the entrance.

3. Begin consistently closing garage entrances with malfunctioning bollards and using backup entrances or other secure mitigation measures to replace the use of traffic cones; and
4. [REDACTED]

OLES concurred with this recommendation. OLES and OFAS will coordinate to ensure that traffic cones are no longer used. Instead, ramps with bollard malfunctions will be closed and backup ramps used; if a backup ramp also malfunctions, OLES will dispatch an armed guard to the primary ramp and place bicycle racks across the ramp to serve as a secondary security measure. The armed guard and bicycle racks will remain in place until the bollards are functioning correctly.
