### Environmental Conditions at Michigan Metroplex Processing and Distribution Center

### Management Advisory Report

Report Number  
HR-MA-17-001

January 25, 2017

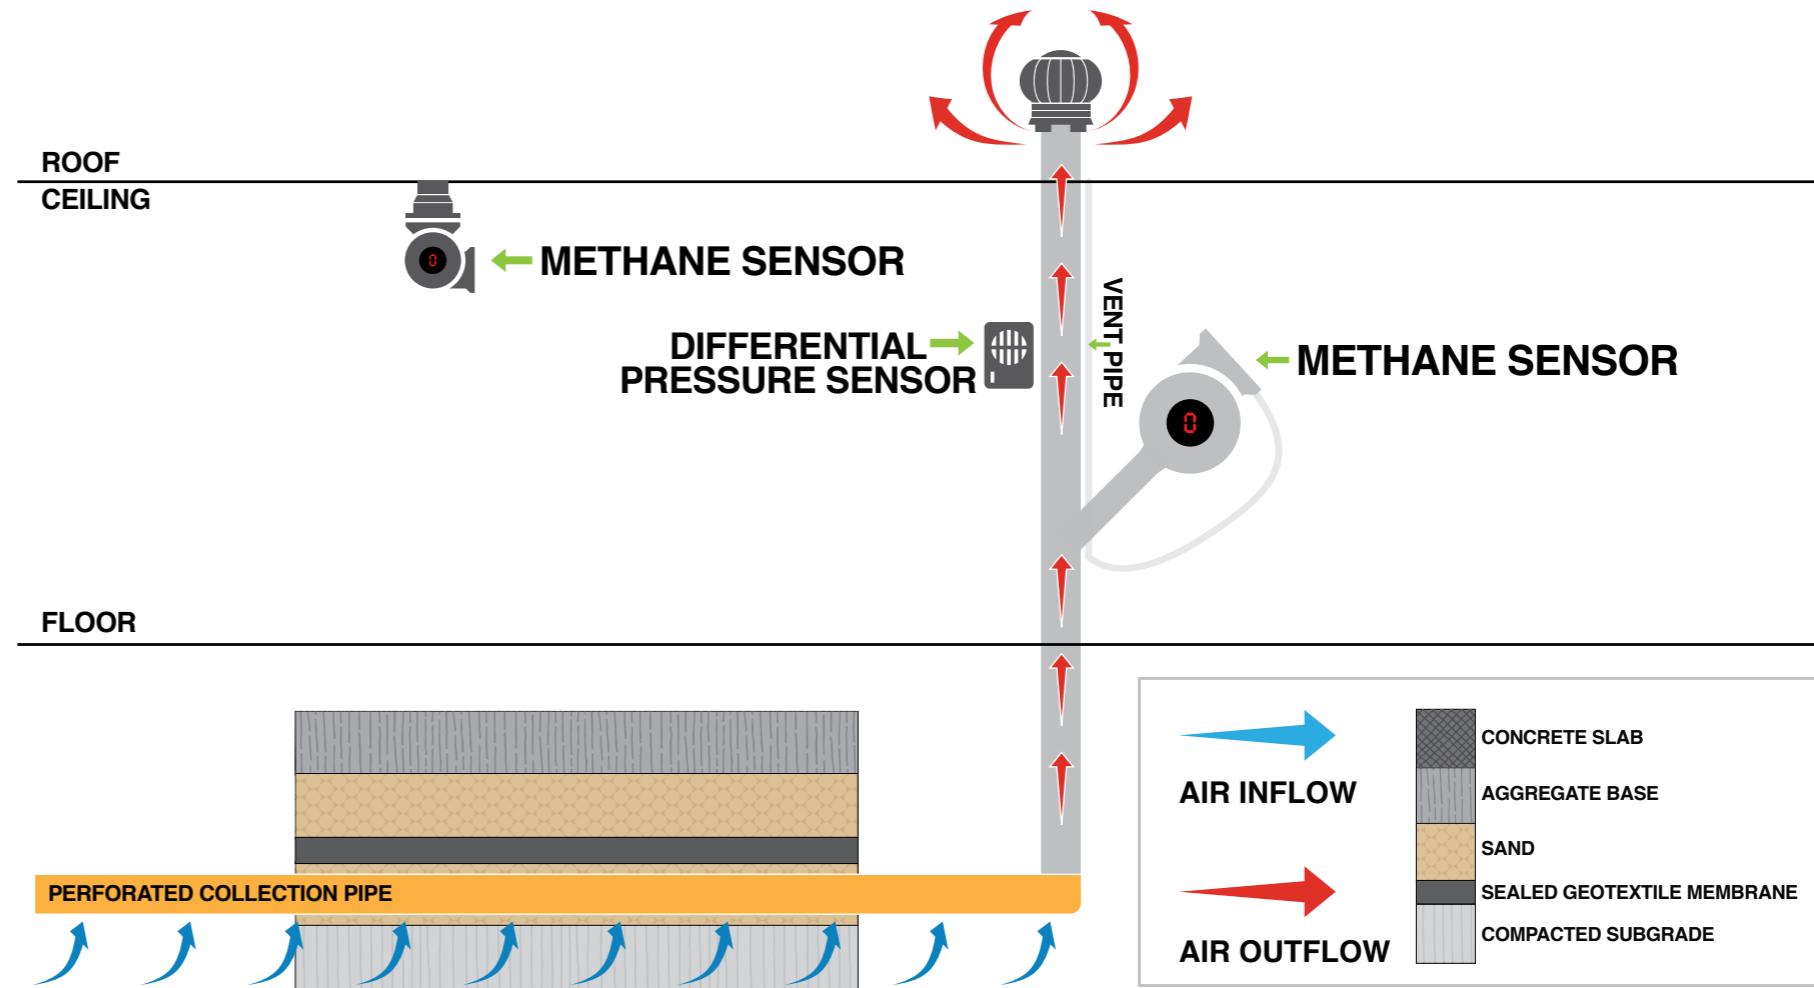
## PASSIVE VENTILATION SYSTEM WITH SENSORS TO DETECT METHANE

The results of the additional testing (November 2016) disclosed methane levels of the building subslab sampled from two vent pipe locations (D1 and D2) exceeded the concentrations considered when the building was designed.

- Four sensors in the ventilation pipes that monitor and detect pressure differences between the subslab and indoor air did not have alert notifications for increases in relative pressure differences due to weather changes and events that may cause vapor intrusion into the facility. We observed excessive differential pressure levels during our site visits and no alarms or alerts were triggered. In their response to this report, management provided documentation to show the system was set for notification if the building experiences negative pressure for 5 consecutive minutes. Further, no action is needed once the system is converted from passive to active, as an active system will mitigate the pressure in the pipes.

- Spacing between the collection pipes is greater than 50 feet and may not effectively collect and passively vent accumulated gases from beneath the building. However, given the Postal Service's plans to convert the methane detection system from passive to active at the two vent stack locations, no further action is needed regarding this issue.

An active system should include fans or vacuum blowers within the vertical pipes to remove potentially contaminated air through the pipes to vents above the exterior roof line of the building. This should mitigate the risks of vapor intrusion of methane and VOCs due to collection pipe spacing and increased pressure differentials. An active system also eliminates the need to look for potential cracks, openings, and pathways that could be sources of vapor intrusion in the event the pressure differential exceeds a set threshold.
