**Event Inquiry
into the
Nuclear Regulatory Commission's
Oversight
of the
Auxiliary Feedwater System
at
Diablo Canyon Nuclear Power Plant**

**OIG CASE No. 20-025
March 25, 2022**

SUBJECT: THE NRC'S OVERSIGHT OF THE AUXILIARY FEEDWATER
SYSTEM AT DIABLO CANYON NUCLEAR POWER PLANT
(OIG CASE NO. 20-025)

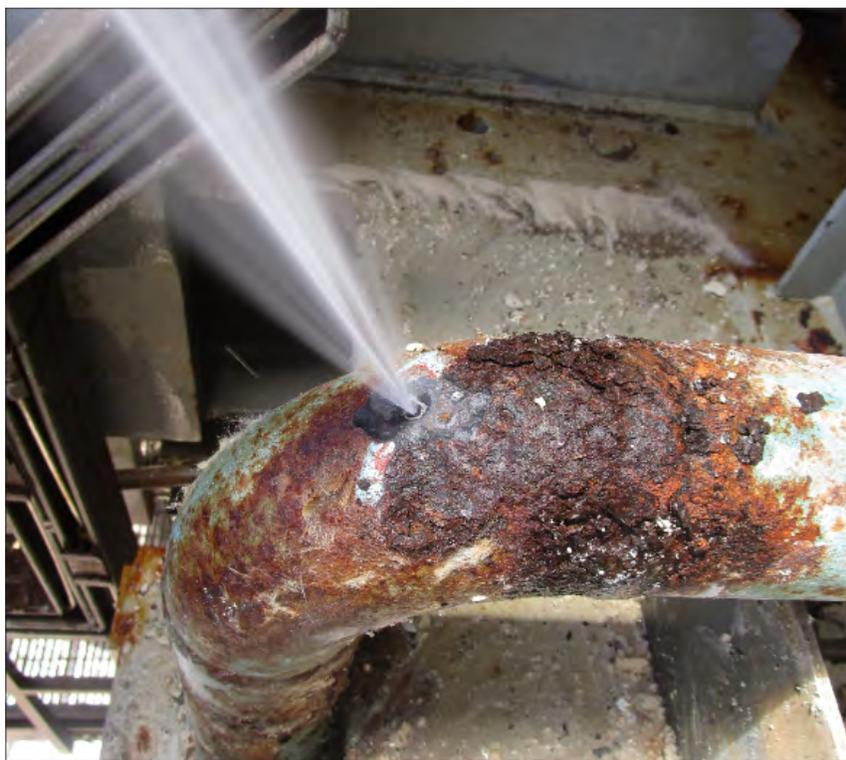
Figure 1: AFW Leak at DCNPP

On July 23, 2020, a DCNPP operator noticed water coming down from the Unit 2 AFW pipe gallery, an area of the plant commonly called the "pipe rack." The operator identified water leaking from under the insulation covering the 3-inch, carbon steel AFW pipe. DCNPP maintenance staff removed the degraded pipe insulation and found a 1/16-inch diameter hole leaking 3.9 gallons per minute of feedwater (see Figure 1).

This photo shows the July 2020 leak and the corrosion that appears to be far more long-standing.

The licensee identified that the AFW piping had long-standing damage to the insulation and its aluminum covering, which allowed moisture and contaminants to be absorbed by the insulation and caused corrosion on the outside of the pipe.

On July 31, 2020, 8 days after the AFW pipe leak, the licensee restarted Unit 2. Prior to restart, the licensee had remedied the leak with numerous actions, such as inspecting 40 pipe sections and repairing piping in 7 locations to ensure pipe thickness met requirements. Significantly, the licensee also determined that the AFW piping located outdoors—including the piping where the leak occurred—did not need to be insulated, and it therefore removed the insulation.

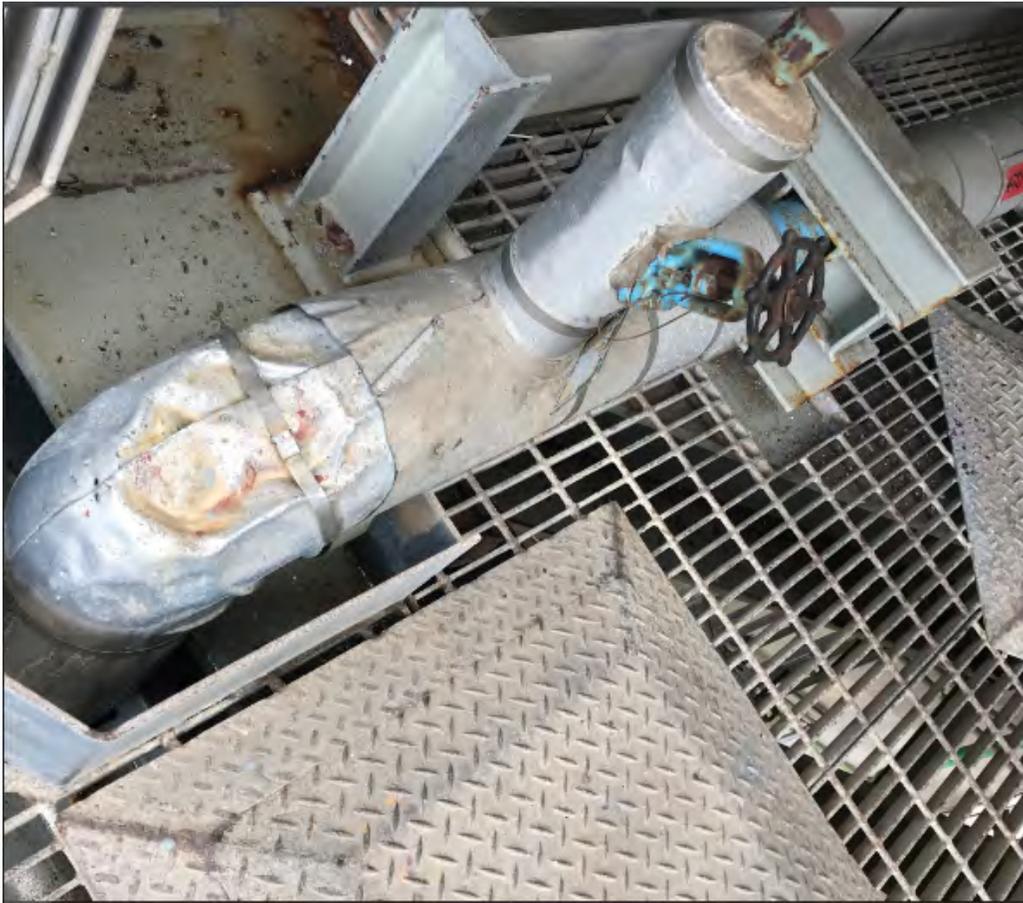
Figure 3: Degraded Insulation

During routine inspections, the NRC failed to identify rain-soaked, long-degraded insulation. The resulting moisture caused surface corrosion that led to a leak in the Unit 2 AFW system piping. This phenomenon is called corrosion under insulation. The licensee was required to shut down the unit on July 23, 2020, because two AFW pumps were inoperable.

Upon viewing pictures of the degraded insulation, well-placed NRC principals said that “dented” insulation is not a safety issue they would identify during an inspection because it would have looked like an operator had stepped on the insulation and it was still “intact” (see Figure 3).

One principal said that if insulation is degraded, it will be “loose” or easily ripped off, such that it could go into a drain and clog it, therefore not allowing the drain to perform its function. In other words, the principal suggested that because the insulation on the Unit 2 AFW system piping was not loose, he would not have identified its degraded condition. Another principal said there was no way the corrosion could have been identified because it was under insulation.
