# **Management Alert – Security and Safety Concerns at Border Patrol Stations in the Tucson Sector (REDACTED)**

September 29, 2017

SUBJECT: *Management Alert – Security and Safety  
Concerns at Border Patrol Stations in the Tucson  
Sector – Law Enforcement Sensitive*

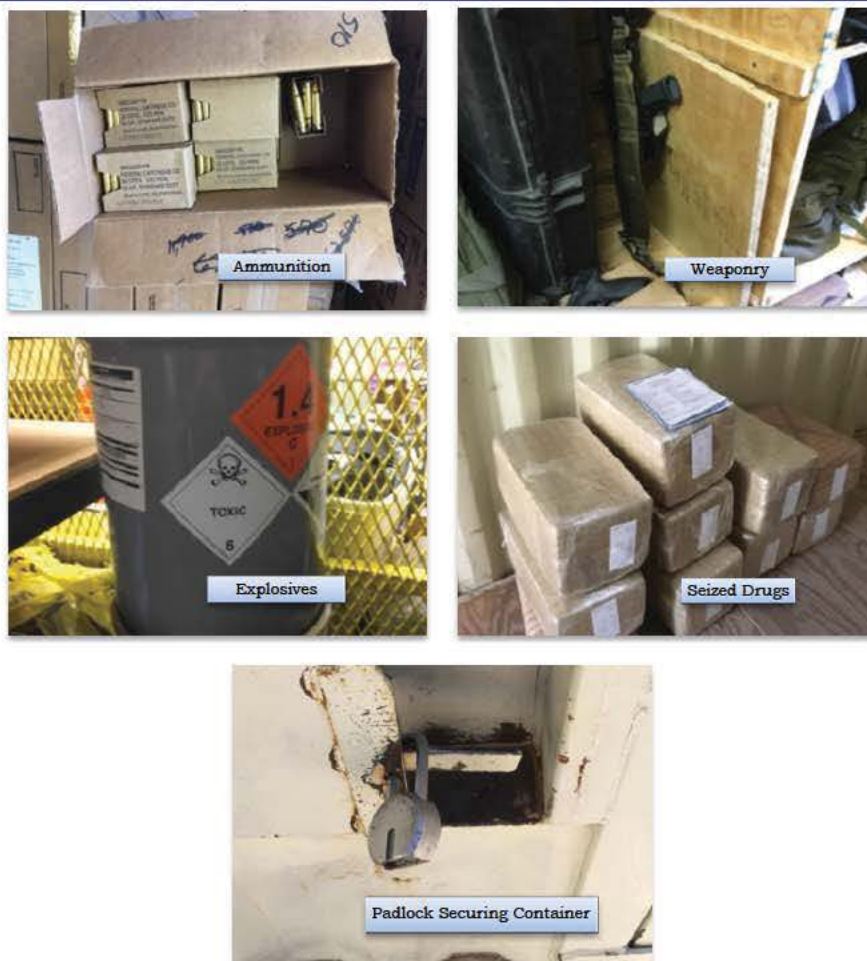
During our recent spot inspections of Border Patrol stations in the Tucson Sector, we observed, and Border Patrol agents corroborated, multiple physical security issues that raise concerns about agent safety at two locations. Both facilities have vulnerable outdoor storage containers secured with padlocks that could be easily opened with common bolt cutters. Container tops and walls could also easily be compromised with a blow torch or other widely available tools. The containers we inspected held ammunition; small arms; riot control explosives; proprietary surveillance equipment; seized drugs; and sensitive hardcopy prosecution, investigation, and personnel documents.

Figure 1. Photos taken during inspection of storage containers at stations in the Tucson Sector showing a sample of dangerous and sensitive items in easily accessible padlocked containers.

**Recommendation 1:** We recommend that CBP promptly upgrade the infrastructure at Tucson Sector stations and ensure Border Patrol agent safety by providing the resources necessary to correct the urgent physical security issues.

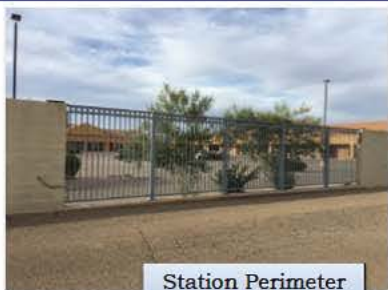
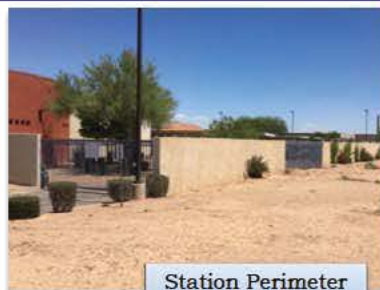
Station Perimeter Wall

One station's 8-foot high perimeter wall has inadequate camera coverage and allows public access to the full perimeter and visibility of storage containers, as well as seized and Government vehicles. Further, poor outdoor lighting hinders night camera surveillance. At another station exterior cameras are inoperable, and the surrounding 6-foot high chain link fence allows public access to the full perimeter and visibility of Government vehicles, storage containers, structures, a fuel storage tank, and operations.

Figure 2. Photos taken during OIG inspection of the station perimeter walls and adjacent public area.

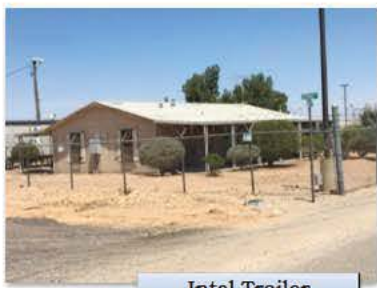
Intel Trailer

- An “intelligence” trailer<sup>1</sup> at one station in a vulnerable location near the perimeter fence;
- Incidents at one station in which detainees forced open detention cells; and
- Agents having to park their personal vehicles in a public lot adjacent to the station because of insufficient space

<sup>1</sup> Agents assigned to the Tucson Sector Intelligence Unit occupy the intelligence trailer, which is designated for processing and handling Border Patrol intelligence information.
