SIGAR 17-65 Inspection Report

Afghan Ministry of Interior Headquarters
Project: Phase 2 Experienced Lengthy
Delays, Increased Costs, and Construction
Deficiencies that Need to Be Addressed

SEPTEMBER
2017

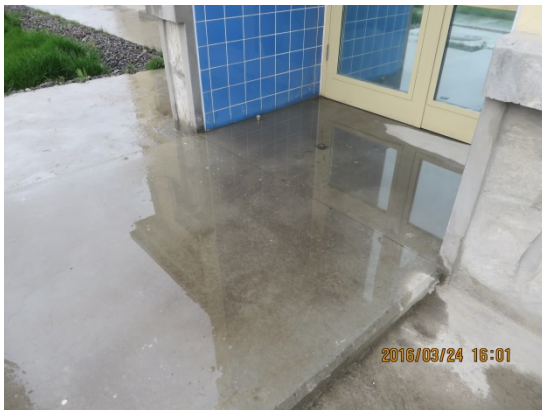
Photo 1 - Pooling Water in the MOI Headquarters Building Entrance

- **Some areas of the project site were not well graded or compacted.** We found that areas around the headquarters building, special entry gate, and sidewalks were not properly sloped so that water could

drain away from them. For example, rainwater pools in front of the main headquarters building entrance (see photo 1). Storm water also flooded communication and electrical manholes. In addition, the soil in some areas of the project site was not well compacted. For example, we found that the area around the wastewater treatment plant has settled about 50 centimeters below grade level (see photo 2). Further, we conducted soil field density tests at 10 project site locations and found that the soil density in 8 of the sites did not meet contract requirements. The contract required a density of 95 percent, and the density levels in the eight sites ranged from 70 to 94 percent. As a result, the soil at the sites will continue to erode over time and lead to unnecessary repairs. In its comments on a draft of this report, USACE stated that it was not responsible for the poorly graded and compacted soil deficiency, and that this was the result of work performed by a different contractor under a follow-on contract. We accept that an unidentified party, possibly another contractor working at the site, damaged some areas around the MOI headquarters building and that USACE's contractor, Yuksel Insaat, is not responsible for that damage. However, we found ground settlement and water pooling in areas that would not have been affected by other contractors.

2. Obtain a refund from Yuksel Insaat for deficient workmanship or direct the contractor to correct the issues identified in this report involving noncompliance with the contract and poor workmanship, such as the use of substituted door closers and hardware, smaller than required wires for panel boards and receptacles, rigid instead of flexible electrical conduits and cable trays across seismic joints, lack of seismic bracing for suspended equipment in the electrical and mechanical rooms, poorly graded and compacted soil, and step risers that exceed specified height limits.

USACE also stated that its contractor Yuksel Insaat was not responsible for the poorly graded and compacted soil. We accept that an unidentified party, possibly another contractor working at the site, may have damaged some areas around the MOI headquarters building. However, we also found poorly graded and compacted soil in areas of the phase 2 construction that were not damaged by other parties. Because these other areas were Yuksel Insaat's responsibility, this recommendation remains open until USACE addresses the issue.
