**SIGAR 19-55 Inspection Report**

**Afghanistan's Ghulam Khan Road Project:  
Construction of the Road and Bridge Generally  
Met Contract Requirements, but Deficiencies  
Have Created Safety Hazards for Users**

**AUGUST  
2019**

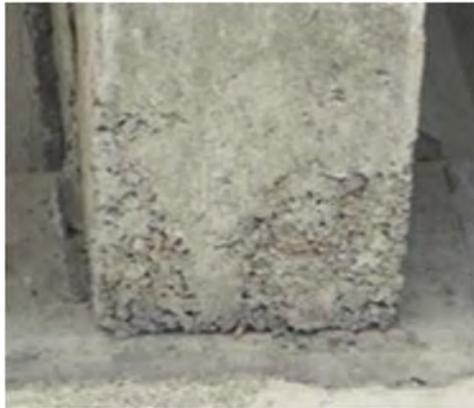
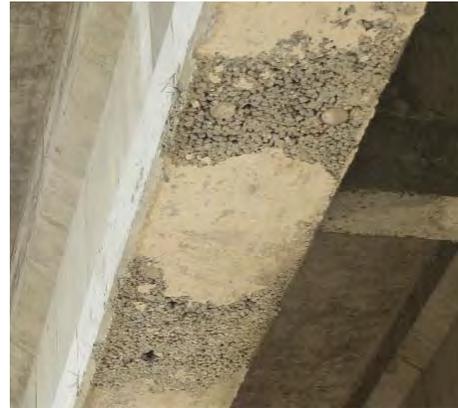
During our July and November 2018 site visits, we found that the bridge's support beams contain honeycombing as a result of BDCI's poor workmanship (see photos 1 and 2).<sup>3</sup> The bridge is supported by five concrete columns. The bases of these columns are submerged below ground and extend vertically to the bridge's road surface. The support beams, which consist of concrete and steel reinforcing rods, extend the length of the bridge and sit on top of the columns. The columns and beams provide structural integrity to the rest of the bridge.

The contract required BDCI to ensure that all of the bridge's concrete work was free of defects. If any faulty work existed, for example honeycombed concrete, BDCI was to repair the concrete to ensure that it had a smooth finish that matched the surrounding concrete. Honeycombed concrete is porous; if it is not repaired, moisture will enter the concrete and cause the reinforcing steel rods to rust and the concrete to disintegrate. This situation could cause the concrete beams to fail, which would affect the bridge's structural integrity and could cause it to collapse.

**Photo 1 - Bridge Support Beam with Honeycombed Concrete**

**Photo 2 - Bridge Support Beam with Honeycombed Concrete**

- 1. Notify the Ministry of Public Works of the deficiencies and maintenance issues with the road and bridge—specifically, bridge support beams with honeycombing; shorter than required bridge stone barriers, protective retaining walls, and protective railings; missing protective walls around culverts; and broken stone masonry and uncleared debris around culverts—so the ministry can take action to correct them.**

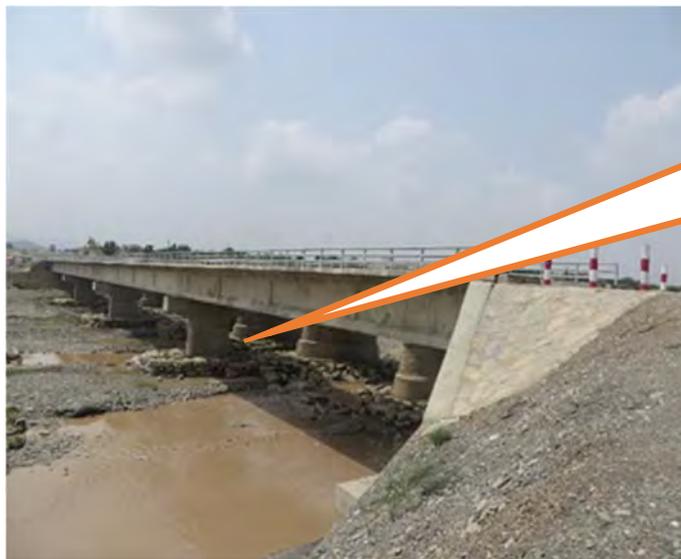
The contract required BDCI to build a 4.1-foot-tall stone filling around each of the bridge's foundations. This stone filling helps prevent soil erosion around the column foundations, which stabilize the bridge. However, during our July and November 2018 site visits, we found that BDCI only loosely stacked the stones and to about 3 feet high (see photo 3). As a result, some of the stones have washed away from the column foundations and the soil has eroded. In particular, we found that soil erosion around the east end of the bridge has placed abnormal pressure on the abutment foundation, which could affect the bridge's stability (see photo 4).<sup>4</sup>

**Photo 3 - Stones Stacked Around Bridge Foundations**

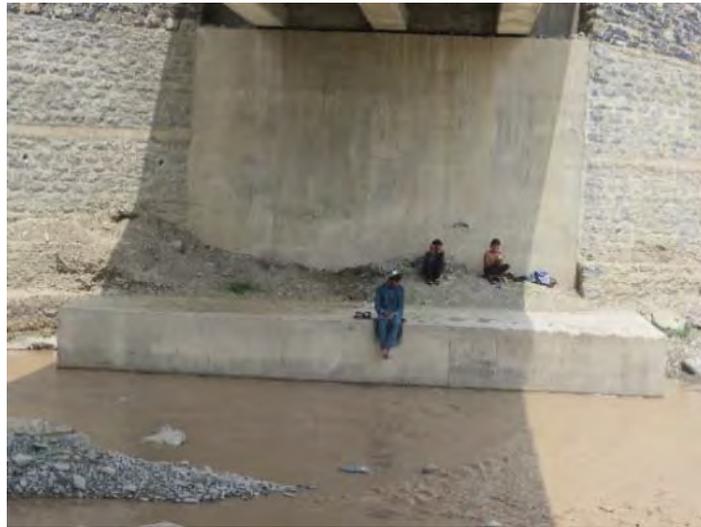
#### Photo 4 - Bridge Abutment with Exposed Foundation Due to Soil Erosion

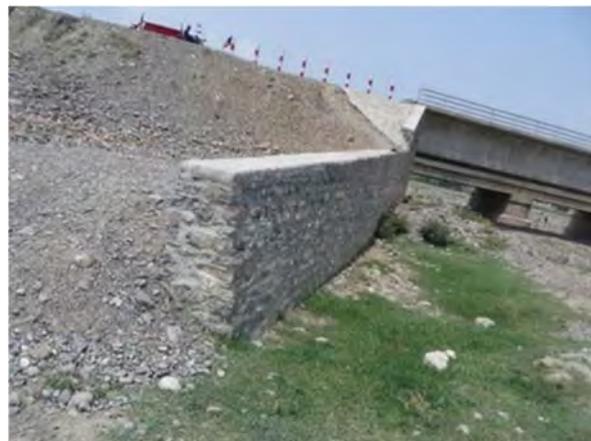
The contract required BDCI to construct retaining walls at each end of the Ghulam Khan bridge. The walls were to be 13.1 feet tall on the ends closest to the bridge and decrease to 6.6 feet on the ends farthest from the bridge. During our July 2018 site visits, we found that BDCI constructed the four retaining walls and that the walls were the required 13.1 feet on the ends closest to the bridge. However, BDCI constructed the farthest ends of the walls to about 5.1 feet tall, about 1.6 feet lower than required (see photo 5). Retaining walls are designed to hold back any material, usually earth, and prevent that material from sliding or eroding. Because the end of the bridge's retaining walls are shorter than required, the bridge's foundations could be exposed to erosion, which would weaken the bridge's stability.

#### Photo 5 - 5.1 Feet Bridge Retaining Wall

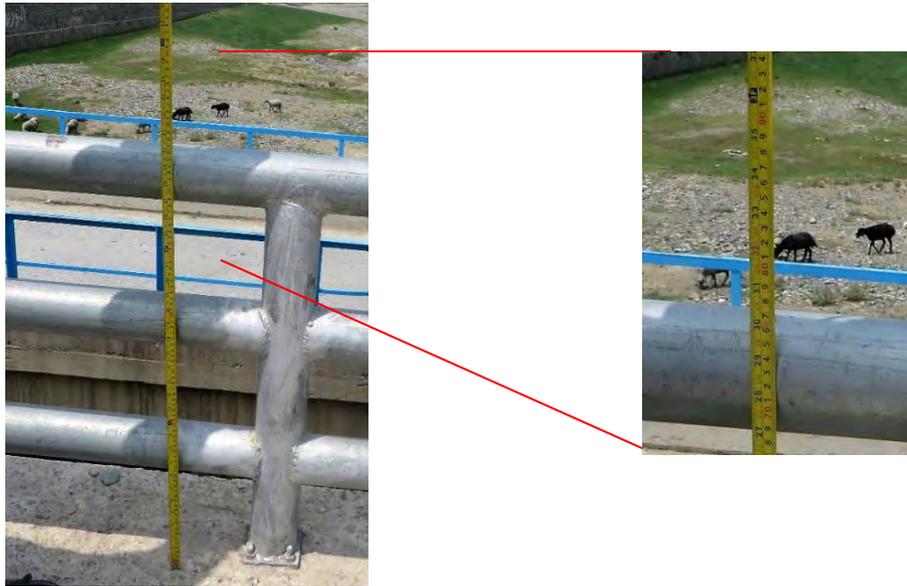
During our July 2018 site visits, we found that BDCI constructed the bridge's pedestrian and cyclist railings, which are bolted on the sidewalk's concrete surface, about 30 inches tall (see photo 6). However, the contract required BDCI to follow the American Association of State Highway and Transportation Officials' standards for bridge design. The standards require pedestrian railings along bridges to be at least 42 inches tall and bicycle railings to be at least 54 inches tall. Although BDCI built the sidewalks on each side of the bridge to accommodate pedestrians and cyclists as required, the low railings create a safety hazard by increasing the risks that they might fall from the bridge.

**Photo 6 - 30-Inch High Bridge Railing**

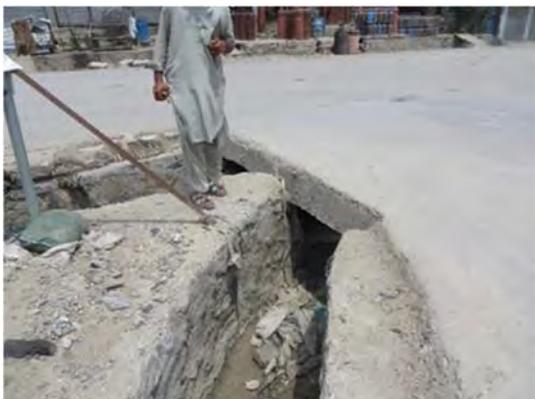
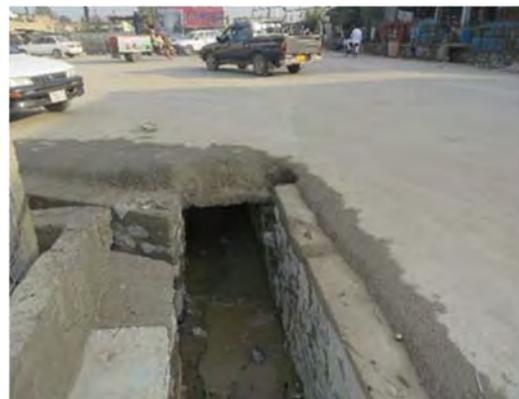
The contract required BDCI to construct 21 culverts under the roadway. Each culverts was to have 2.3-foot-high protective walls known as parapets, which are designed to ensure that vehicles and pedestrians do not fall into the culverts, thereby enhancing safety.<sup>5</sup> However, during our July 2018 site visits, we found that BDCI did not construct protective walls around two road culverts: culvert 1 and culvert 16 (see photos 7 and 8, respectively). Without these walls, vehicles and pedestrians are more at risk of falling into the culverts, which could damage vehicles and injure drivers and pedestrians.

**Photo 7 - Culvert 1 Missing Required Protective Walls**

**Photo 8 - Culvert 16 Missing Required Protective Walls**
