VA Office of Inspector General

Veterans Health Administration

*Review of
Alleged Hazardous
Construction Conditions at
the Jack C. Montgomery
VA Medical Center,
Muskogee, Oklahoma*

March 27, 2018
15-04678-114

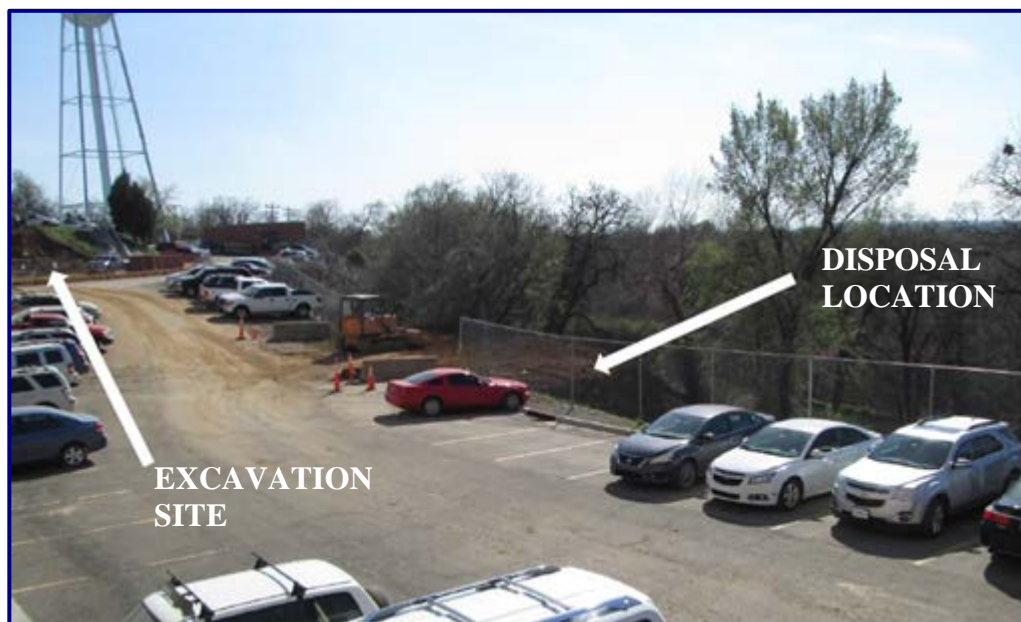
Figure 1. Excavation and Disposal Location

The COR allowed BCI Construction to proceed with excavation without an approved excavation and shoring design plan,¹ which increased the risk of excavation failure. In addition, although the contract gave the COR authority to dispose of soil to designated areas on VAMC property, the COR's failure to properly assess the stability of the hillside as a disposal location for the project contributed to the hillside collapse.

Engineering employees were in the process at the time of clearing the underbrush on the hillside below parking lots 10 & 12. There was a group of engineering employees, including myself, that walked along the west edge of parking lots 10 and 12. It was identified in the walk there was significant erosion in two areas along the fence line of the parking lots. I felt that there would be a benefit to take the spoils and place them in one of the eroded areas, which was to [sic] at the north end of the parking lots and west of parking lot 12. At the time vehicles were parking in the area and the location would have minimal impact on parking spaces. With the amount of material being moved I envisioned an added benefit of possibly some additional parking in the future. I also considered at the time that perhaps this would be a good stockpile for dirt if needed back on the project for fill. There was a geotechnical report that was completed for the Generator project area and the report did not raise any concerns. It has also been a practice in the past years for fill to be placed on the west side of the campus.

The COR did not properly assess the stability of the hillside for use as a disposal location for the project. According to a United States Army Corps of Engineers, Engineering Branch Chief, a proper assessment of the hillside as the disposal location may have identified vulnerabilities and provided recommendations to mitigate potential problems.

According to a United States Army Corps of Engineers, Engineering Branch Chief, a geotechnical investigation would have likely detected instability of the parking lot and hillside area. He further stated that the movement of excavated soil over the hillside was a contributing factor to the hillside collapse. In addition, past practices of dumping soil, debris, and rubble that included large concrete pieces and broken plumbing pieces was an obvious clue that an additional assessment should have been conducted at the hillside disposal location. While the geotechnical investigation was not required, had a geotechnical investigation been performed, some of the issues with the parking lot and hillside disposal location could have been identified and appropriate action could have been taken.

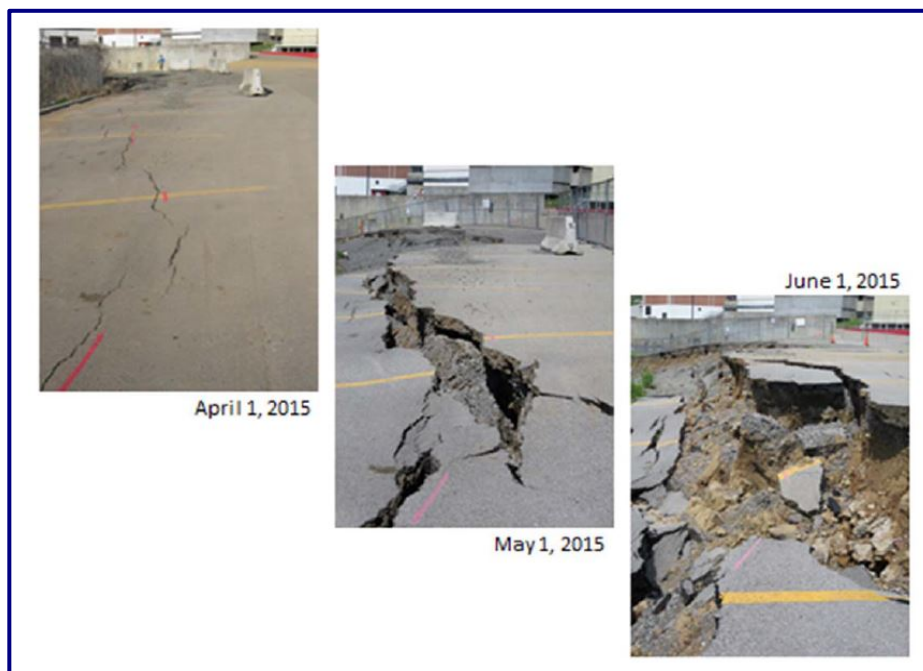
Figure 2. Deterioration of Parking Lot

According to the COR, dump trucks moved excavated soil from the excavation site, across the adjacent parking lot, to the hillside for disposal. He further stated that dump trucks made approximately 49 to 59 trips and moved about 20,000 to 24,000 pounds of soil, per trip. The OIG team estimated the trucks moved about 1 million pounds⁵ of excavated soil across the parking lot during an approximate two-week period.⁶ After the excavated soil was moved across the parking lot, fractures in the pavement and deterioration at the crest of the hill began to occur, and continued to the point of collapse. Figure 2 shows the deterioration of the parking lot.

According to a VA civil engineer on the Construction Safety Committee, he had concerns about the soil disposal and the vibrations from dump truck movements. This VA civil engineer believed that vibrations from the continual dump truck and excavator traffic contributed to the hillside collapse. The VA civil engineer obtained an opinion from a private professional engineer regarding conditions at the parking lot and hillside. The private professional engineer disclosed the following observational opinion in a letter dated April 3, 2015.

As of August 2017, VA had spent nearly \$5 million. VA’s costs to repair the hillside and parking lot, as well as to redesign, remove, and reconstruct the shoring wall, would add about \$17.5 million to the costs already incurred. In addition to the approximately \$22.5 million in paid and anticipated costs, which would far exceed the original \$8.7 million awarded for the Full Facility Standby Generator contract, VA will likely incur additional costs as a result of the termination of the contract.

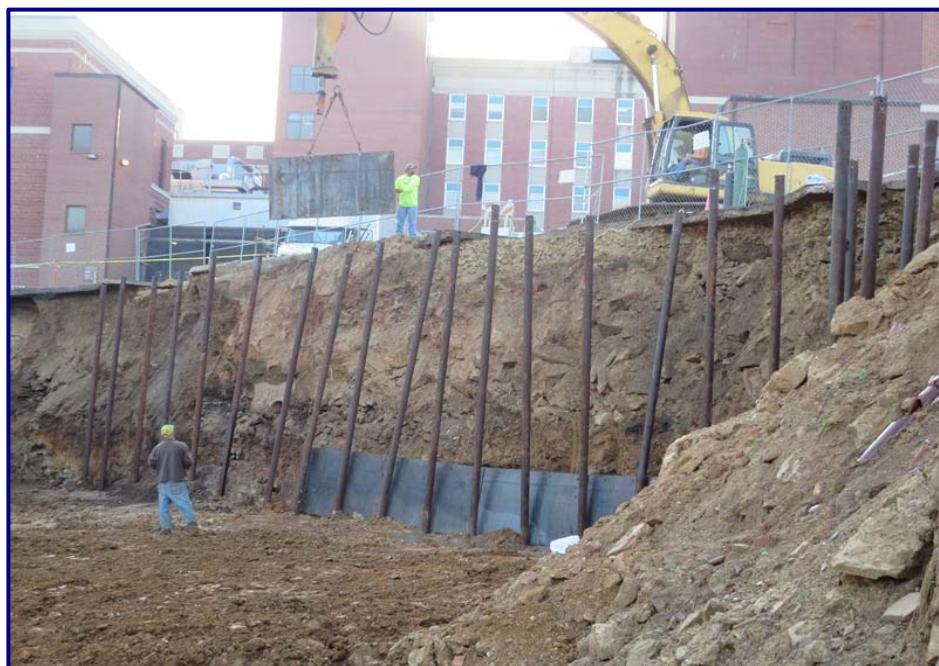
Figure 3. Lack of Personal Protective Equipment, Protection from Falling Debris, and Fall Arrest System

Figure 3 illustrates an example of individuals at the excavation site without required personal protective equipment.¹⁵ This is an example of a safety violation that was identified by a VA employee and not reported.

In accordance with the FAR, the contracting officer is required to notify the contractor of any condition that poses a serious or imminent danger to the health or safety of the public or government personnel. This notice shall be deemed sufficient notice of noncompliance and that corrective action is required. Further, if the contractor fails to promptly take corrective actions, the contracting officer may issue an order stopping all or part of the work until satisfactory corrective action has been taken.¹⁶ According to the contracting officer, she relied on the COR and CSO for information regarding safety violations for the Full Facility Standby Generator project. She stated that she had not been provided any information regarding safety violations for this project until April 29, 2015. On April 29, 2015, she received an email from the COR stating that BCI Construction's noncompliance with FAR created a safety hazard and caused interruption to the government's day-to-day operations.¹⁷ This email discussed excavation safety but did not include any information related to individuals without personal protective equipment, as required by OSHA.
