Office of Inspector General

AUD-MERO-16-35

# Improvements Needed To Strengthen Vehicle-Fueling Controls and Operations and Maintenance Contract at Embassy Kabul, Afghanistan

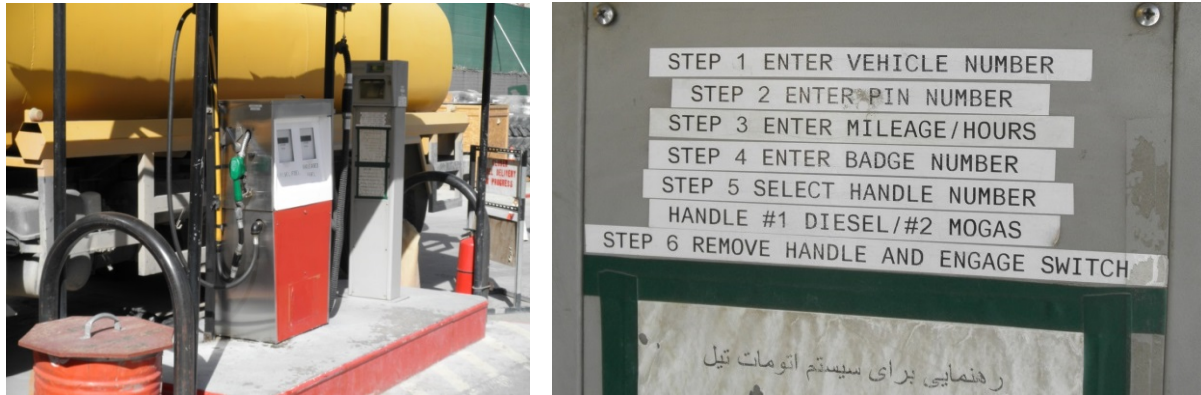
Figure 2: Kabul Embassy's Fueling Station and directions for using the fuel system.

dispensing fuel. Figure 2 shows photographs of the fueling station on the embassy compound and the directions for accessing the fuel pump—the directions are provided in both English and Dari.

OIG found that, out of the eight controls reviewed, four were ineffective to prevent unauthorized access to vehicle fuel. For example, the first control is entering a valid vehicle identification number (VIN number) that matches the VIN listed in the vehicle inventory maintained by either the Department's Integrated Logistics Management System or the embassy's Fleet Management Information System. OIG reviewed the fuel transaction records and found that 97 (or 37 percent) of the 261 vehicles that received fuel in April 2015 did not have VINs listed in either the Department's Integrated Logistics Management System or the embassy's Fleet Management Information System. This occurred because the VINs maintained by PAE in the vehicle-fueling system did not match the VINs (and consequently the vehicle inventory) that the embassy motor pool manager maintained. Specifically, the embassy's vehicle inventory includes only vehicles registered to the Department, the U.S. Agency for International Development, and "other agency" or "other funding"; it does not include vehicles that fall under Chief of Mission authority at the embassy compound. PAE's list may include these other vehicles. The cost associated with fueling these vehicles not on the embassy's list totaled \$6,212, or 22 percent of total fuel costs (\$28,307) for the month.

In addition to the ineffective controls at the vehicle-fueling station, OIG also found that the hardware and the Petro Vend<sup>16</sup> software for the vehicle-fueling station itself are outdated, increasing the risk that the fueling station will malfunction. PAE officials stated that the software was developed in 2001 and that the vendor (OPW Fuel Management Systems) had stopped making replacement parts for the hardware. They further explained that when the fueling system malfunctions or requires repairs, they find the part on the open market or devise with an alternate solution to fix the system. Hours-long temporary shutdowns to the vehicle-fueling system have occurred. During these shutdowns, vehicles at the embassy can obtain fuel from other embassy-maintained camps such as Camp Sullivan. However, obtaining fuel from Camp Sullivan, or other locations, can be difficult because of restricted movements resulting from sometimes daily changes to the security situation. Using an outdated vehicle-fueling system increases the risk that the system will break, causing the embassy to go without fuel for an indeterminate period of time. This, in turn, negatively affects the embassy's operations and security.

**Recommendation 6:** OIG recommends that Embassy Kabul procure a new vehicle-fueling system (hardware and software) to replace the current outdated system.

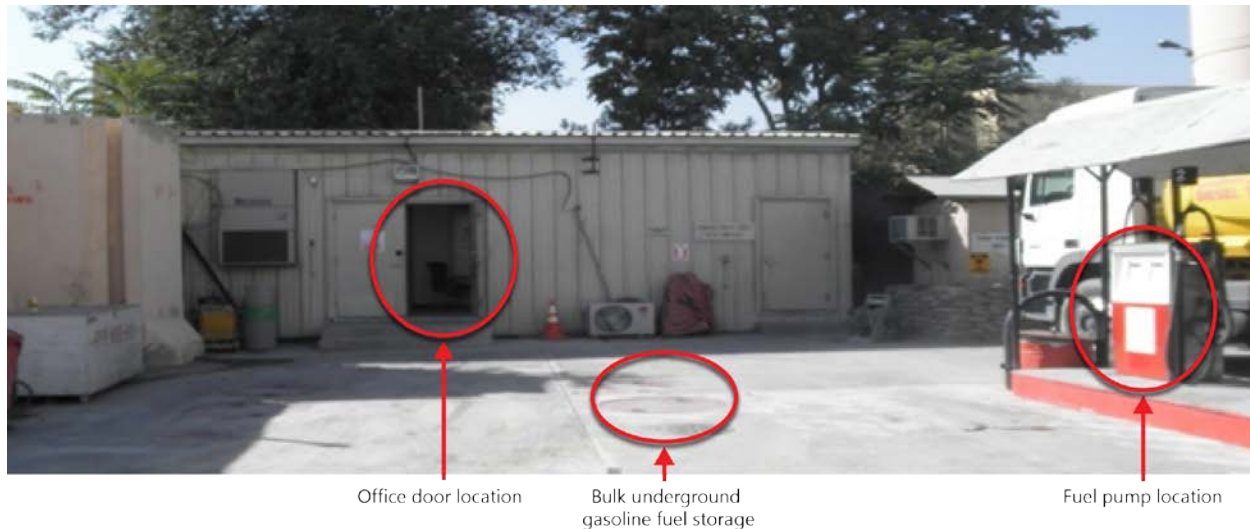
Figure 3: Fueling Station Office at Embassy Kabul.

Lastly, although the embassy moved the office used at the fueling station to comply with egress standards, PAE staff must enter the old office building throughout the day to access the vehicle-fueling system computer and retrieve spare parts. As such, the egress hazard has not fully been addressed.

During audit fieldwork, OIG determined that the location of the office building used for the fueling station at Embassy Kabul did not comply with egress standards established by the Department's Bureau of Overseas Buildings Operations. The *Fire Protection Guide* states that "no storage or handling of flammable or combustible liquids or flammable gases shall be permitted in any location where it would jeopardize egress from a structure."<sup>27</sup> The office building has one path of egress, which runs directly above the bulk fuel storage for the fueling station. Given the hazardous nature of fuel<sup>28</sup>—especially unleaded gasoline—if a fire occurred at the fueling station, anyone working in the office building would be at risk due to the blocked egress from the building. Figure 3 shows a photograph of the fueling station office located on the east compound near Compound Access Control #5.

**Recommendation 10:** OIG recommends that Embassy Kabul relocate the fueling system computer and spare parts storage to a location that meets egress standards outlined in the *Fire Protection Guide*, Section F-7, "Flammable and Combustible Liquids."
