AUD-MERO-17-28

Management Assistance Report: Improvements Needed to the Security Certification Process To Ensure Compliance With Security Standards at Embassy Kabul, Afghanistan

MANAGEMENT ASSISTANCE REPORT

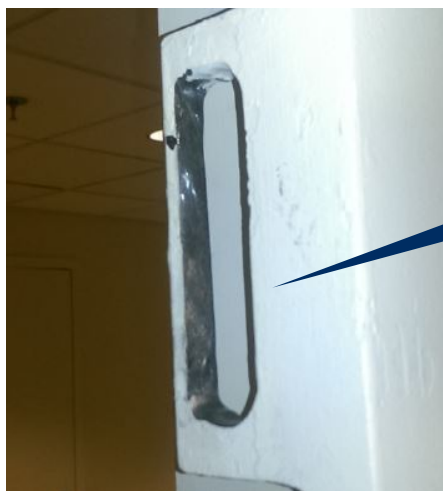
In an informal follow-up inspection in February 2016,¹¹ the same DS/PSD physical security specialist who initially identified the deficiencies with the doors discovered that the strike plates on one of the double doors had been ground down to make the doors functional. The physical security specialist also found that a strike plate on a third door, an issue that was not identified in his original inspection report, had also been ground down. The DS/PSD physical security specialist told OIG that the strike plates were likely ground down by the construction contractor Caddell in an effort to permit the forced entry locks to engage correctly.

However, according to OBO's contract with Caddell, "No part of the forced entry lock ... may be altered including, but not limited to, grinding, cutting or re-welding any part of the [forced-entry lock] strike, strike plate (steel couple with vertical slot welded to the frame) and strike plate receiver (vertical slot in door leaf)." If any alteration occurs, "The only acceptable fix for defective or altered parts is to unbolt the altered piece and replace [the] altered piece in its entirety."¹² Therefore, any actions to grind down the strike plates would not comply with the contract specifications. Moreover, they may have affected the overall security performance of the doors. According to the DS/PSD security inspection officer, security doors are designed and manufactured to exacting tolerances: all elements, including the door and the embedded door frame, work together as a unit. If any of these elements are installed incorrectly, or if the tolerances are off even slightly, the overall performance of the door can be affected. The security inspection officer stated that, if a strike plate has been ground down, for example, the door may not seamlessly lock when engaged.

Figure 2 shows one of the ground-down strike plates associated with a security door in SDA-1.

According to a DS security inspection officer, any modifications to the forced entry/ballistic resistant doors, including grinding of strike plates, effectively decertifies the door.

Figure 2: Example of ground-down strike plate to a security door in SDA-1

Recommendation 1: OIG recommends that the Bureau of Overseas Buildings Operations instruct Caddell Construction, Inc., to immediately replace the improperly altered security door components in accordance with contract terms and obtain confirmation from the Bureau of Diplomatic Security that the replaced components meet physical security standards.
