AUD-MERO-18-01

December 2017

**Management Assistance Report:
Lapse in Oversight at Embassy Islamabad,
Pakistan, Allowed Design Change To
Proceed Without the Contracting
Officer's Knowledge**

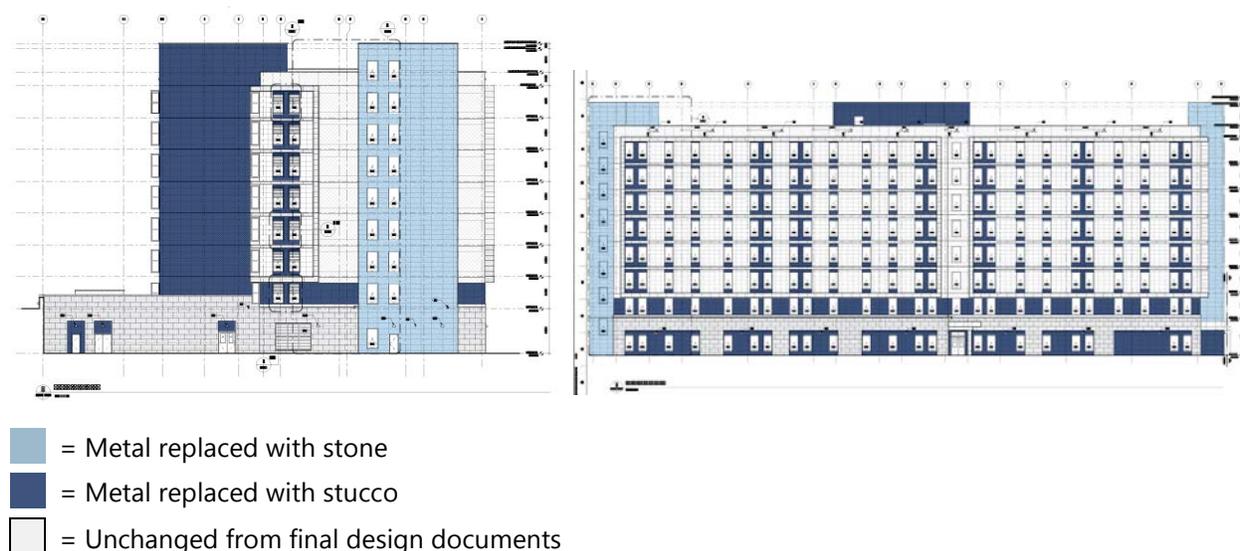
Figure 2: SDA-1 East and North Design Elevations Showing Planned Changes

In January 2016, BL Harbert contacted the contract's former OBO Project Director/COR by telephone and asked if it could change the design of the facade. According to the former OBO Project Director/COR, BL Harbert wanted to use stone instead of the metal panels contemplated in the Final Design Documents. OIG notes, however, that BL Harbert did not state it planned to replace metal panels with stucco, as it ultimately represented in Bulletin 29. At the time of the phone call, the OBO Project Director had returned to OBO headquarters and *was no longer* serving as the COR for the Islamabad construction project. The former OBO Project Director/COR told OIG that he informed BL Harbert that he supported the proposed change because he believed that stone is a better product than metal panels. However, he emphasized that he did not approve or authorize the change and advised BL Harbert to coordinate with OBO's Architect/Design Manager. When OIG interviewed OBO's Architect/Design Manager, she was not aware that BL Harbert planned to replace metal panels with stucco until OIG showed her the contractor's Bulletin 29. Subsequently, OBO's Architect/Design Manager assisted OIG in preparation of Figure 2 below.

Note: Bulletin 29 is a technical document and does not describe in narrative the design change. Rather, Bulletin 29 shows sections of the facade where metal, stone, or stucco were to be used. OIG met with the OBO architect/design manager on March 17, 2017, and provided the architect/design manager with a comparison of the design documents for all four facades of SDA-1. She verified the design had changed and that BL Harbert was using more stucco than included in the Final Design Documents. OIG, with the assistance of the OBO architect/design manager, annotated the drawings to show where the changes occurred.

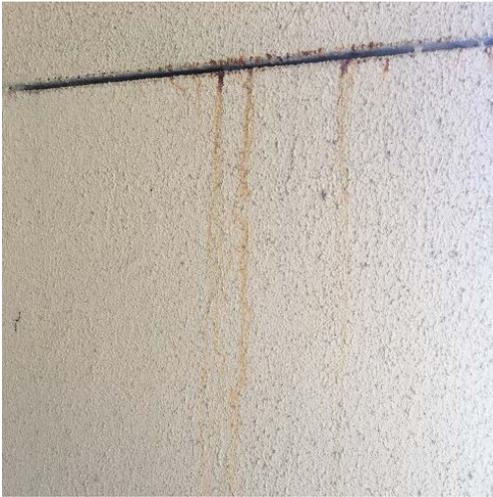
OIG also notes that, notwithstanding OBO's seeming decision to accept the changes, BL Harbert's use of stucco on other embassy buildings in Islamabad has resulted in warranty claims. During audit fieldwork at Embassy Islamabad in February 2017, OBO facility management personnel raised concerns to OIG about the poor quality of the stucco finish on several buildings, including the Marine security guard quarters, the access control buildings, the warehouse, the support annex, the utility building, and the "swing-space building." They explained that they had filed warranty claims with BL Harbert to correct the poor quality stucco work on these completed structures. For example, they filed warranty claims requiring BL Harbert to repair rust from the metal stripping and corner molding that was bleeding through and staining the stucco of several buildings, including the Marine security guard quarters. To

correct these deficiencies, BL Harbert had to grind off the rust from the metal underneath the stucco, reapply new stucco, and repaint the affected portion of the exterior of those buildings. However, the paint applied to repair the areas with rust does not match the color of the existing paint and the result is a checkerboard appearance. See Figures 3 and 4.

Figure 3: Rust bleeding through stucco and running down exterior wall of Marine security guard quarters. Photo taken February 13, 2017.

- Figure 3 on Page 10, showing rust spots seeping through stucco material, is an issue that has been raised to our contractor.
- Regarding the stucco issues on pages 9-10, during the past year OBO, Post, and BL Harbert worked cooperatively to identify workmanship problems in how the Phase I stucco was applied. The number of locations needing attention has been a cause for concern for all parties, and the corrective action to fix these problems has been discussed at length. The contractor acknowledges having problems with the Phase I plaster products and taken responsibility to take remedial action where needed. They have since proposed (and OBO approved) alternative stucco system for Phase II. The contractor has used this same product line worldwide, and has successfully finished other OBO projects. The OBO project team can also attest that stucco quality issues have been prime topic of both QC meetings and Project Meetings since my arrival onsite.

OBO's comments, Tab 2	<p>OBO stated that the issues associated with Figure 3, which shows rust spots seeping through stucco material, has been raised with BL Harbert. OBO further stated that BL Harbert acknowledges having problems with plaster products and has accepted responsibility to take remedial actions where needed. OBO stated that BL Harbert will use an alternative stucco system during Phase II of the construction process.</p> <p>OIG Reply: OIG acknowledges that OBO is taking action to address this issue with BL Harbert. At this time, OIG does not know if BL Harbert is charging the Department for remedial actions. However, the audit team will visit the embassy to conduct additional fieldwork on the ongoing audit of the New Embassy Compound and Housing Project focusing on invoice reviews in the fall. OIG will follow-up on this issue and inform OBO if it identifies additional concerns.</p>

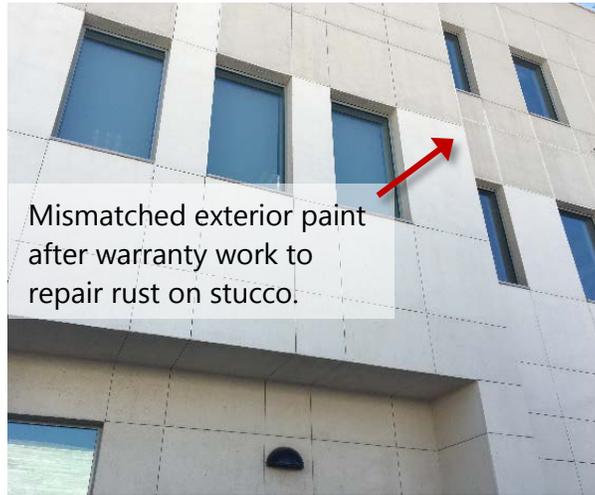
Figure 4: Mismatched paint on exterior wall of support annex. Photo taken February 13, 2017.
