AUD-MERO-18-32

April 2018

Management Assistance Report: Improper Installation of Key Components of U.S. Embassy Kabul, Afghanistan's Fire Alarm System Needs Prompt Attention

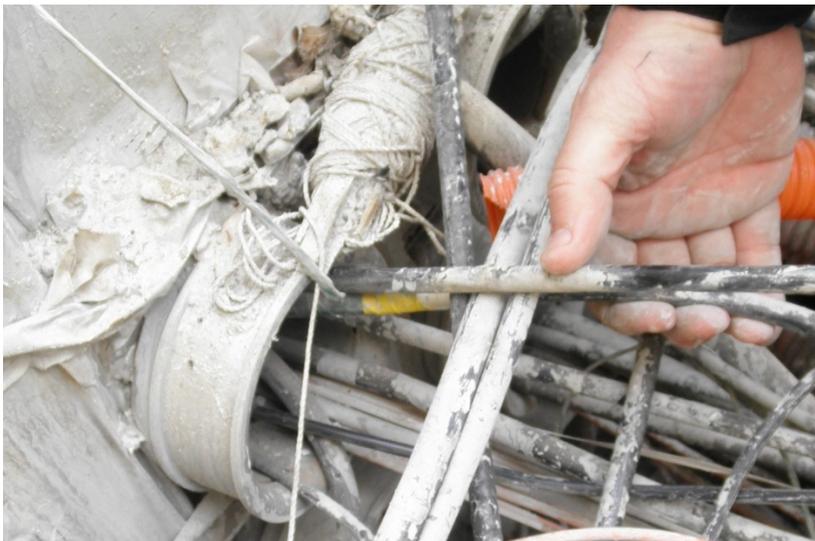
OIG agrees that cables can run in the same direction but cannot run in the same conduit. OIG found, however, that a number of the runs currently installed at Embassy Kabul did, in fact, have fiber optic cables bundled together in the same conduit. The photo below shows the current configuration at Embassy Kabul in which fiber optic cables are bundled together in the same conduit. This is contrary to NFPA standards for a redundant path. OIG made no changes to the report on the basis of this comment.

Figure 2: Fiber optic cables bundled together in the same conduit.
Source: Photo taken by OIG on February 20, 2018.

As set forth in this report, OBO is not in compliance with NFPA 72 regarding the requirement for a redundant path. In addition, a number of the runs currently installed at Embassy Kabul have fiber optic cables bundled together in the same conduit, which similarly fails to comply with NFPA 72. The NFPA codes and standards are designed to minimize the risk and effects of fire by establishing criteria for building, processing, design, service, and installation around the world. Failure to adhere to these requirements thus presents potential risk to embassy personnel and property. Therefore, the improper installation of key components of Embassy Kabul's fire alarm system requires immediate attention. OIG made no changes to the report on the basis of this comment.

Recommendation 1: OIG recommends that the Bureau of Overseas Buildings Operations' Office of Fire Protection, in coordination with Embassy Kabul, take immediate action to establish a separate redundant path for the fire alarm system that will allow operational capability to continue in the event of damage to one part of the network, in accordance with National Fire Protection Association requirements.
