Office of Inspector General

MA-16-01

# Management Alert: Hazardous Electrical Current in Office and Residential Buildings Presents Life, Health, and Safety Risks at U.S. Embassy Kabul, Afghanistan

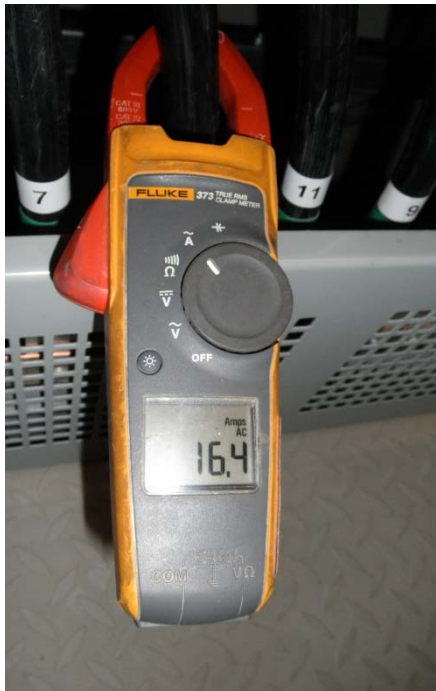
Figure 1: Objectionable Current Reading  
Taken February 14, 2016 – New Office  
Annex (NOX) Basement Switchgear  
Room. (OIG photo)

During the course of Task Force POWER’s testing of ground wiring in the NOX and SDA 1, multiple sources of objectionable current were identified throughout. Specifically, testing revealed objectionable currents measuring up to 16.7 amperes (or amps) at the NOX and up to 27 amps at SDA 1.

Based on its inspection, Task Force POWER’s initial observation is that improperly installed wiring is the likely cause of the objectionable current in both buildings. Task Force POWER tested a sample of electric panels in the NOX and SDA 1 and found evidence of an improper neutral and ground bond in at least one panel. Given the levels of objectionable current identified in both buildings, Task Force POWER believes that other improper connections—which electricians refer to as neutral-to-ground, or neutral-to-case bonds—exist but have yet to be located. In the course of its work throughout Afghanistan, Task Force POWER found that improper grounding and bonding are major contributors to electrical accidents. Task Force POWER also performed tests in which it shut down major equipment and found that the shutdown did not result in any drop in objectionable current, which further indicates that the likely cause of the objectionable current is faulty wiring.

**Recommendation 1:** OIG recommends that the Bureau of Overseas Buildings Operations' Facilities Management Office, in coordination with Embassy Kabul, take immediate action to: (1) examine the installation of electrical wiring, equipment, and appliances in the New Office Annex and Staff Diplomatic Apartment-1; (2) determine the cause for the objectionable current, and (3) correct the deficiencies.
