# Alert Memorandum: Building Safety Concerns in PBS's Federal Aggregated Solar Procurement Pilot Contracts in Region 9

Memorandum Number A201020-2  
October 27, 2020

SUBJECT: Alert Memorandum: Building Safety Concerns in PBS's Federal Aggregated  
Solar Procurement Pilot Contracts in Region 9  
Memorandum Number A201020-2

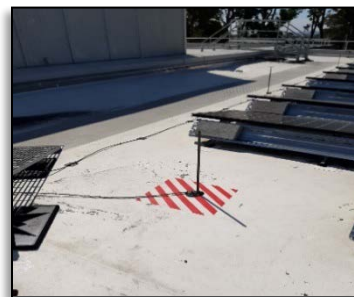
**Figure 1 – LPS rods at Leo J. Ryan Federal Records Center**

Based on the LPS technical drawings, there are 52 lightning rods placed around the solar arrays. As shown in *Figure 1*, these lightning rods stand vertically from the flat roof surface and measure two feet in height. We observed there were no barriers or caps to reduce the risk of impalement, and that only one rod had red stripes at the base to caution personnel working in close proximity. In addition, we noticed potential fall hazards from loose ground wiring connected to the rods and the slippery composition of the roof. Lastly, visibility is reduced when sunlight reflects off of the white roof.

Section 5(a)(1) of the Occupational Safety and Health Act of 1970 requires employers to provide a workplace free from hazards that may cause death or serious physical harm. In addition, an Occupational Safety and Health Administration (OSHA) interpretation letter states that “Where a lightning rod poses a recognized hazard of impalement and a [sic] there is a feasible means of protection, the employer is required to provide that protection.”

The lightning rods pose a risk of impalement to those who work on the roof or maintain the PV system. The risk of impalement from the rods is exacerbated by the fall hazards posed by the loose ground wiring and slippery roof. PBS should evaluate these fall hazards and the location of the LPS rods and implement measures to protect employees and contractors working on the roof while still providing adequate fire protection.

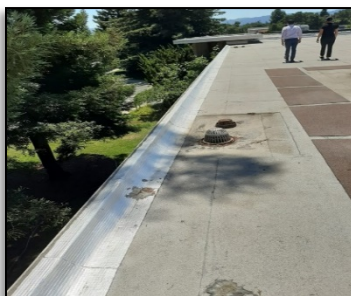
**Figure 2 – Photograph at USGS campus showing no fall protection**

The United States Geological Survey (USGS) Campus in Menlo Park, California, is equipped with carport and roof-mounted PV panels. GSA contractors and employees routinely access the roof to provide the required maintenance to the PV and other systems. During our site visit to the campus, we noticed that the roof lacked adequate fall protection as shown in *Figure 2* below. Specifically, we observed that the roof did not have a parapet or perimeter railing to protect against falls. Furthermore, warning lines or other markings were not present on the sides of the roof that are close to the installed PV system to alert personnel that they are in close proximity to the edge of the roof.

OSHA's general industry standards require that when workers are exposed to fall hazards of 4 feet or more, they must be protected by a standard railing.<sup>2</sup> If such a railing is not present, then workers must be protected by a fall protection device such as a personal fall arrest system or a safety net. In addition to these OSHA standards, PBS P100 requires that flat roofs designed for access include a parapet or perimeter railing that is at least 42 inches high. PBS P100 also requires that where parapets or railings are not feasible, other fall protection measures such as warning lines or personal fall arrest systems should be included.

The lack of a railing or other fall hazard mitigation systems exposes maintenance personnel and contractors to fall hazards and is not in compliance with OSHA standards or PBS policy. Accordingly, PBS should take necessary steps to enforce contract compliance and protect individuals from fall hazards at the USGS Campus in Menlo Park.
