SUBJECT: Audit Report – Mail Delivery, Customer Service, and Property

Conditions Review - South Columbus Station, Columbus, OH

(Report Number 22-043-R22)

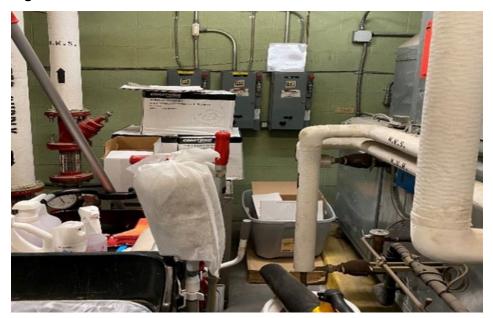
Figure 2. Blocked Electrical Panels

We found safety and maintenance issues at the South Columbus Station, including blocked electrical panels in the boiler room²² (see Figure 2) and exposed wiring below the customer counter in the lobby (see Figure 3). During our audit, the custodian took corrective action to unblock the electrical panel in the boiler room. We also identified several issues in the customer parking lot, including damaged/misaligned wheel stops and potholes (see Figure 4).

Management has placed a sign on the electrical panel to make sure that it is not block. The parking lot is still an issue with a work order has not been addressed yet.
