Westside Station, Tallahassee, FL: Delivery Operations

AUDIT REPORT

Report Number 24-085-3-R24 | June 7, 2024

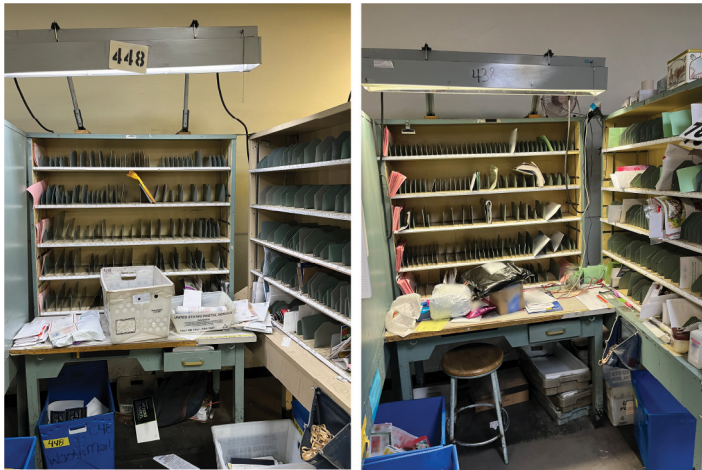
Figure 2. Examples of Delayed Mail in the Carrier Cases

On the morning of April 2, 2024, we identified 1,539 delayed mailpieces¹³ at 29 carrier cases. Specifically, we identified 790 flats, 693 letters and 56 packages. See Figure 2 for examples of delayed mail found at carrier cases. In addition, management did not report this mail as undelivered in the Delivery Condition Visualization (DCV)¹⁴ system. Further, the carriers were not using Postal Service (PS) Forms 1571, Undelivered Mail Report,¹⁵ to document the undelivered mailpieces.

Management did not provide adequate oversight to verify that all mail was cleared from the unit. The station manager stated that management relied on carriers to complete their deliveries, as instructed, and as a result, did not verify whether the closing supervisor conducted a walkthrough to check for delayed mail. Unit management did not report delayed mail in the DCV system or require carriers to complete PS Form 1571 because they had not

Delayed Mail: Management will conduct a standup talk on the proper use of PS Form 1571 to identify any mail left at carrier cases. A service talk will also be given to local management on the proper handling of delayed mail and recording in DCV. Additionally, management at the district level will conduct reviews to monitor for compliance.

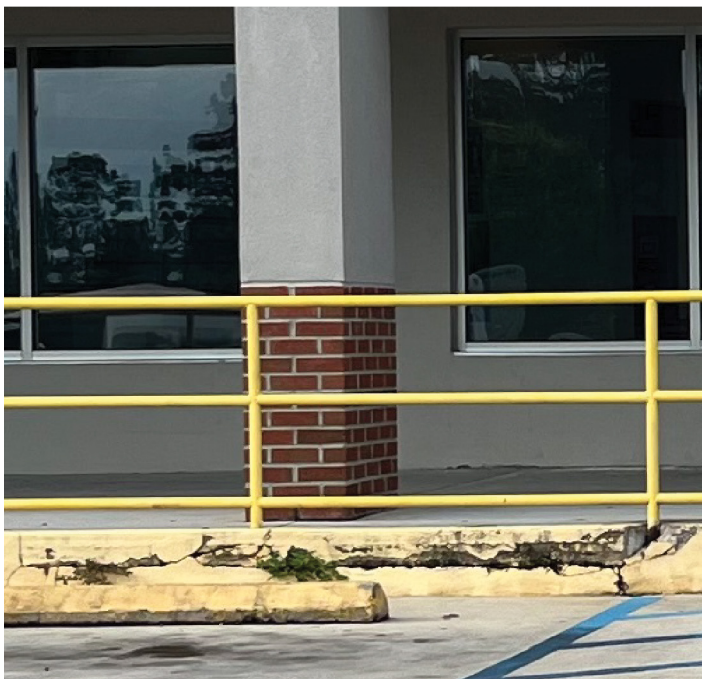
Figure 3. Deteriorating Handrail in Front of Building

- Thirteen fire extinguishers missing monthly and annual inspections. Four fire extinguishers were missing monthly tags, three were not mounted, and one was blocked.
- Three unsecured ladders on the workroom area.
- Handicap rail concrete support in front of the customer entrance deteriorating and posing a potential fall hazard to customers (see Figure 3).
- Several electrical sockets and light switches missing plate covers or broken (see Figure 4). Several junction boxes also missing covers.

Property Conditions: Management has begun abating the property condition issues and will submit work orders for repairs required by other resources.

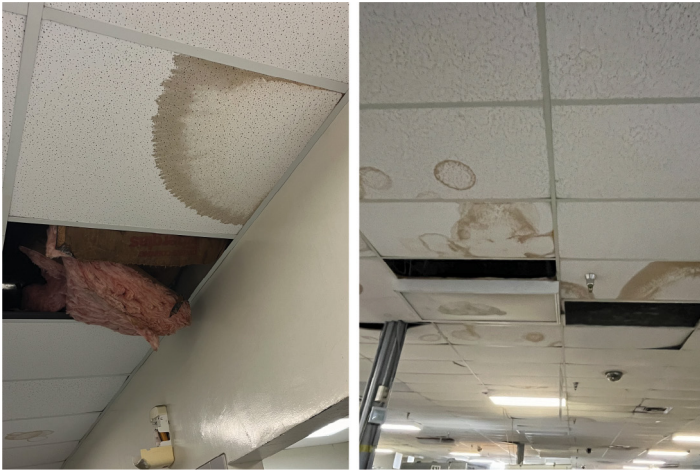
Figure 5. Stained and Missing Tile in Men's Restroom and Workroom Areas

- Walls throughout the facility such as lobby and workroom floor needed repainting.
- Several lights on the workroom floor not working due to numerous leaks from the roof.
- Loading dock area with damaged gutter allowing rain to trickle down where carriers load their vehicles.
- Parking lot needed resurfacing and parking bumpers deteriorating.
- Multiple stained, missing, broken, and misaligned ceiling tiles throughout the facility (see Figure 5).

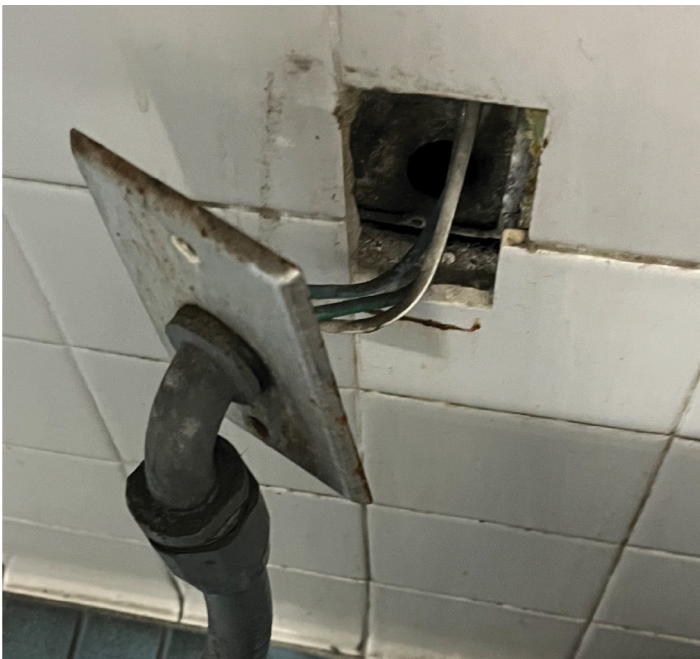
Figure 6. Loose Water Pipe Socket in Men's Restroom

- A loose water pipe socket in men's bathroom (see Figure 6).
- Broken floor tiles in customer lobby (see Figure 7).
