Fleet Modernization – Facility Preparedness for Electric Vehicles at the Topeka Sorting and Delivery Center

AUDIT REPORT

Report Number 24-056-R25 | January 8, 2025

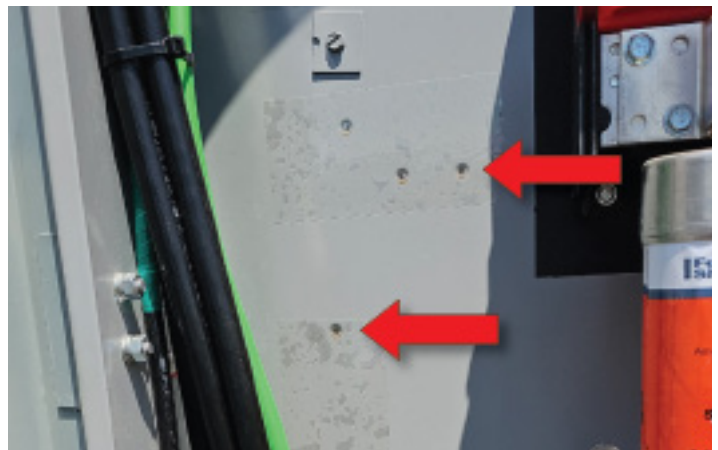
Figure 3. Taped Drill Marks Inside Electrical Panel

operated as a 24-hour facility, local management did not need to lock the delivery operation gates. Since its transition to an S&DC on June 3, 2023, and the cessation of round-the-clock operations, it is now necessary to secure the delivery gates daily. However, local management stated they never got into the habit of locking the gates once the facility stopped operating as a 24-hour facility. The facility's deteriorated signage, indicating vehicles are subject to search in the employee parking areas, resulted from prolonged exposure to sunlight and was not monitored or reported by local management as required. During the commissioning process, the drill holes in the panels were identified; however, the Postal Service contractor determined that the National Electrical Manufacturer Association 3R rating was intact.

Recommendation #3

Regarding recommendation 3, management stated it will require the contractor to validate that the National Electrical Manufacturer Association 3R rating is not compromised. The target implementation date is February 28, 2025.

Recommendation 3: We recommend the Chief Logistics and Infrastructure Officer and Executive Vice President, require the contractor to validate the National Electrical Manufacturer Association 3R rating is not compromised.

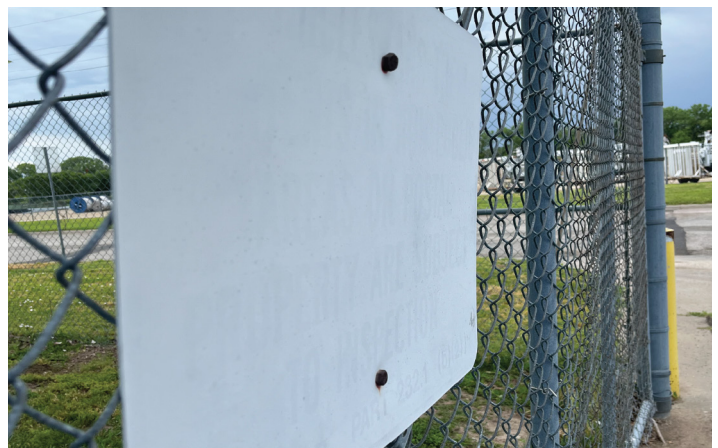
Figure 4. No Readable Signage to Restrict Public Access

The **Vice President, Retail and Delivery Operations – Central Area**, require local management to replace deteriorated exterior signage throughout the facility.

Regarding recommendation 2, management stated it will require local management to replace deteriorated exterior signage throughout the facility. The target implementation date is March 31, 2025.

Recommendation 2: We recommend the Vice President, Retail and Delivery Operations – Central Area, require local management to replace deteriorated exterior signage throughout the facility.

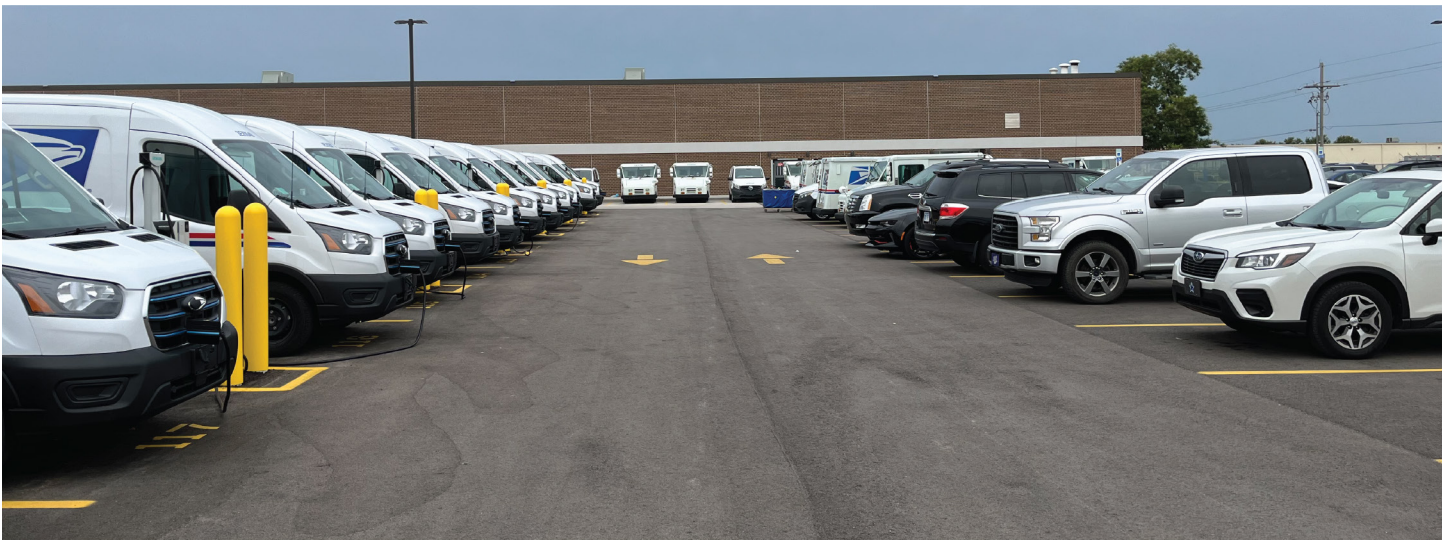
The Postal Service did not confirm the parking lot construction met the design criteria blueprints.²⁰ During a site visit on June 5, 2024, we statistically selected 35 of the 95 EV parking spaces and found 12 of the 35 (34 percent) spaces were less than the 20 feet in length as outlined in the design specifications. This — along with the size of the COTS EVs and the width of a parking lot drive aisle being shorter than the specified 24 feet (see Figure 5) — did

not provide sufficient space for maneuvering. The OIG witnessed and multiple Postal Service delivery carriers stated it takes six-to-eight attempts to safely maneuver the vehicles in and out of the parking spaces. Additionally, bollard spacing at one electrical panel frame did not meet design criteria blueprints for protecting critical electrical equipment from vehicular traffic (see Figure 6).

Figure 5. Insufficient Space for Maneuvering of COTS EVs

The drive aisle spacing constraints create a risk of damage to charging station infrastructure and the newly acquired EVs and could result in

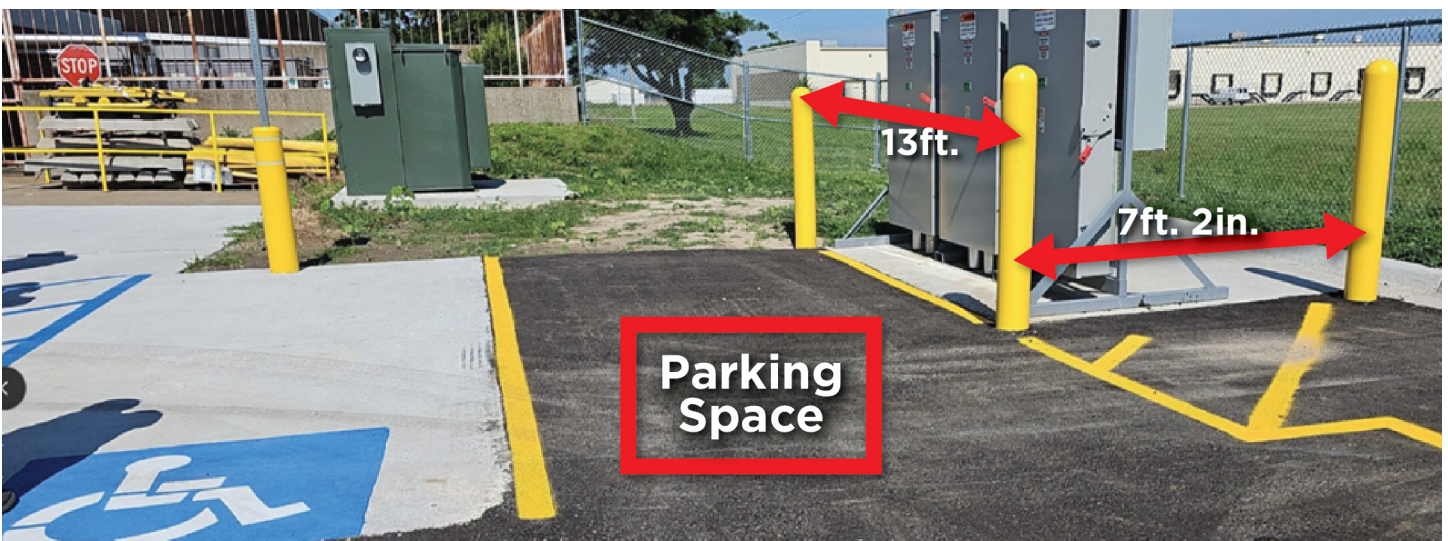
Figure 6. Insufficient Number of Bollards Near Electrical Panels

The **Chief Logistics and Infrastructure Officer and Executive Vice President**, require the contractor to either stripe the space near the electrical panel or add an additional bollard to protect the panel from potentially being damaged.

Regarding recommendation 4, management stated it would act on this recommendation to the extent that it will perform an assessment and determine the next steps. The target implementation date is February 28, 2025.

Recommendation 4: We recommend the Chief Logistics and Infrastructure Officer and Executive Vice President, require the contractor to either stripe the space near the electrical panel or add an additional bollard to protect the panel from potentially being damaged.

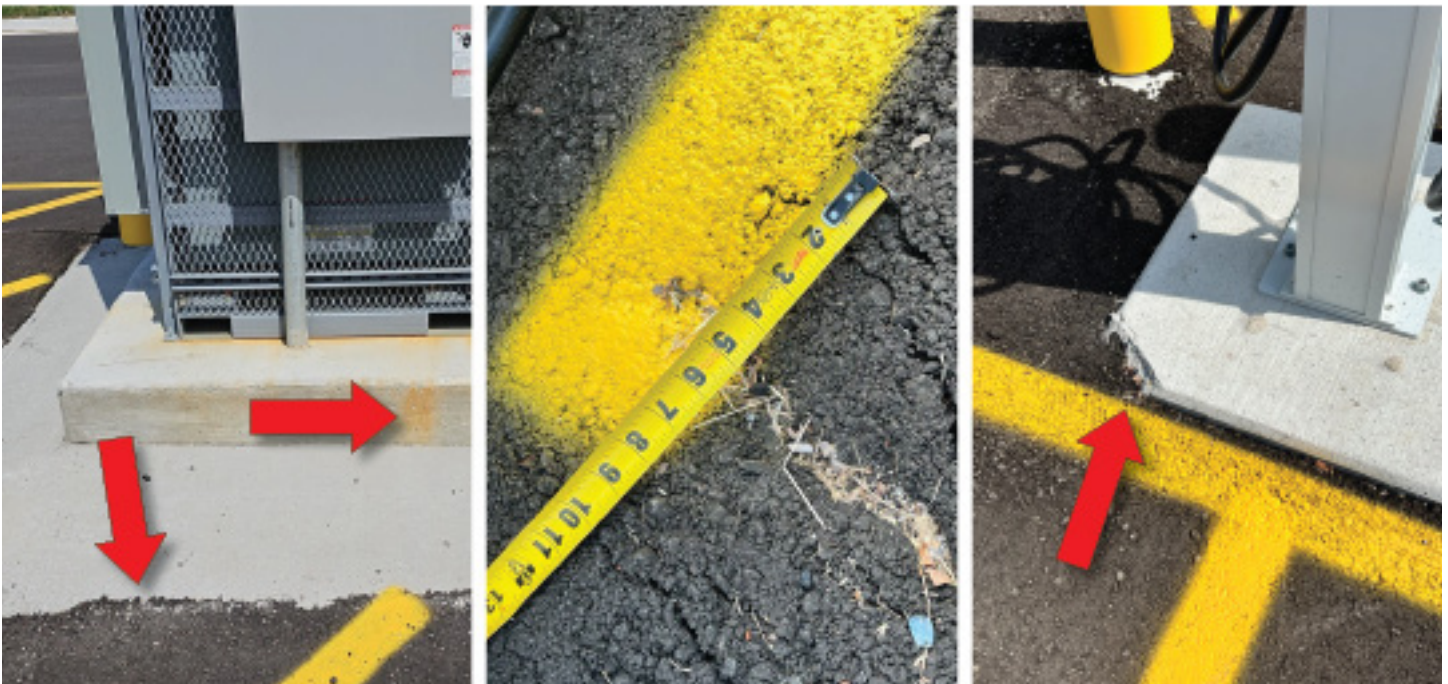
We also identified three additional potential safety issues in the parking lot such as visible rust, chipped concrete slabs, and the deterioration of pavement (see Figure 7). These issues were discussed with management during our audit and not previously reported to the NFRL or locally on a Postal Service

Figure 7. Rust, Chipped Concrete, and Sinking Asphalt in Parking Lot.

Management acknowledged that the items flagged in Figure 7 may represent minor quality or workmanship issues, so it was not concerned about failing to meet construction standards or design requirements. Management stated notable issues should be captured in either the construction punch list or in the commissioning process (which the field personnel participate in) for remediation by the installation supplier.

The **Chief Logistics and Infrastructure Officer and Executive Vice President**, in coordination with **Retail and Post Office Operations Vice President**, communicate to locations with electric vehicle infrastructure that policy regarding reporting safety hazards also includes electric vehicle infrastructure.
