# Hazardous Waste Management at Postal Service Vehicle Maintenance Facilities

## AUDIT REPORT

Report Number 23-091-R24 | November 3, 2023

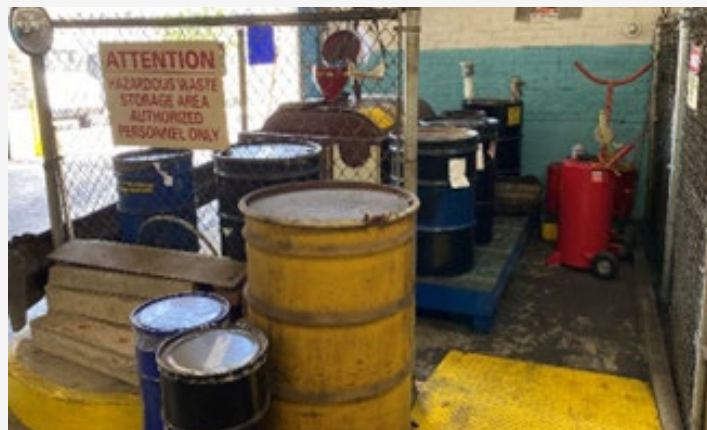
### Central Accumulation Area

- Central accumulation areas are for the storage of hazardous waste containers prior to shipment to an off-site disposal location.
- Satellite accumulation areas are for temporary storage of small quantities of hazardous waste at or near the area or process where the waste is first generated.
- Aboveground storage tanks are used to store fluid products and waste, such as motor oil, gasoline, diesel fuel, heating oil, and antifreeze.
- Local storage is used to store universal waste consisting of materials that are common,<sup>5</sup> including certain batteries; lamps (light bulbs); mercury-containing equipment, such as thermometers, thermostats, and electrical switches; aerosol cans; and pesticides.

Source: Site visit to Fall River VMF on May 23, 2023.

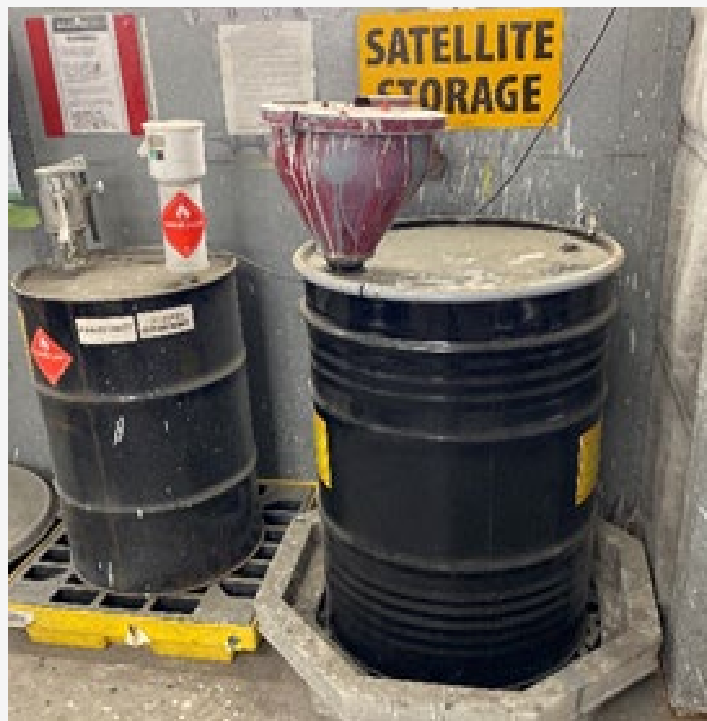
### Satellite Accumulation Area

Source: Site visit to Boston VMF on May 25, 2023.

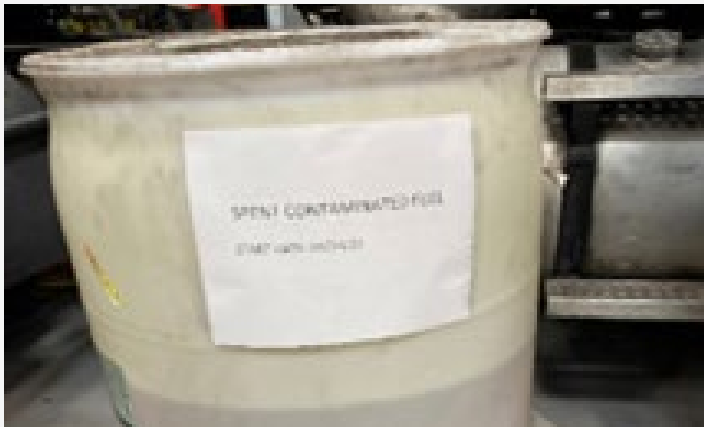
Waste Fuel Without Proper Label

- All 19 (or 100 percent) VMFs had container labels that were missing, incomplete, or illegible. Labels are important to ensure proper identification of contents or to indicate when the container becomes full.
- 16 (or 84 percent) VMFs' personnel did not keep containers closed to prevent accidental spills.
- Nine (or 47 percent) VMFs had containers in poor condition (showing evidence of damage, leakage, bulging, rusting or other deterioration) and did not ensure proper storage of hazardous waste.

These hazardous waste deficiencies occurred because Fleet Management did not have effective procedures to verify that policies requiring weekly and monthly inspections and annual training were followed. Instead, for oversight, management relied on Environmental Compliance Reviews, which are not conducted often enough for efficient monitoring of environmental compliance. High priority sites, such as VMFs, undergo an Environmental Compliance Review to assess compliance with environmental laws and regulations at least every three years. Because VMFs are on a three-year cycle, relying on the Environmental Compliance Reviews for oversight is insufficient to timely rectify any deficiencies identified.

We recommend the **Senior Vice President, Facilities and Fleet Management**, develop and implement oversight procedures to verify that weekly and monthly hazardous waste inspections are performed, as required.

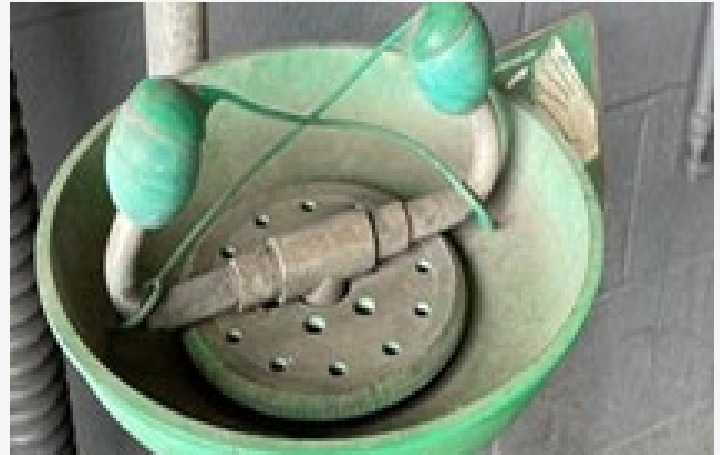
### Dirty Plumbed Eyewash Equipment

- Water flowing from the eyewash and shower equipment was either low-flowing, dirty brown with the appearance of contamination, or did not drain after activation.
- Equipment was covered in dust, dirt, and debris or blocked by doors or other items.
- Protective eyewash covers were missing from equipment, or covers did not come off when activated, which could prevent timely usage.
- Self-contained eyewash containers and squeeze bottles held unusable contents that expired between October 2020 and September 2022.

These emergency eyewash and shower deficiencies occurred because there were no oversight procedures in place to ensure VMF and maintenance personnel were performing the weekly testing and monthly/annual inspections, as required. Maintenance Operations management stated training was not necessary because of the simplicity of the weekly testing requirements. Additionally, one VMF employee stated they were given verbal instructions on how to perform the testing and inspection of the emergency eyewash and shower equipment. However, they were not made aware, or provided a copy, of the policy that details the specific weekly and monthly tasks for proper maintenance of emergency eyewash and shower equipment. The identified deficiencies are likely to continue without (1) applicable training in accordance with existing policy, and (2) communicating the importance of regularly

We recommend the **Vice President, Processing and Maintenance Operations**, and the **Senior Vice President, Facilities and Fleet Management**, develop and implement oversight procedures to verify weekly testing and monthly/annual inspections of emergency eyewash and shower equipment are performed, as required.

We recommend the **Vice President, Processing and Maintenance Operations**, and the **Senior Vice President, Facilities and Fleet Management**, provide applicable training on testing and inspecting emergency eyewash and shower equipment to responsible personnel, as required in relevant Maintenance Management Orders.

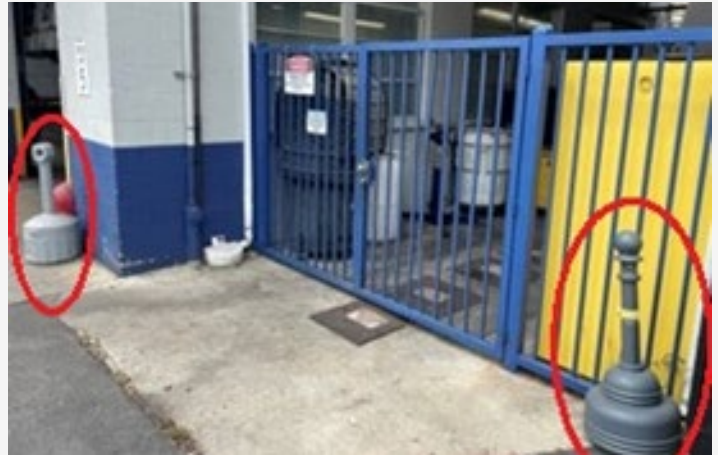
Designated Smoking Area Located Adjacent to Hazardous Waste Central Accumulation Area

VMF management placed designated smoking areas within 25 feet of VMF buildings, which allowed employees to smoke near operations involving hazardous waste or other flammable materials. Specifically, five (or 26 percent) of 19 VMFs visited had designated smoking areas adjacent to buildings, in close proximity to hazardous waste central accumulation areas, and next to roll-up bay doors. (See Figure 5.)

The smoking related deficiencies occurred because VMF management did not enforce policies on the location of designated smoking areas. Specifically, management stated the facilities have been there a long time, and designated smoking areas were in place prior to their employment at the facility.

We recommend the **Senior Vice President, Facilities and Fleet Management**, enforce existing policy for designated smoking areas to be more than 25 feet from oil storage or other operations involving flammable liquids or gases.

the other side of the roll-up door and walls and is therefore not in compliance with Postal Service policy. However, even though management disagreed with the finding, they moved the smoking area that was near the roll-up door and removed the smoking area that was adjacent to the VMF building. These actions satisfy the intent of Recommendation 5.
