## AUDIT REPORT

# Facility Condition Reviews – Short Hills, Roseville, and Wood Ridge Post Offices

Report Number 20-159-R20

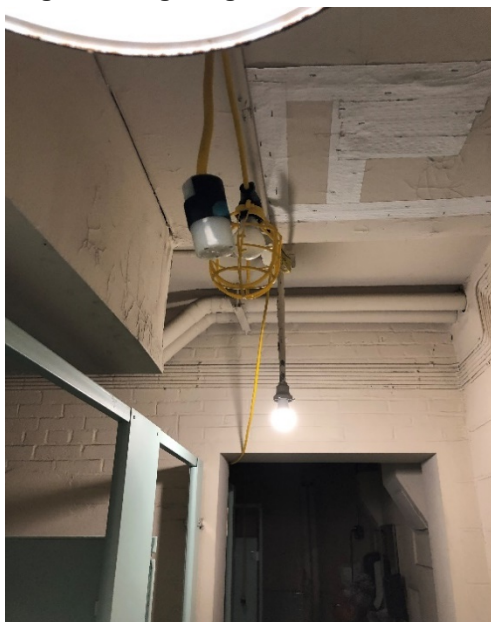
**Figure 1. Lighting in Men's Restroom**

Several areas throughout the facility had poor lighting, including temporary lights installed in the men's restroom (see Figure 1). In addition, walls throughout the facility were chipped, peeling, and dirty (see Figure 2) and there was missing tile in the men's restroom. Although some issues were previously reported in eFMS, others were not.

**Recommendation #1:** We recommend the **Manager, Northern New Jersey District**, address all building maintenance, safety, and security issues identified at the Short Hills, Roseville, and Wood Ridge Post Offices.

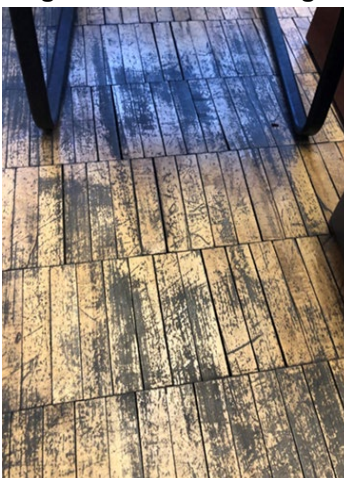
**Figure 5. Worn Flooring**

At the Roseville Post Office, the flooring was stripped and worn (see [Figure 5](#)) and the front of the building was missing bricks (see [Figure 6](#)). There were also dirty air vents; and ceiling tiles were missing, buckling, or stained throughout the facility (see [Figure 7](#)).

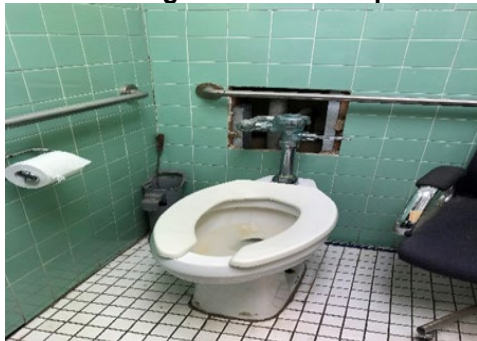
**Figure 8. Missing Tile in Handicap Restroom**

At the Wood Ridge Branch, we identified issues related to walls and ceilings, plumbing, dirty vents, and improperly stored supplies and equipment. The wall behind the toilet in the handicap restroom had a hole with exposed pipes (see [Figure 8](#)) and the toilet in the men's restroom leaked when flushed and the urinal was slow to drain. In the lobby, the customer counter had packing tape around the edges instead of trim (see [Figure 9](#)). In addition, walls throughout the facility had cracks, were peeling, dirty, and in need of paint; and ceilings had missing or stained tiles (see [Figure 10](#)).

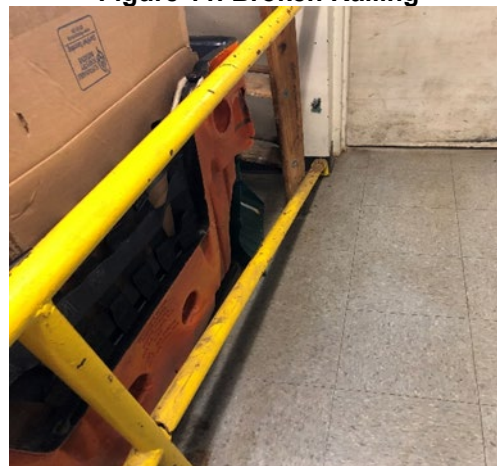
**Figure 11. Broken Railing**

1. Light fixtures missing covers.
2. Broken railing in vestibule (see Figure 11 above).
3. Latch on the storage room door taped to prevent locking.
4. Rusted parking signage.
5. Wooden storage shed rotted with a broken door hinge.

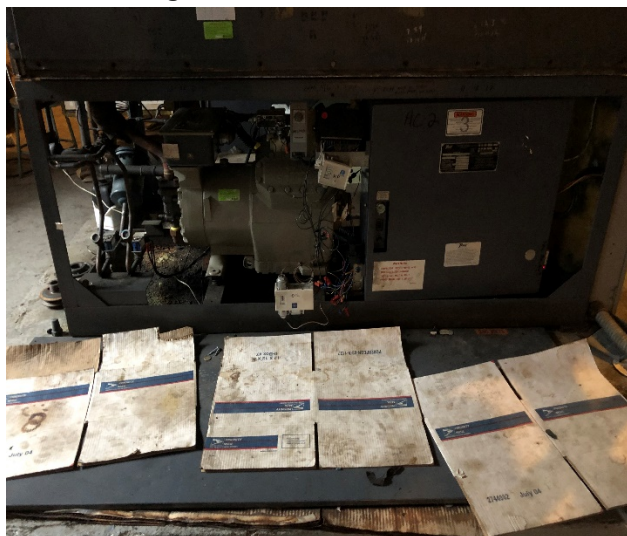
**Figure 12. Uncovered Boiler**

Electrical panels throughout the facility were missing covers. The boiler panel was removed, exposing the wires, and the voltage associated with the unit could not be easily identified (see [Figure 12](#)). A combination light switch in the postmaster's restroom

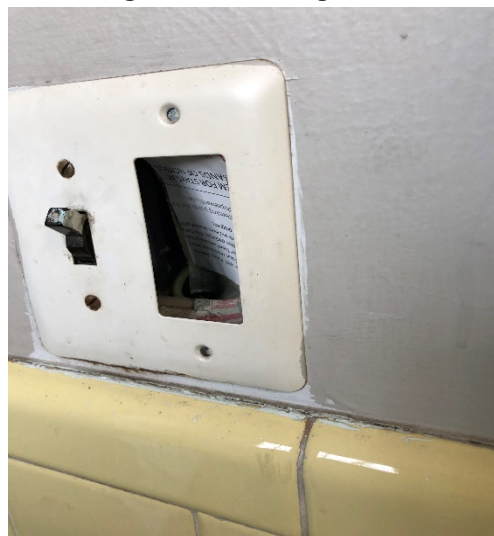
**Figure 13. Missing Outlet**

was missing the outlet section, and a piece of paper was placed in the hole to cover exposed wires (see Figure 13).

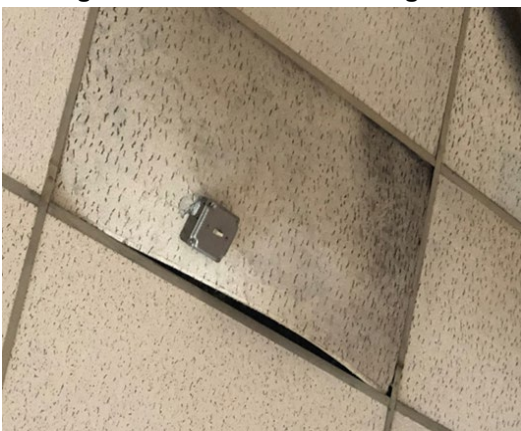
Figure 14. Unsecured Ceiling Tile

The workroom floor at the Roseville Post Office had an electrical switch attached to the ceiling tile not securely mounted (see [Figure 14](#)). In addition, one fire extinguisher had not been inspected since September 2018 (see [Figure 15](#)) and the remaining fire extinguishers had not had monthly inspections since November 2019.

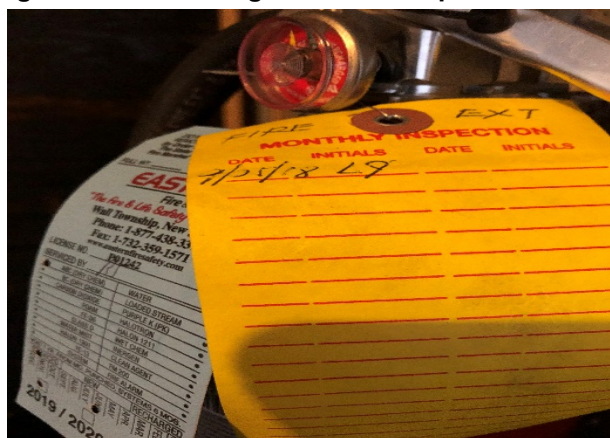
Figure 15. Fire Extinguisher not Inspected Monthly

Fire extinguishers were not always inspected monthly as required<sup>5</sup> due to a lack of oversight. Housekeeping inspections were not conducted semiannually, as required,<sup>6</sup> because local management was not aware of the requirement.

**Recommendation #3:** We recommend the **Manager, Northern New Jersey District**, ensure fire extinguishers are inspected monthly at the Short Hills, Roseville, and Wood Ridge Post Offices.

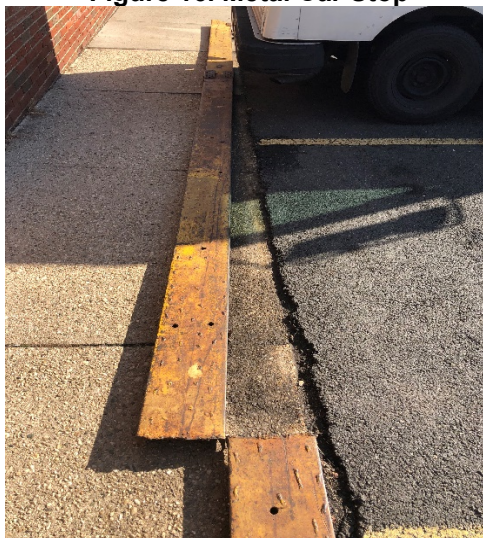
Figure 16. Metal Car Stop

1. Unsecured ladders on the workroom floor and vestibule.
2. Exposed electrical wiring in the manager's bathroom.
3. Blocked internal Inspection Service door.
4. Flammable items improperly stored.
5. Potential trip hazard caused by a separated and protruding metal car stop along the employee sidewalk (see Figure 16).

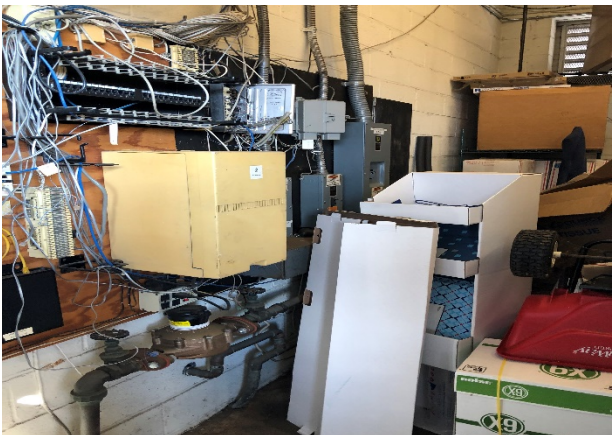
**Figure 17. Blocked Electrical Panels**

At the Wood Ridge Branch, we identified issues related to missing fire extinguisher inspections, outlets with missing covers, and potholes in the parking lot. Electrical panels and the ladder leading to the roof in the electrical room were blocked by boxes and equipment. This room also served as a storage room and was cluttered with supplies (see [Figures 17](#) and [18](#)). In addition, one fire extinguisher had not been

Management took corrective action during our site visit and unblocked the electrical panels and access to the roof.
