## Evaluation Report

# Improvements in State Agency Oversight Needed to Prevent Asbestos Exposure and Fraud in Blight Demolitions

**SUBJECT:** Improvements in State Agency Oversight Needed to Prevent Asbestos Exposure and Fraud in Blight Demolitions  
(SIGTARP 19-002)

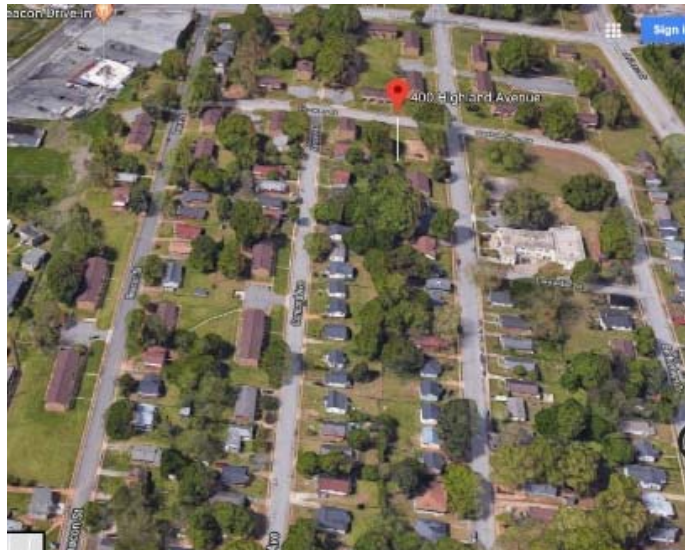
Cammie Clagett Courts (figure 1) was a residential apartment community built in a mixed neighborhood of private homes located in the Highland Street area of Spartanburg, SC, circa 1970; the owner is the City of Spartanburg. The complex includes an administrative office and approximately fifty residential apartments in duplex buildings (Figure 1). The colonial style buildings are constructed of brick veneer over 2" x 4" wood studs, conventional framing with decorative shiplap siding insets, and pre-manufactured wood trusses, gable ends and a single layer of asphalt shingles that are tacked and appear to be in good shape. The buildings are configured in either: one story, one bedroom, one bath; two story, three bedroom, one bath; or two story, four bedroom, one and a half baths. The Dwelling Units are located in fifty (50) one and two story buildings with the following breakdown:

Figure 1 – 400 Highland Avenue, Spartanburg, SC 29306

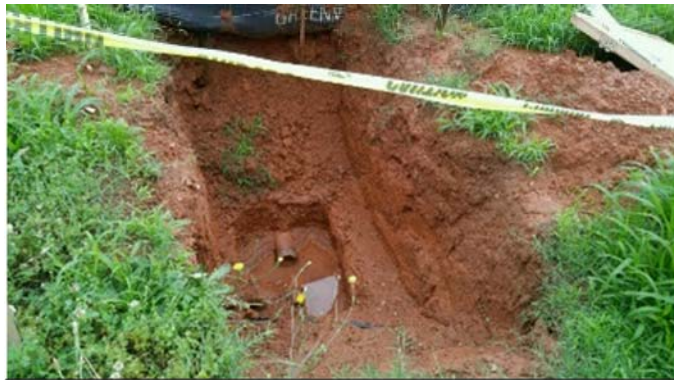
No active utilities were observed at the site which appears to be consistent with reports that the properties were vacant and abandoned. WH worked with the City to cap all sanitary sewer lines with either rubber boots or vitreous cement (per the City's direction), (figure 2). The utility company removed gas meters at each apartment and capped the gas lines at the main distribution line. All other distribution branches were abandoned in-place. Water lines are capped at the street by the City. Electric meters were removed at each apartment and de-energized at the transformers by the utility.

Figure 2 – Capped utilities in front of 211 Bunker St., Spartanburg, SC

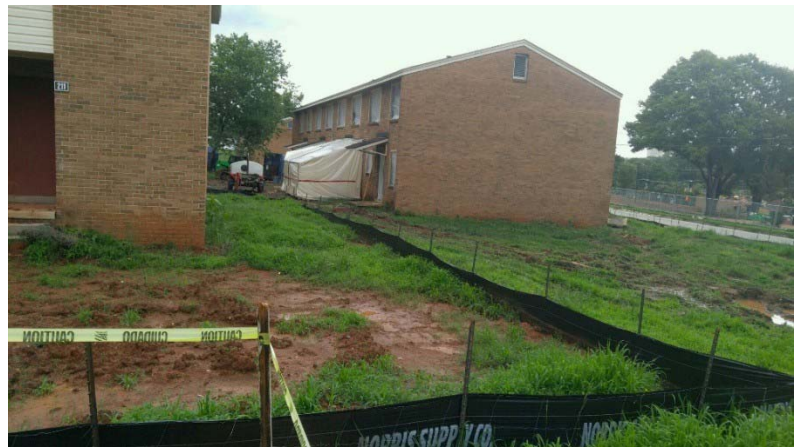
The process begins with WH's contractors Duncan or Eastern Environment stripping out all recyclable items from the units, this includes: interior doors, kitchen sinks, toilets, cast iron bathtubs, door casings, carpet, tile, base moldings, any abandon appliances, and HVAC systems including condensing coils—though many of these HVAC units may have been previously looted because of their resale and scrapping

Figure 3 – Encapsulated remediation of asbestos, 310 Highland Ave., Spartanburg, SC.

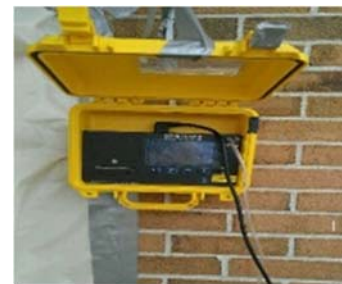
value. The contractor sorts these materials for recycling and stockpiles like materials until there is enough material to warrant transportation to a recycling facility. This process leaves just the wall and ceiling gypsum board in place and ready for demolition. Next, by apartment, all windows are covered on the exterior with plastic. Special air blowers are installed with asbestos filter traps to create negative air pressure within the unit. An exterior tent is erected to act as a “clean room” airlock (figure 3) with asbestos air monitors (figure 4) to ensure that no friable asbestos is released to the environment during demolition. Workers inside the units wearing Tyvek protective clothing and respirators, remove the contaminated gypsum board and place it in black plastic bags labeled “biohazard.” These are transferred to other workers in the airlocks to double bag and take to specifically labeled plastic-lined containers. At the end of the process, the workers vacuum up all the contaminated dust using special vacuums and spray a white latex material that captures any possible air-borne material. All filters and contaminants are bagged and placed in the containers and shipped to Anderson Regional Landfill, LLC in Belton, South Carolina (figure 5). This company is a subsidiary of Waste Connections Inc. (DHEC license # R1805067). The containers are then weighed and properly disposed of by the landfill. This entire process is monitored and observed by the third party environmental monitoring firm

Figure 4 – Asbestos meter and containment 310 Highland Ave.

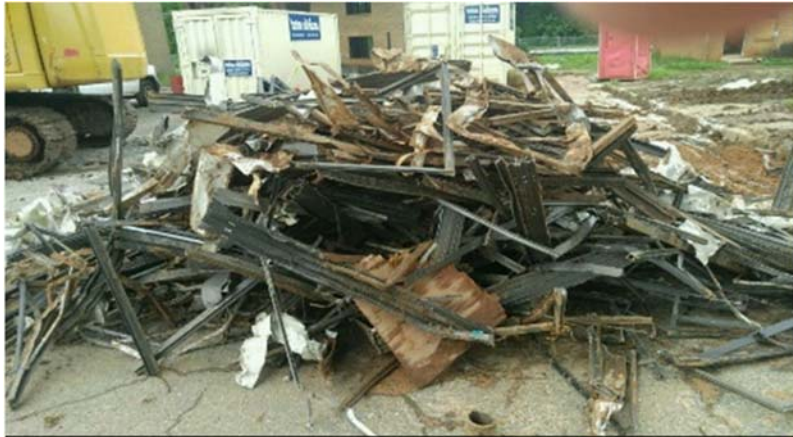
After Summit clears the buildings, the recycling process continues. The buildings are completely open, where possible WH is using portable fencing to secure the site from pedestrians and vandals. Next, WH workers remove all aluminum window frames (figure 6); copper wires and pipes; and any remaining heavy iron for sorting and recycling. This leaves just the exterior structure of the building and the interior bare studs left for demolition.

Figure 6 – Aluminum scrap pile recovered from the razing of 331 S. Forest St.

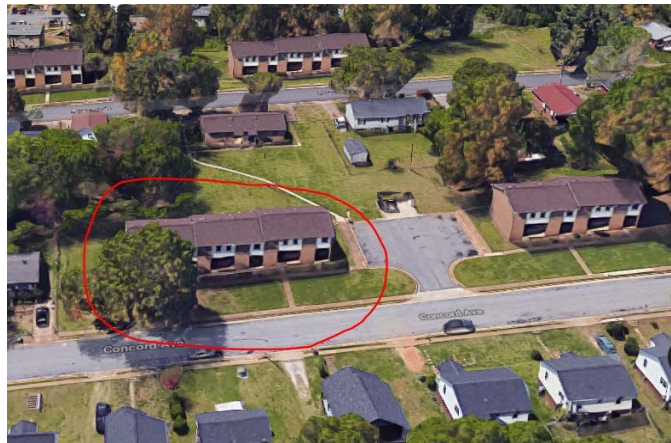
Figure 7, shows the pre-demolition of Building 38, apartments 420, 422, 424, 426, 428 and 430, (address: 422 Concord Ave., Spartanburg, SC). This unit was razed while we were onsite. The contractor used water for dust abatement during demolition and appeared to observe all safety protocols for this type of demolition.

Figure 7 – 422 Concord Ave, razed when we were there.

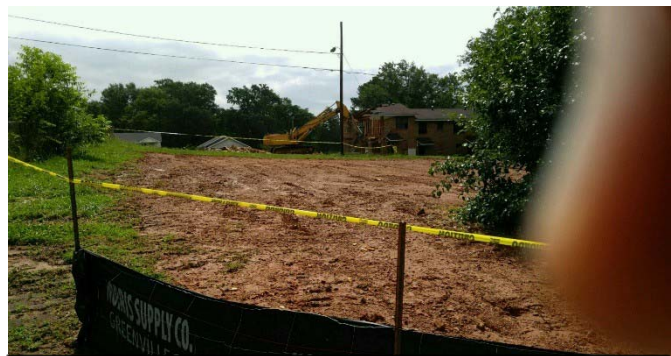
Figure 8 shows post demolition remediation at (418 Beacon St. Spartanburg, SC). The lot is protected with a silt fence and all debris have been removed. It is roughly graded back to adjacent elevations and sloped to prevent ponding. This lot is an example of a lot that is awaiting final grading and seeding with grass and straw mulch.

Figure 8 – Lot 418 Beacon St., Spartanburg, SC

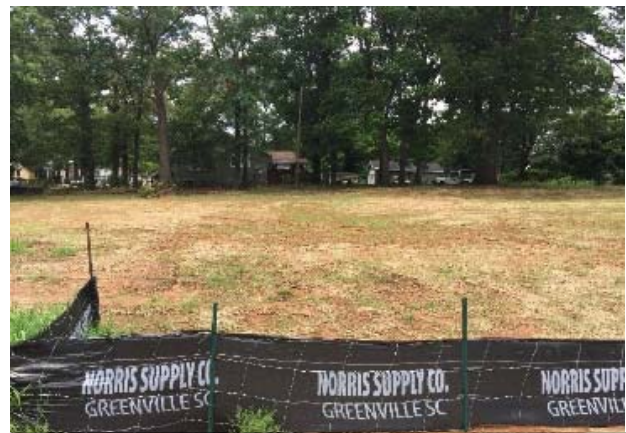
Figure 9 shows a remediated lot (447-449 Highland Ave. Spartanburg, SC) post final grading and planting. Note the appearance of grass growing on the lot. At this point, the sites are ready for reuse by the city at the close of the project.

Figure 9 – 447-449 Highland Avenue
