CONDITION OF BUREAU OF INDIAN AFFAIRS FACILITIES AT THE PINE HILL BOARDING SCHOOL

Subject: Inspection Report – Condition of Bureau of Indian Affairs Facilities at the
Pine Hill Boarding School
Report No. C-IS-BIE-0023-2014-A

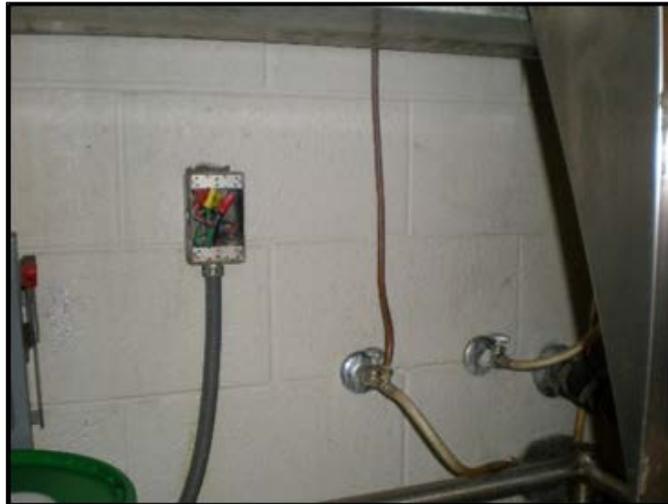
Exposed electrical wiring found near water sources presents shock and fire hazards. Wires should be enclosed in the proper electrical box, and outlets near water sources should be ground fault circuit interrupter (GFCI) protected. We found improperly protected wires (see Figure 2) and several outlets that were either not GFCI or not marked properly.

Figure 2. Improperly protected wires under cleaning equipment and near water lines in the kitchen in the cafeteria. Source: OIG

1. Take immediate action to correct the health and safety issues or ensure that the students and staff are adequately protected until these problems are resolved; and
2. Take corrective action for the general facility deficiencies noted in this report and Appendix 2 or ensure that these items are entered into Facilities Management Information Systems (FMIS) or Maximo for future funding consideration.

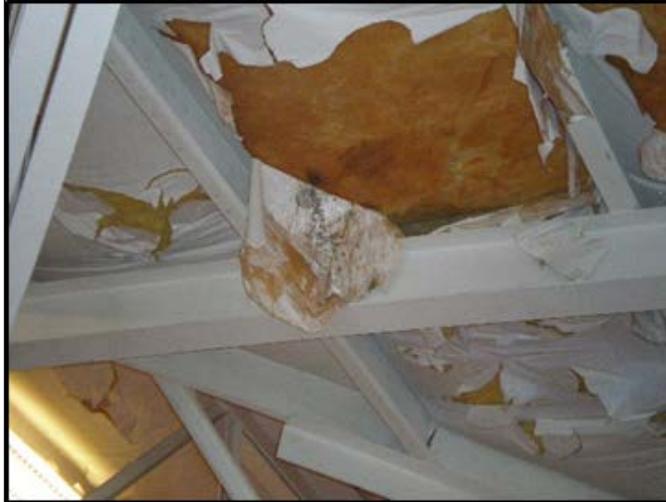
Several buildings appeared to have significant roof leaks. This has resulted in extensive water damage in the library, gymnasium, and around the skylight and elevated windows in the instructional buildings (see Figure 3).

Figure 3. Water damage and mold indicated in the ceiling of the gymnasium. Source: OIG

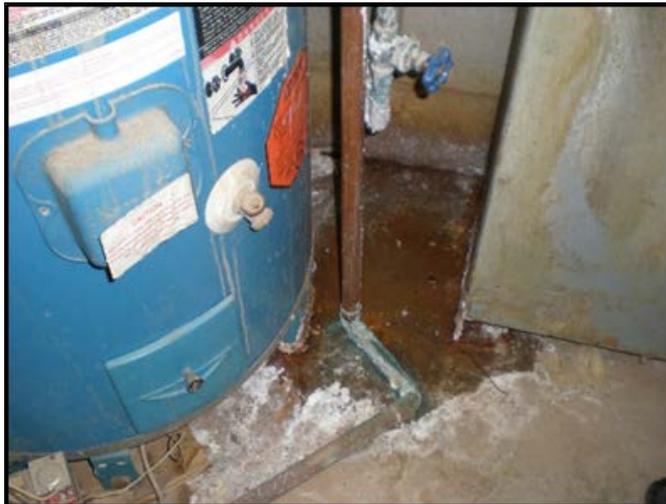
One water heater in the gymnasium was not functional and the other was leaking (see Figure 4). The shower faucets were corroded, and we are concerned that students do not have adequate showering facilities.

Figure 4. A water heater in the gymnasium was leaking. Source: OIG

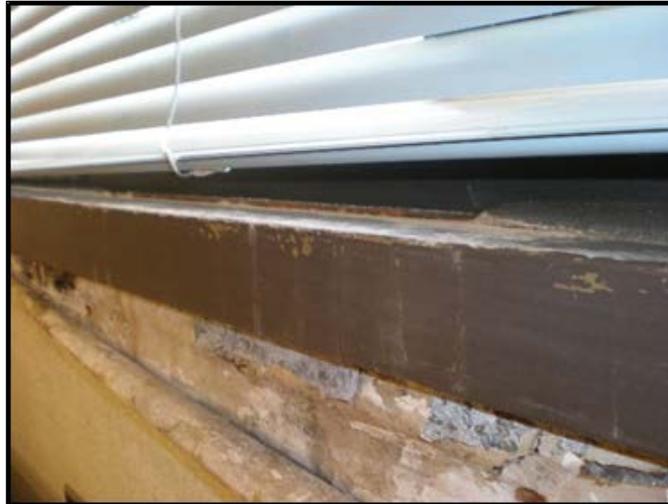
Windows that were reportedly installed in the library within the last 2 years were already showing signs of extensive leaking, deterioration, and mold (see Figure 5).

Figure 5. Water damage and mold around a window in the library. Source: OIG

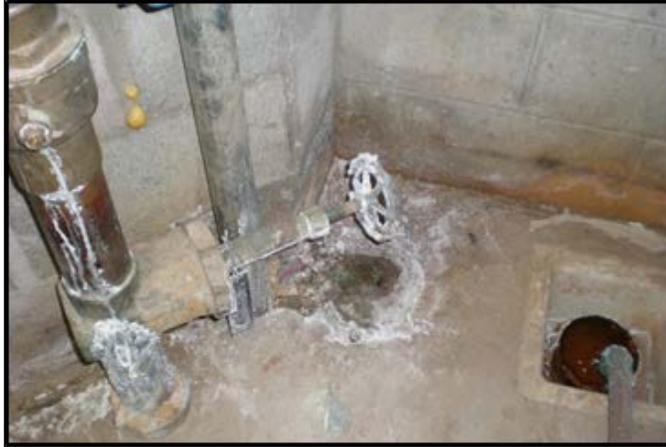
We found evidence of corrosion on several pipes in the building and leaks have already developed in various bathrooms and in the kitchen (see Figure 6). Given the inadequate maintenance found at the school, we are concerned that these issues will likely continue uncorrected until more costly repairs are necessary.

Figure 6. Corroded pipes in the gymnasium. Source: OIG

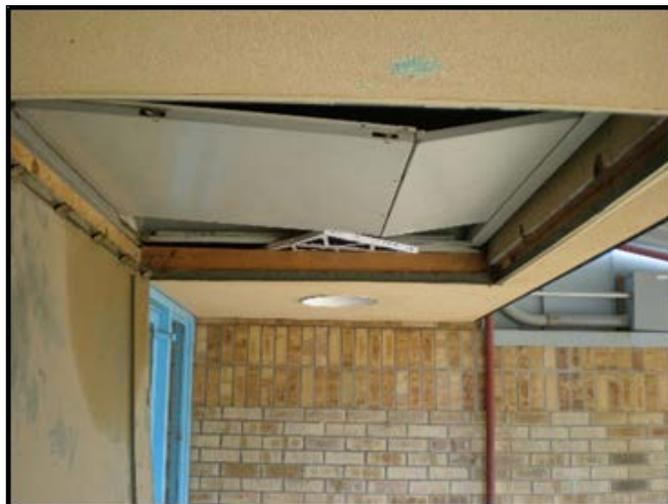
Overall, the kindergarten classroom is in poor condition. It is so cluttered that a fire could swiftly spread throughout the classroom. Further, the walkway leading from the classroom to the play area is directly under an access point to the ventilation unit, and the metal door was left hanging open (see Figure 7). The only thing holding up the metal door was an air filter wedged into one side.

Figure 7. The metal door to the ventilation unit was left hanging open outside the kindergarten classroom. Source: OIG

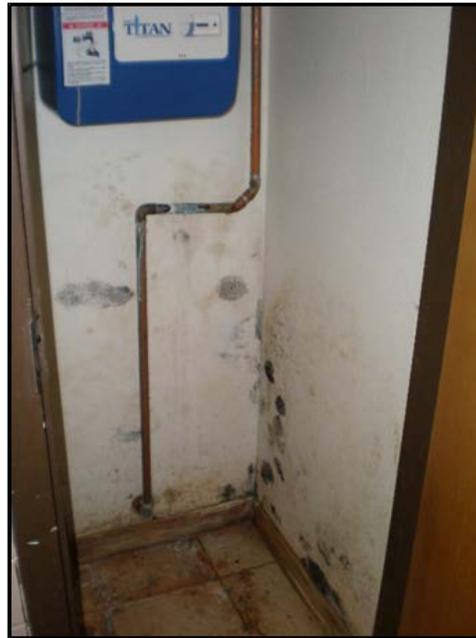
We found mold in multiple school buildings, including the gymnasium, elementary classrooms, and the library (see Figure 8). None of these locations are being treated, and the moldy locations are all accessible to students.

Figure 8. Mold found in the restroom of the kindergarten classroom. Source: OIG

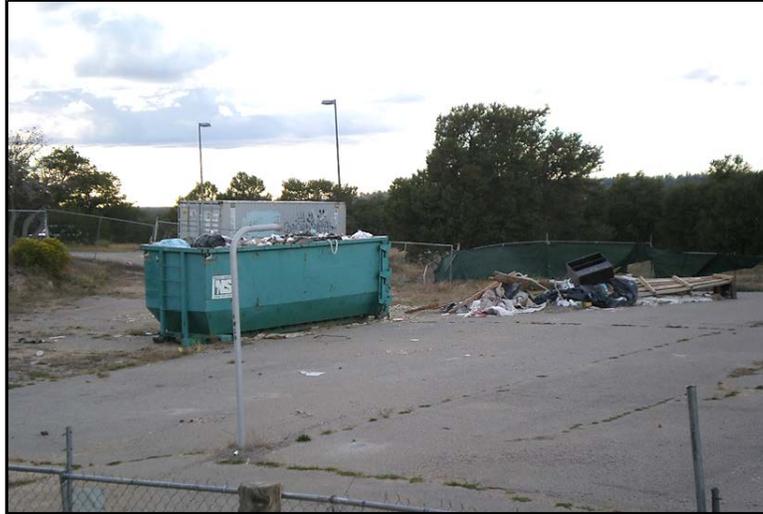
Outside some of the academic buildings, we found a commercial-sized trailer overflowing with trash (see Figure 9). This unnecessary health and safety hazard can easily be accessed by students because the fencing is falling down in multiple places.

Figure 9. A commercial-sized trailer overflowing with trash near two academic buildings. Source: OIG

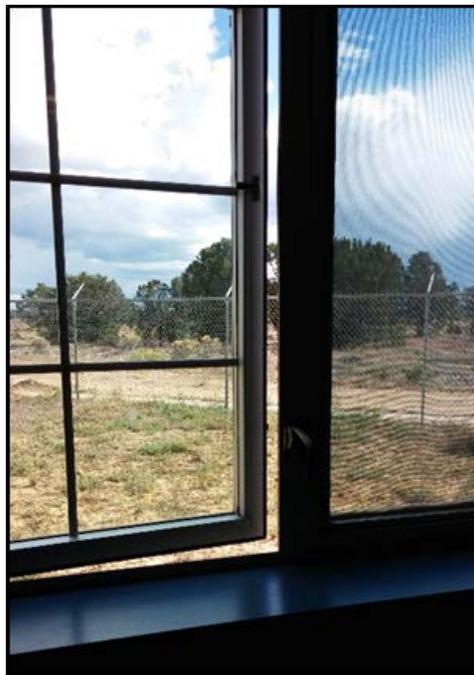
The school campus does not have complete fencing. This makes other means of security necessary for the dormitory. We found a window into a bedroom wing that was broken and could not be closed, which leaves the boarding students exposed to various threats, including unauthorized persons (see Figure 10).

Figure 10. One window in the dormitory does not close. Source: OIG

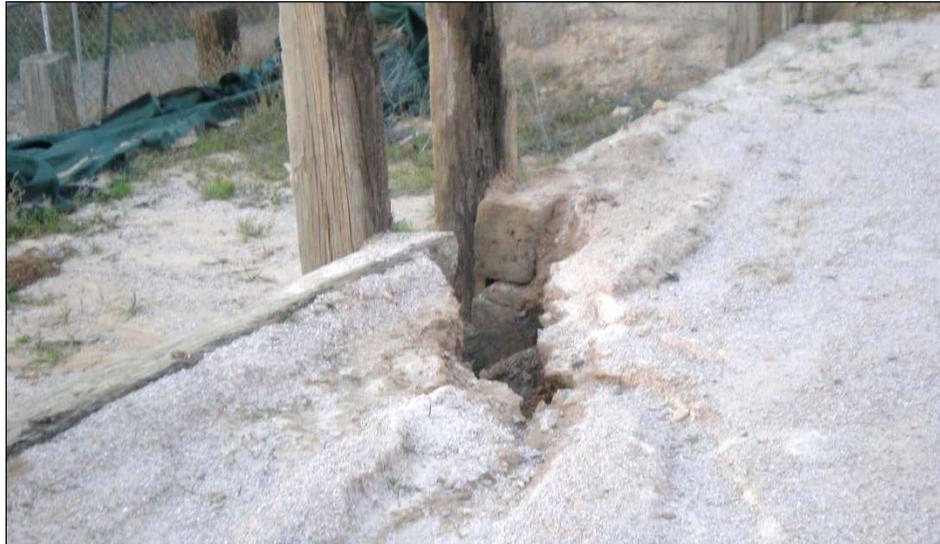
Further, the school began construction on a new elementary school building in 2010. Since then, this building has been continually faced with problems. Specifically, contractors have performed inferior quality work, leaving the school with a building that was unable to pass inspection until recently, and construction that had still not been completed at the time of our inspection. This included doors that did not latch properly, walls with cracks, lights that could not be turned off,

floors that were not even, poorly installed cabinets and plumbing fixtures, and concrete work that was already cracking and breaking (see Figure 11).

Figure 11. A retaining wall installed in the new building is already structurally compromised.
Source: OIG

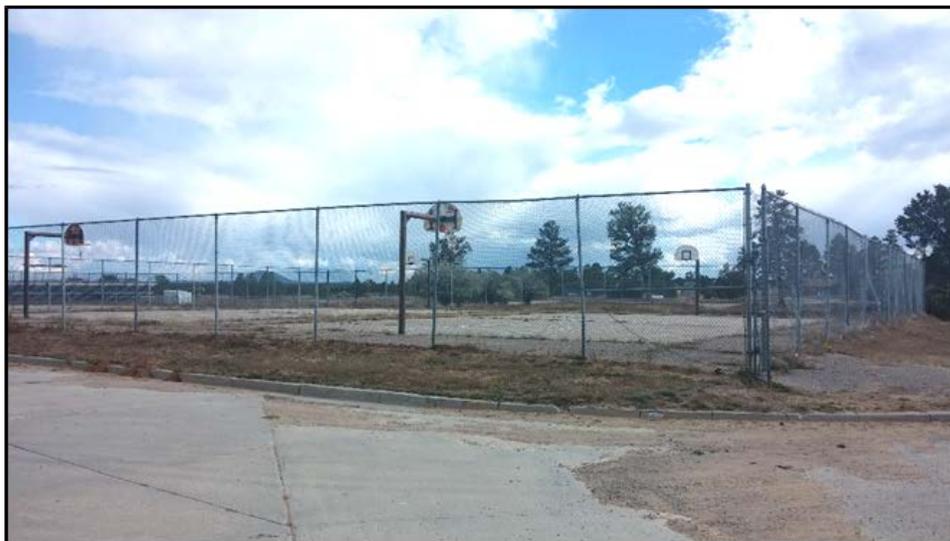
In addition to the significant deficiencies and health concerns mentioned earlier, the whole school campus is poorly maintained. Overgrowth makes the school look semi-abandoned and basic preventative maintenance activities do not appear to be performed consistently (see Figure 12). The overgrowth not only presents a fire hazard, but it also leads to accelerated deterioration of school facilities.

Figure 12. Overgrowth on and around the main basketball court on campus. Source: OIG

11. Clean up the campus landscaping, walkways, recreation areas, and fencing, and make sure that fire hazards are properly maintained.

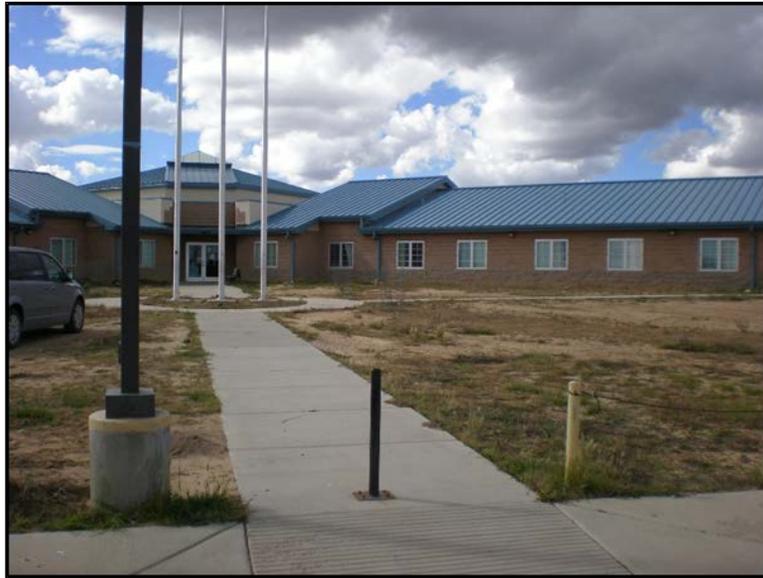
BIA built a dormitory for the school in 2007 (see Figure 13), to replace a building in poor condition. This new dormitory is only housing about 25 students in over 25,000 square feet of space, although the dormitory is designed to accommodate up to 100 students. A dormitory of this size is not needed, given that this is the only student boarding facility on campus and most of it is empty. In addition, the building is not being maintained properly. Some of the maintenance problems include broken door handles, fraying carpet, overgrown play areas, moisture damage in some bathrooms, non-functioning hallway lights, damaged gutters, and garbage scattered in several sleeping spaces. Further, one wing of the dormitory had the heater set to the mid-80s, while doors to other parts of the building were left open. BIA told us that the computer-automated heating system is no longer working, and parts may have been improperly removed from the site. BIA has still worked to secure even more funding to have this system replaced.

Figure 13. The new dormitory, which was built in 2007, has been poorly maintained. Source: OIG

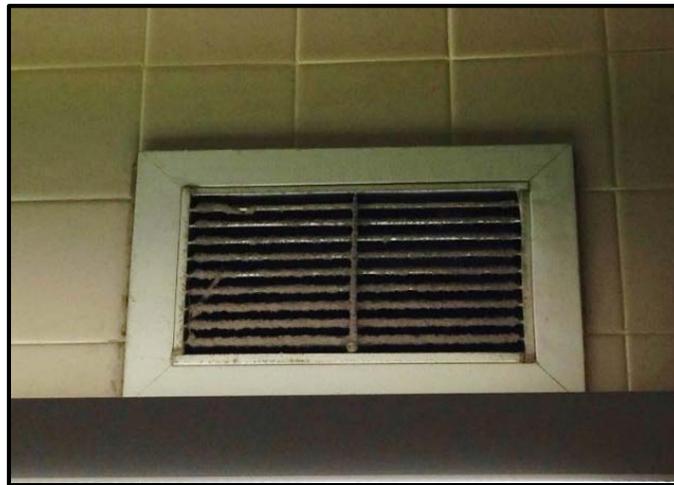
Substantial amounts of dirt around the vents indicate a poorly maintained air distribution system and may be reducing the operational efficiency of the system.

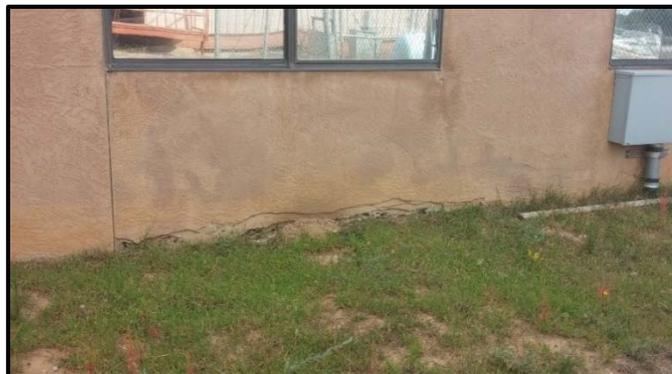
Water saturation at the base of buildings is eroding walls and may be impairing the structural integrity of building foundations.

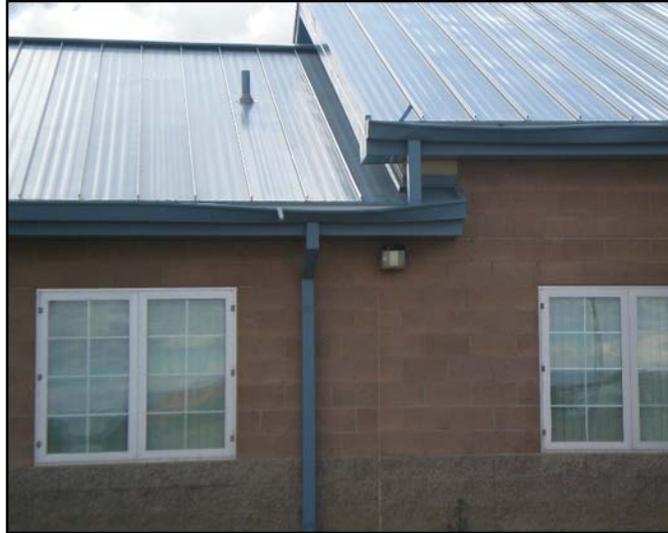
Gutters are broken or improperly hung on some portables. Several gutters on the administration buildings drain straight down to the building foundation (not

drained away from the building). Further, gutters on some academic buildings and the dormitory are damaged and not properly protecting the buildings from water damage.

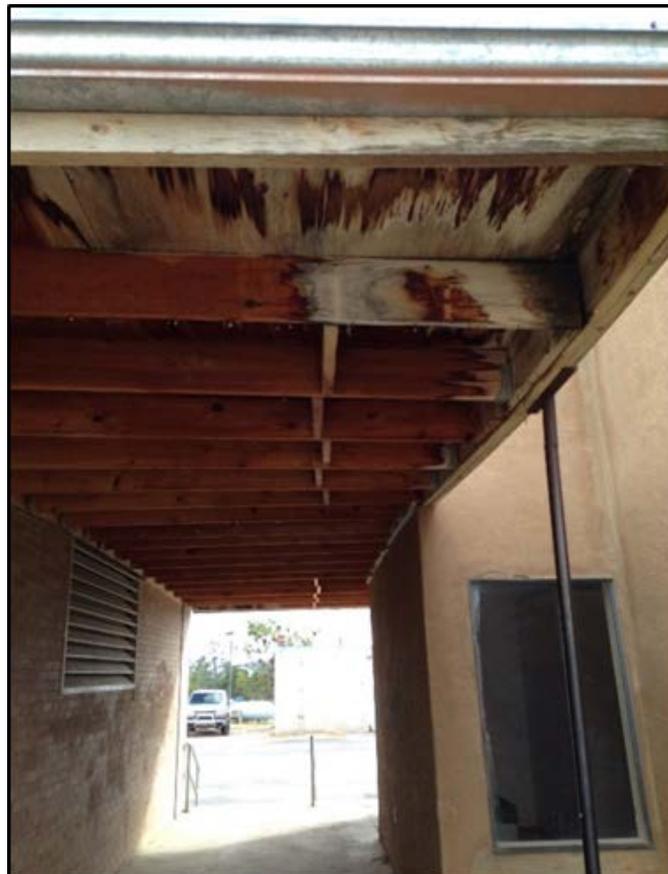
Indications of poor drainage and subsequent water damage can be seen on deteriorating eaves and overhangs.

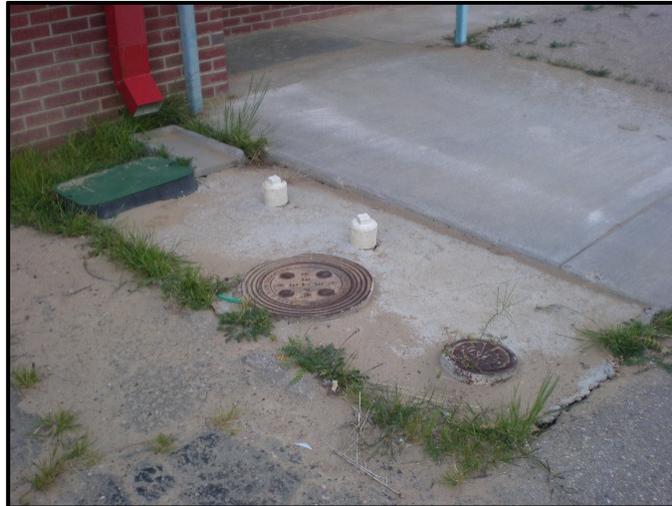
Drainage areas are poorly maintained around the campus, which has resulted in cracked areas and trip hazards. Clogged drains also lead to additional problems when water backs up above ground onto walkways and towards the foundations of nearby buildings.

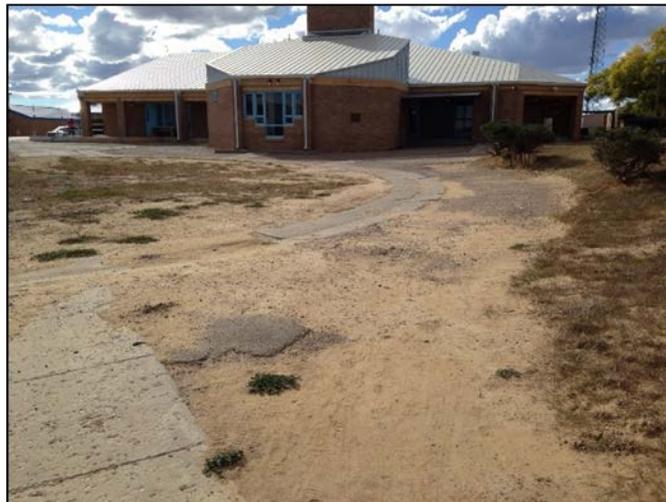
The grounds and student walkways are extremely deteriorated with debris, cracks, and loose particulates that pose a safety concern for students and staff, especially when weather affects walking visibility.

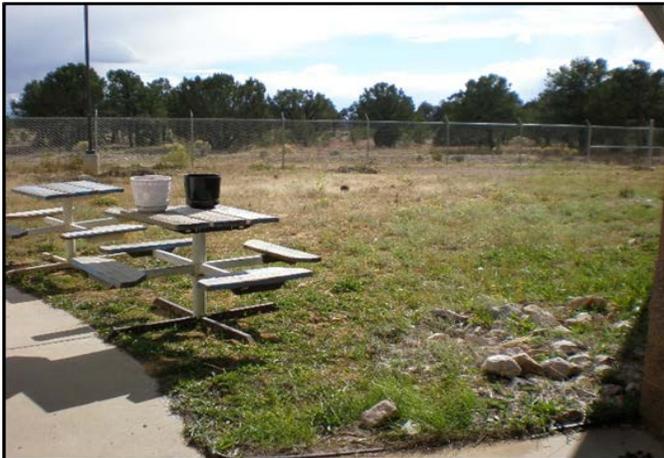
The backyard and patio of the dormitory is not a safe place for boarding students to play or relax.

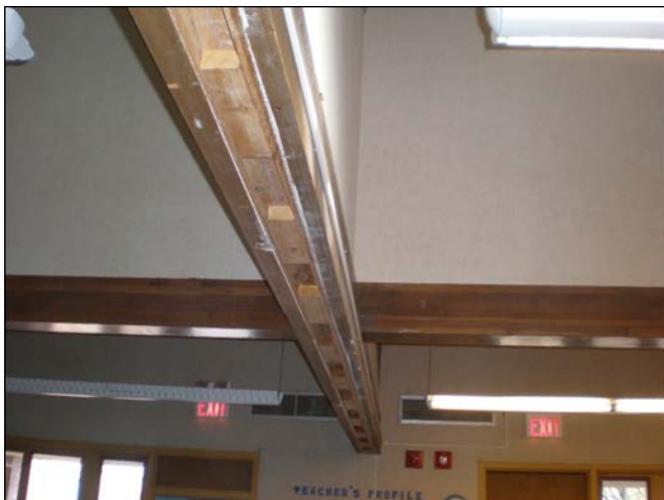
An unfinished beam in classroom space leaves unsafe and rough edges accessible to students and staff.

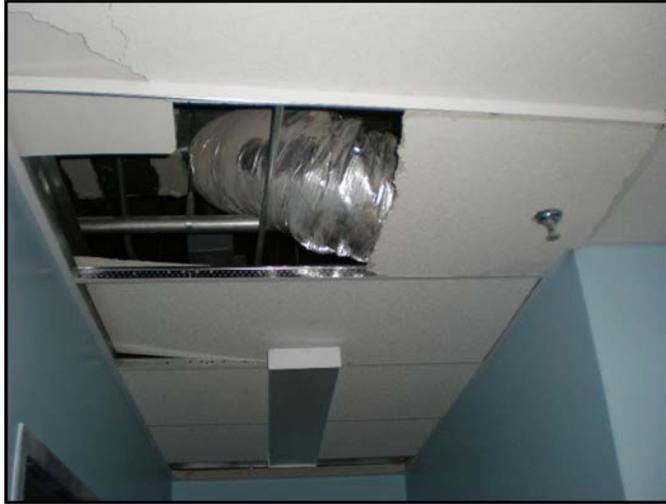
Improperly installed equipment is putting undue pressure on the ceiling and breaking tiles, including those surrounding lighting fixtures.

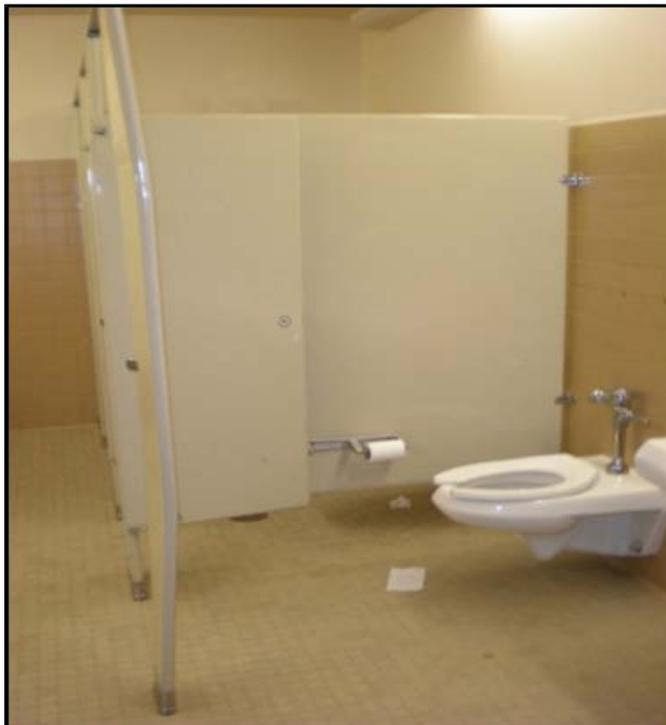
Missing panels and bent frames in student restroom stalls is a privacy issue. The cause of this damage is unknown.
