OFFICE OF  
**INSPECTOR GENERAL**  
U.S. DEPARTMENT OF THE INTERIOR

# **Facility Improvements Still Needed at Pine Hill School**

Subject: Final Inspection Report – *Facility Improvements Still Needed at Pine Hill School*  
Report No. 2019-CR-062

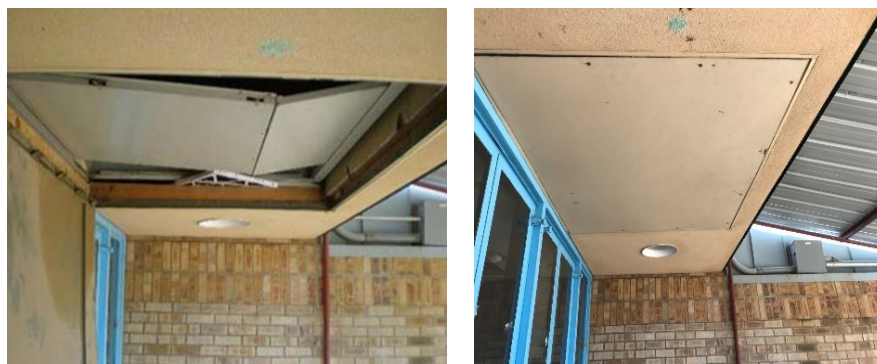
The school also addressed 9 of the 12 recommendations from our 2016 inspection, (see Appendix 2). For example, we previously recommended that the school and the IA take immediate action to correct the safety and health issues we identified or ensure that students and staff were adequately protected until the problems were resolved. Specifically, we had identified water damage and mold in the library, kindergarten classroom, and gymnasium. In response, the school closed the library and the kindergarten classroom, and according to a school official, the students were moved elsewhere on campus. It also tested the gymnasium's air quality to ensure a safe environment for students and staff. In addition, the school fixed a hazardous condition in the walkway outside the kindergarten classroom, where we had previously found a metal ventilation unit door held partially closed by an air filter wedged into one side (see Figure 1).

**Figure 1: Ventilation Unit Outside Kindergarten Classroom in 2016 (left) and 2019 (right)**

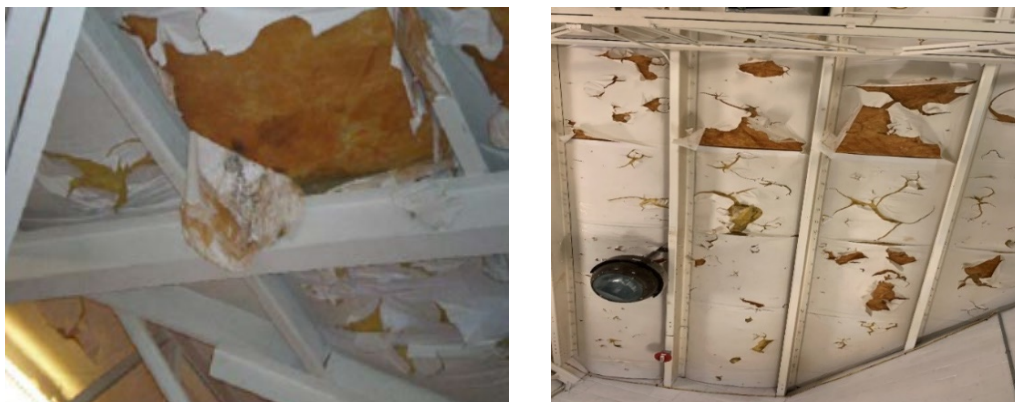
Significant facility deficiencies identified in our 2016 inspection were not corrected, such as water damage and mold at the library, kindergarten classroom, and the gymnasium. Specifically, the Pine Hill School facility manager told us that the library and kindergarten building have been closed since 2015, when mold testing was performed at those buildings. We verified during this inspection that the library and kindergarten remained closed, but the moldy conditions therein have yet to be mitigated. Additionally, the significant damage to the gymnasium ceiling still existed despite the school's attempt to cover up some of the damage (see Figure 2).

**Figure 2: Damage to the Gymnasium Ceiling in 2016 (left) and 2019 (right)**

1. Coordinate with Pine Hill School to ensure that the general facility deficiencies noted in this report are either addressed or included as part of the consolidation and renovation of the school facilities (Phase II)
2. Coordinate with Pine Hill School to complete the planned consolidation and renovation (Phase II)
3. Coordinate with Pine Hill School to complete the gymnasium replacement project (Phase III)

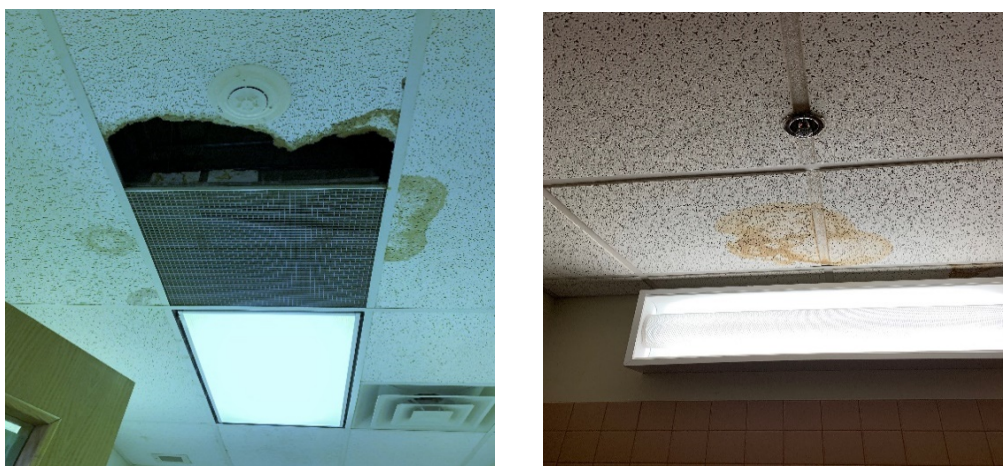
In addition, some of the general facility deficiencies identified in our prior inspection, including water damage on ceilings, ineffective gutters and downspouts, poor drainage, and deteriorated exterior walkways had not been corrected. For example, we found signs of water damage on the ceilings of all nine buildings we inspected (see Figure 3). While water damage in ceilings is not uncommon in older school buildings, moisture left uncorrected could lead to mold. According to the U.S. Environmental Protection Agency (EPA), molds have the potential to cause health problems as they produce allergens, irritants, and in some cases, potentially toxic substances.<sup>5</sup> This issue is particularly concerning because the school already closed two other facilities due to mold.

**Figure 3: Ceiling Tile Damage at the Middle School (left) and Elementary School (right)**

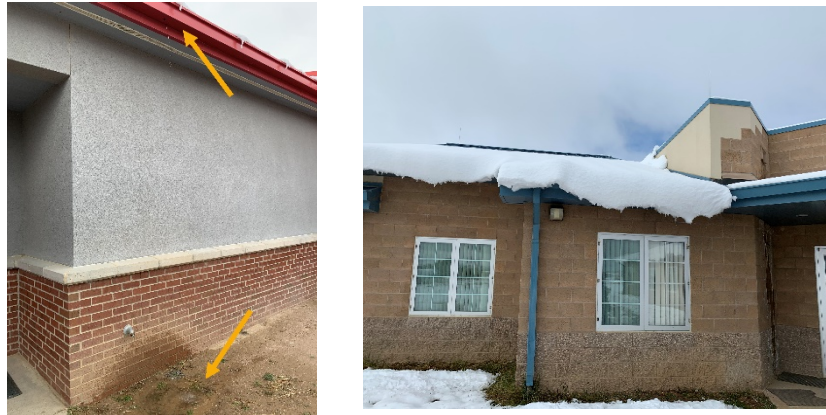
We also found that the gutters were leaking, not working as intended, or in poor condition at all nine buildings inspected. The gutter at the elementary school, for instance, had a hole that allowed water to pour down to the foundation. At the dormitory and the Family and Child Education (FACE) buildings, a large pile of snow extended over the gutters, creating the possibility of snow falling from the roof onto students, staff, and parents who might walk in this area (see Figure 4).

**Figure 4: Hole in the Gutter at the Elementary School (left) and Snow on the Gutters of the Dormitory (right)**

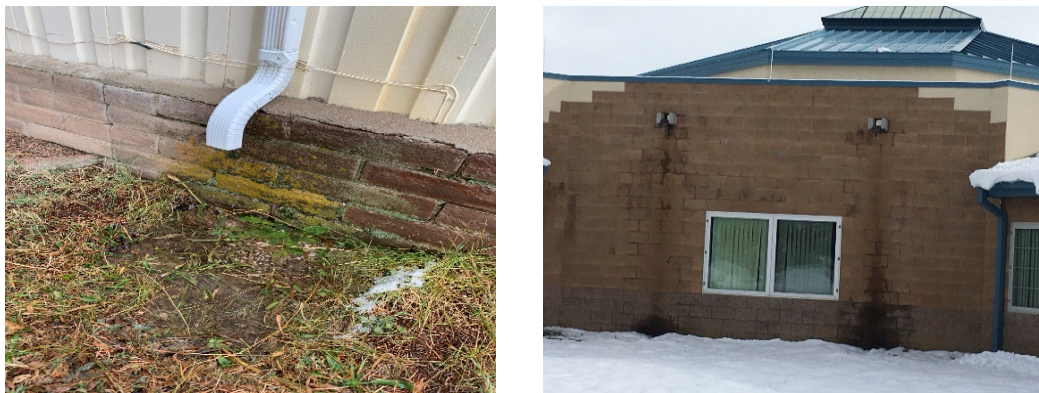
We also found deficiencies in certain downspouts. The EPA recommends that downspouts slope at least 10 feet from the foundation; however, seven of the nine buildings were missing downspouts, did not have downspouts connected to a gutter, or did not have downspout extensions to divert water away from the foundation (see Figure 5). Ineffective gutters and downspouts can damage buildings and their contents, result in more frequent and costly maintenance repairs, and contribute to a shorter building lifespan.

**Figure 5: Downspout Draining Straight Down to the Foundation of the Administration Building (left) and Missing Downspouts at the Dormitory (right)**

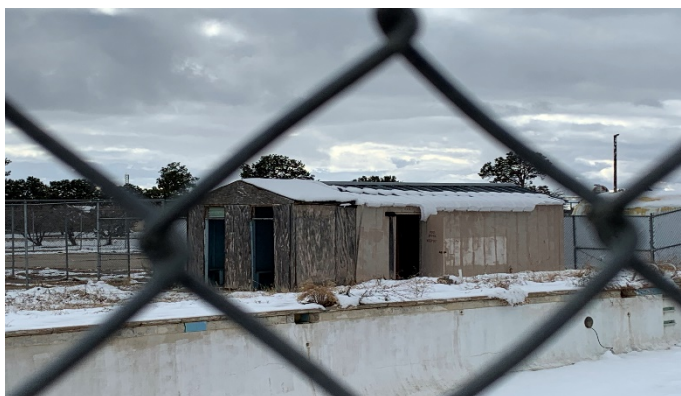
In addition, the school received funding to operate and maintain a structure near the pool that was built in 1974. This shed was surveyed for demolition in June 2017 and was to be removed from the inventory records (see Figure 6). We found that the building was not demolished or removed from the inventory records and that the school was still receiving approximately \$3,000 annually in O&M funding for that structure.

**Figure 6: Storage Shed Surveyed for Demolition in 2017**

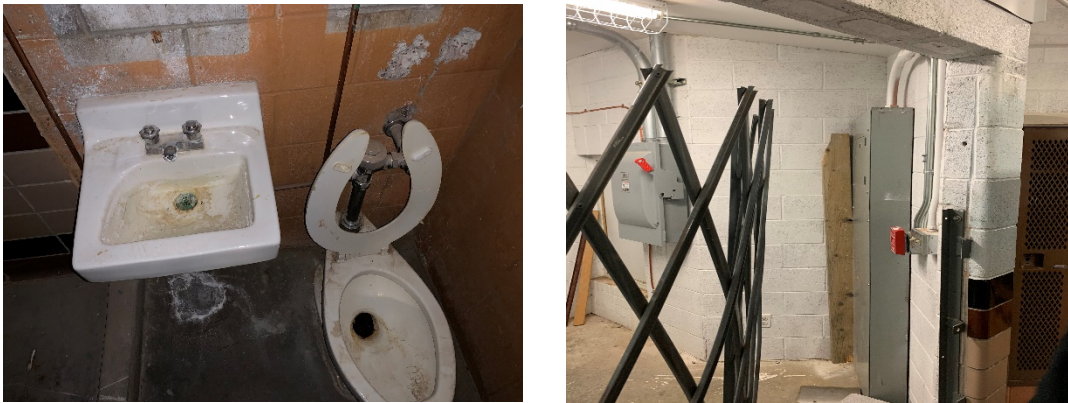
We found that children had access to potentially dangerous areas at six of the nine facilities we visited. For example, fencing was nonexistent, unsecured, or incomplete around external heating and cooling equipment, electrical transformers, and propane tanks. In the locker room of the gymnasium, we found several areas that were potentially dangerous for children, such as abandoned restrooms and showers, a mechanical room, and an electrical room (see Figure 7). The New Mexico Public School Facilities Authority recommends that electrical and mechanical equipment and propane tanks be secured or fenced.<sup>6</sup>

**Figure 7: Abandoned, Unsanitary Restroom (left) and Electrical Room in the Gymnasium Locker Room (right)**

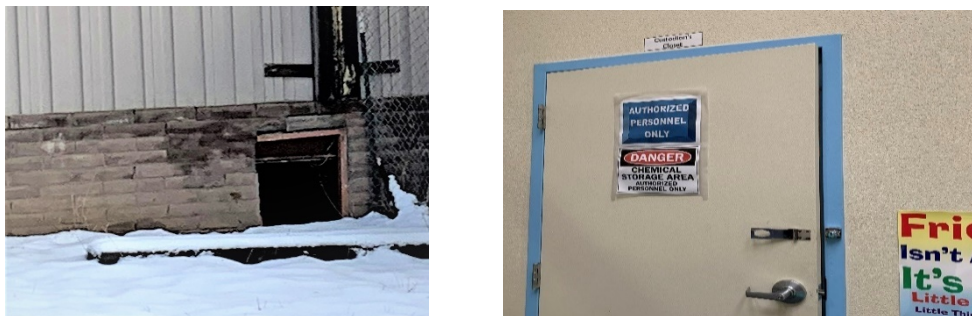
At one of the portable facilities, we noticed an area where children could enter a large open crawlspace, and, at the dormitory, children had full access to two large unoccupied wings where they could congregate unsupervised. Additionally, we found an unlocked custodian closet in the elementary school that contained chemicals (see Figure 8), even though EPA and New Mexico Public School Facilities Authority guidance states that chemicals should be stored in a secure location. Securing exterior crawl spaces, abandoned rooms, and areas at the school that contain electrical equipment, chemicals, and propane gas would prevent both minor and serious injury, such as electric shock and poisoning, as well as prevent children from tampering with and damaging critical equipment.

**Figure 8: Unsafe Access to a Crawlspace at the FACE Portable Building and an Unlocked Custodian Closet at the Elementary School**

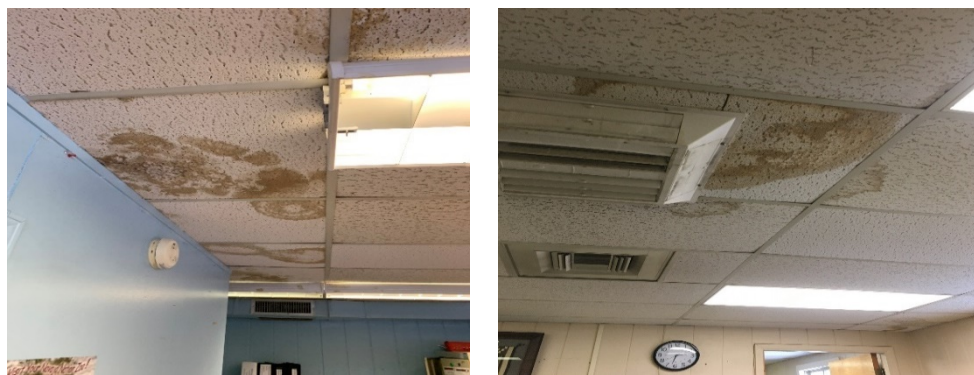
We found that the overall condition of the Administration building and the FACE building—two portable buildings regularly used by staff, children, and parents—was substandard. We observed signs of extensive water damage on the ceilings of both buildings (see Figure 9), a strong musty odor in the FACE building, and a 37-year-old furnace in need of replacement in the Administration building. In addition, the wood floor surrounding the toilet in the men’s restroom of the Administration building had deteriorated so badly that the toilet partially sank into the floor (see Figure 10).

**Figure 9: Extensive Water Damage on the Ceilings of Both Portable Buildings**

10. Inspect, identify, and address any immediate safety and health issues at all IA-funded portable buildings at Pine Hill School, including the Administration and FACE buildings, to ensure the safety and health of students and staff
11. Evaluate all IA-funded portable buildings at the school, including the Administration and FACE buildings, to:
  - a) Assess the need for each portable facility
  - b) Determine whether alternate space on the campus could be used in lieu of the portable facility, the portable building should be replaced, or a permanent structure should be built
  - c) Implement appropriate actions based on the outcome of the evaluation

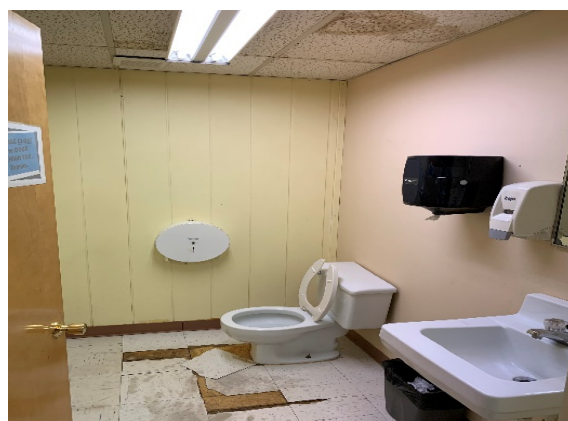
**Figure 10: Sinking Toilet in the Administration Building**
