## Audit Report

# Northeast Area Environmental and Physical Controls Site Security Review

Report Number IT-AR-19-003 | January 31, 2019

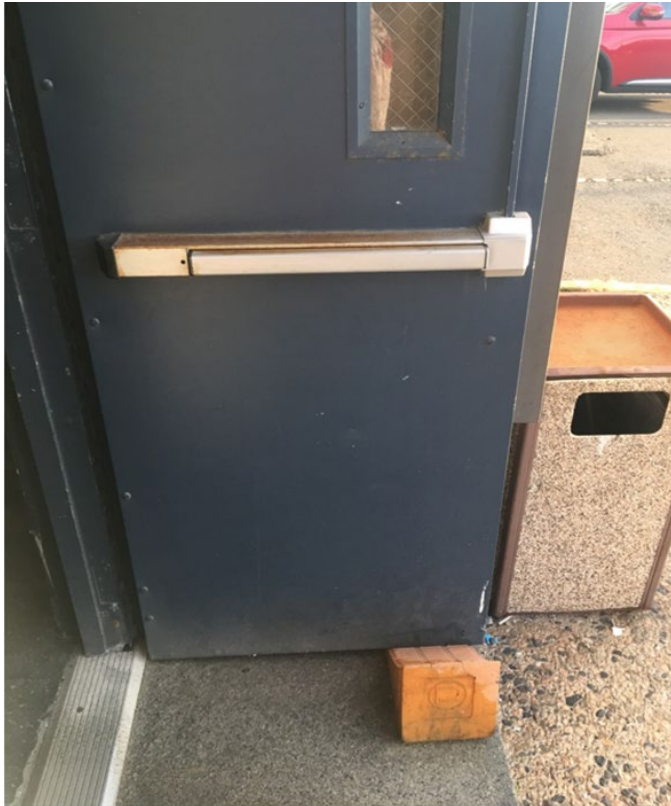
**Figure 1. Entrance Door**

Management did not have operational perimeter security controls in place. Specifically, three entrance door locks were broken and two doors were propped open. In addition, eight overhead dock doors were open and unattended. [Figure 1](#) shows one entrance dock door propped open and [Figure 2](#) shows an open overhead dock door. Postal Service policy<sup>10</sup> states that doors are to be locked and all employees must comply with policy governing access to restricted areas.

This occurred because management was not aware of the broken locks and did not enforce the policy to secure doors. Without secure doors, there is an increased risk of unauthorized individuals gaining access to IT assets and disrupting critical operations.

During the audit, management took corrective action and held a safety discussion for facility personnel stressing the importance of keeping doors secured. Therefore, we are only making a recommendation that the locks be repaired.

The **District Manager**, [REDACTED] **District**, repair facility entrance door locks.
