Physical Security Vulnerabilities at Washington Union Station and Ivy City Yard

Subject: Safety and Security: Physical Security Vulnerabilities at Washington Union

Station and Ivy City Yard (OIG-A-2019-009)

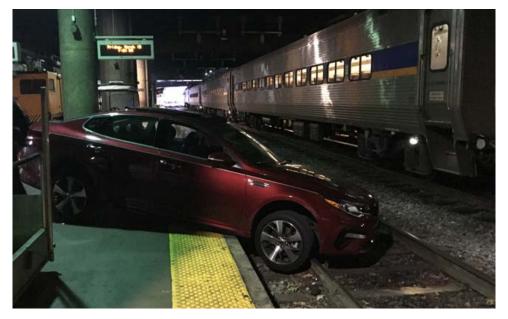
Figure 4. Driver Drove Through Entrance and onto Tracks

During our review, the security at this entrance was weak because of the lack of physical barriers and inconsistent security guard screening, which increased the risk of unauthorized entry. The company had ongoing plans during our review to address the lack of physical barriers; however, on March 15, 2019, a trespasser used the open entrance to access the station and drove an unauthorized vehicle onto the tracks (see Figure 4). In a review of video surveillance coverage of the incident, we observed that the physical barriers were not in place at the entrance, and the guard did not effectively screen the driver of the vehicle, permitting unauthorized access to the station. This placed passengers and employees at risk.

Source: OIG photograph, March 15, 2019

To improve security at the entrance, company officials implemented some of the planned enhancements in March and April 2019 after the March 15, 2019 incident, including repairing the hydraulic wedge, installing an arm gate, and posting new signage (see Figure 5). However, the roll gate remained inoperable, and the continued to block the guards' view of the entrance, making it difficult to control pedestrian trespassers at this entrance.

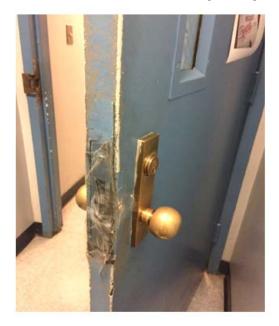
Figure 6. Stairwell Door Propped Open and Station Door Lock Taped Open

Doors are propped open. During our visits to the station in July 2018 and October 2018, we observed doors that were propped open and door locks that were taped to stay open (see Figure 6). Both practices are inconsistent with the company security handbook²⁶ and leave restricted areas vulnerable to trespassers and unauthorized employees. As a result, company property is at risk of theft or misuse.²⁷

Source: OIG photographs, October 9, 2018

- Secure the exterior entrance on of contracted security guards.
- Secure the interior station doors, which includes developing and enforcing measures to effectively maintain regularly repair locks, install and use card readers, and periodically change lock combinations.

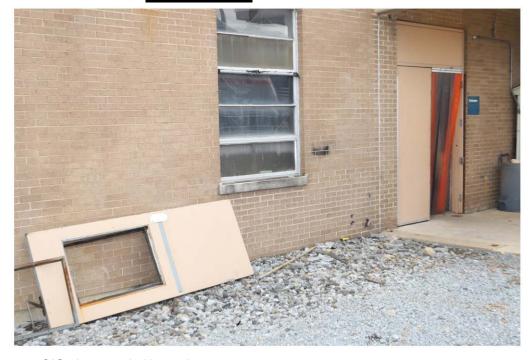
Figure 8. in Coach Yard Building

Source: OIG photograph, November 27, 2018

Note: On March 6, 2019, we observed that the door was in the same location as depicted above.

Coach yard employees told us that the is a key security concern and said they have observed trespassers using the employee and in the building. Engineering supervisors in the building told us that replacing the and has not been identified as a

priority. In September 2018, the Corporate Security office recommended replacing the exterior doors and installing card readers, among other things; however, it was unclear which department would be responsible for prioritizing the projects, securing funding, and implementing the specific projects.³¹ In June 2019, a Corporate Security official said that APD requested FY 2020 capital funds for these projects and that the Corporate Security office will be responsible for implementing them.

- Secure the coach yard, which includes the following:
 - o enhancing security
 - o repairing the to the coach yard's main building
 - o fixing and maintaining the lighting
