Office of Inspector General | United States Postal Service

Audit Report

Facility Conditions, Delayed Mail, and Staffing Levels in Albuquerque, NM

Report Number SM-AR-19-005 | May 29, 2019

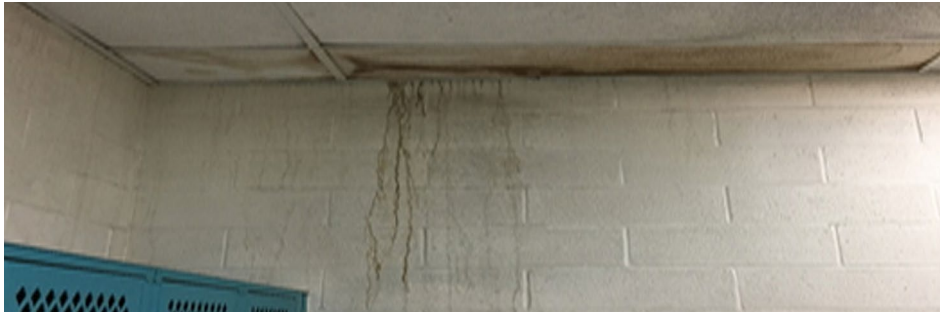
Figure 1. Damaged Ceiling Tiles Near the Manager’s Office and Women’s Restroom

1. Six POs (46 percent) had excessively stained ceiling tiles resulting from water leaks. At the Five Points Station, there were numerous roof leaks. In reviewing work orders for the Five Points Station, which is a postal-owned facility, we identified 11 roof leak repairs performed since October 2016. As shown in Table 2, roof leaks occurred repeatedly in the retail lobby, employee breakroom, and manager's office areas. Based on the repair history, it took on average, about 60 days to complete a work order. The Postal Service does not have a formal response time to complete a repair, as it may vary based on the issue identified. However, there are guidelines that prioritize issues as emergency or non-emergency, and these roof leaks were prioritized as non-emergency and contained until repair was completed.

On October 1, 2018, we observed the ceiling tiles throughout the Five Points Station were replaced or in the process of being replaced after an active roof leak as shown in [Figure 1](#). The next day, after an overnight rain, the newly replaced ceiling tiles had new water stains.

Source: OIG photo taken October 1, 2018, at the Five Points Station.

On October 29, 2018, the Postal Service created a new work order to replace the roof at the Five Points Station. The procurement document to replace the roof estimated a cost of \$500,000. The new roof is scheduled to be installed at the Five Points Station in Spring 2019; however, as of this reporting, a new roof has not been installed.

Regarding recommendation 1, management stated the Five Points Station roof replacement project began on April 16, 2019, and was expected to be completed by May 24, 2019. Management also stated that a water-stained ceiling is not a safety concern and they will replace the roofs as needed. The target implementation date was May 24, 2019.

Management Response/Action Plan: Management is in agreement with this recommendation. The project to replace the roof of the Five Points Station building is currently in progress. The Postal Service has entered into a contract with Tabcon Inc. to perform the roof replacement project. The contract number is 089495-19-B-0039. The roof replacement project commenced on April 16, 2019 and is expected to be completed by May 24, 2019. The Postal Service would note that although water stained ceiling tiles are unsightly, they are not a safety concern and they will be replaced as needed.

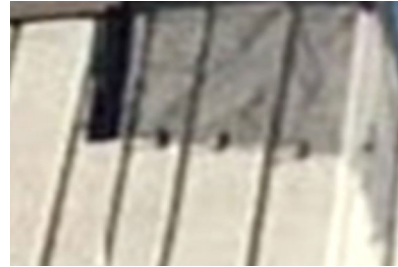
Figure 2. Roof Net To Prevent Bat Entry

- On September 21, 2018, a facility work order was created reporting the seal around the Albuquerque MPO building was old and dry, causing bugs and bats to enter the building through the eaves.
 - Postal Service management consulted with the Wildlife Command Center on recommendations to protect bats, and subsequently hired a contractor to seal intrusion points around the perimeter of the building, as shown in Figure 2.

Source: OIG photograph taken October 1, 2018.

- The work order indicated the contractor’s work was completed in November 2018.
 - As the seal work was ongoing during our site visit in October 2018, we did not observe any signs of bats or bugs.

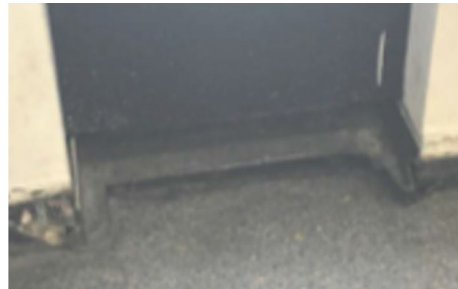
Figure 3. Cracks in the Wall and Floor at the Albuquerque MPO

- During our site visit, we did not observe any mice, but noted several mouse traps throughout the facility for continuous pest control.
3. The Albuquerque MPO has visible structural cracks in the walls and floors as illustrated in Figure 3. To assess the maintenance activity regarding these issues, we assessed the work orders within eFMS,⁹ the Postal Service’s maintenance management system, and identified the following:

Wall Crack Gauge.

Crack Between Baseboard and Floor.

- From October 2016 through September 2018, there was one work order (on October 26, 2017) related to cracks in the walls at this facility.
- Based on the October 2017 work order, the Facilities Repair and Alterations Office contracted with a structural engineering firm to investigate the cracks. The structural engineering firm activities included:
 - In May 2018, installed 10 crack gauges on walls at the facility and measured movement during a five-month period.
 - In November 2018, issued a report concluding most of the cracks sampled have stabilized and were no longer moving.
 - The report further recommended the Postal Service continue to monitor the cracks for an extended one- to two-year period.
 - The Postal Service is searching for a local structural engineer to monitor crack movements and perform crack gauge work as of the issuance of this reporting.

The **Manager, Arizona District**, develop and implement an action plan to monitor and address the movement of cracks in concrete at the Albuquerque Main Post Office, including a timeline for hiring a structural engineer and completing items.

Regarding recommendation 2, management stated that they have contracted with the same engineering firm that investigated the wall crack issues to monitor wall cracks movement at the Albuquerque Main Post Office. Management stated the contractor is scheduled to be onsite May 30, 2019, and monthly thereafter to inspect gauges, take measurements, and submit a report to the Postal Service for review following each visit. The target implementation is May 30, 2019.

Management Response/Action Plan: Management is in agreement with this recommendation. As noted in the OIG Draft Audit, the Postal Service contracted with a structural engineer in October of 2017 to evaluate the cracks at the Albuquerque Main Post Office. In May of 2018, the structural engineer installed multiple crack gauges on walls at the facility to measure movement over a five month period. In November of 2018, a report was issued by the structural engineer concluding that most of the cracks had stabilized and were no longer moving. There was a recommendation that the Postal Service continue to monitor the cracks for an additional 1-2 years. NCA Architects was hired effective May 10, 2019 to monitor the movement in the cracks. The firm is scheduled to be onsite to inspect the gauges and to take measurements on May 30, 2019. Thereafter, the firm will visit the facility monthly to take measurements and after each visit will submit a report of findings.

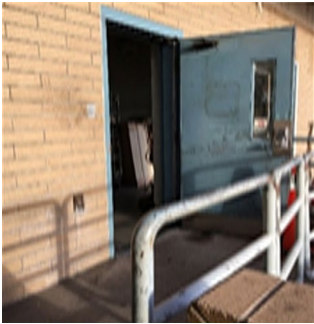
Figure 4: Unsecured Door

- Nine POs (69 percent) were missing annual fire extinguisher inspections. Two extreme examples include annual inspections not being conducted since 2012 and 2015.
- Four POs (31 percent) were missing monthly fire extinguisher inspections.
- Five POs (38 percent) had blocked fire extinguishers.
- Five POs (38 percent) had blocked electrical panels.
- Four POs (31 percent) had multiple instances of ladders and flammable materials not stored properly.
- Five POs (38 percent) had unsecure rear building doors (see [Figure 4](#)).

Source: OIG photo taken October 1, 2018 – Five Points Station.

Maintenance staff remedied certain deficiencies brought to their attention during our site visits, such as unblocking exits and electrical panels and securing unlocked doors; however, these were temporary remedies and not long-term solutions. When corrective actions are not implemented, or are implemented but inadequate, issues may continue to exist, increasing the Postal Service’s potential exposure to OSHA fines and the risk of injury to employees and customers.

Regarding recommendation 3, management stated the required annual (2019) and monthly (May) fire extinguisher inspections have been completed at all facilities, and maintenance supervisors will monitor monthly inspections for compliance. Management also stated that they have corrected the blocked fire extinguisher, the electrical panel, and ladder storage issues identified in the audit, and have added these items to the daily building inspection safety checklist report. Further, management stated that they have instructed facility managers and supervisors to verify and enforce compliance with building security requirements. Lastly, management stated that they have informed all employees at all Albuquerque facilities about door security requirements. Management did not provide a target implementation date.
