Audit Report

Mail Delivery, Customer Service, and Property Conditions Review – Select Units, St. Louis, MO Region

Report Number 22-115-R22 | August 31, 2022

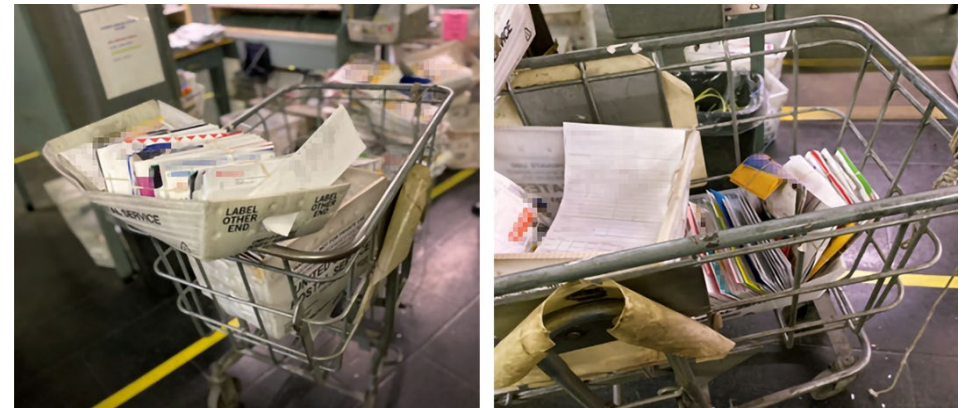
Figure 1. Delayed Mail

At the Maryville Gardens Station, we identified about 5,145 pieces of delayed letter and flat mail. Although a portion of this mail volume was from an undelivered route, another portion was attributed to substantial amounts of letter mail that arrived from the St. Louis P&DC and was not sorted in Delivery Point Sequencing¹¹ order.¹² In addition, management did not accurately report this delayed mail in DCV. While they reported 1,631 delayed letters and flats, this only represented about 31.70 percent of the delayed mailpieces we identified at the delivery unit (see Figures 1 and 2). We did not find any delayed mail issues at the Saint Peters MPO or the Chouteau and Marian Oldham Stations.

We recommend the **District Manager, Kansas-Missouri District**, develop a plan to ensure that all committed mail at the Maryville Gardens Station is delivered daily, all delayed mail volume is entered into the proper system, and management systematically reviews the data and enforces reporting compliance.

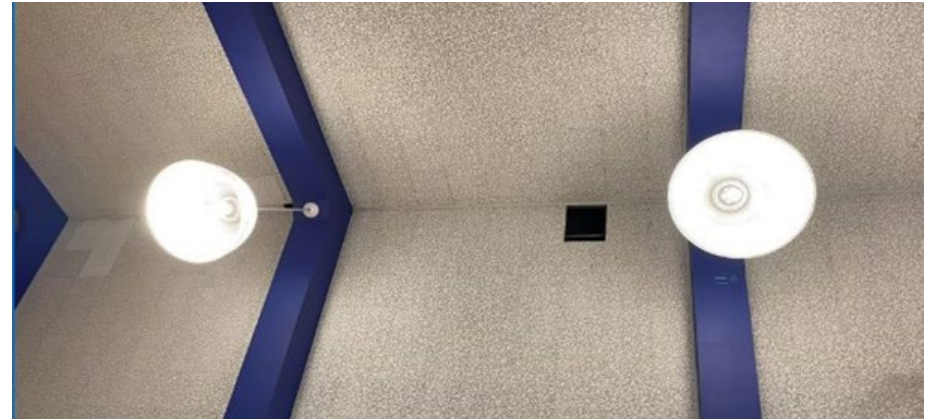
Figure 3. Missing Ceiling Tile

We found safety, security, and maintenance issues at all four delivery units. At the Saint Peters MPO, we identified a missing ceiling tile in the customer lobby (see Figure 3); a dirty ceiling fan over the retail window; a ceiling fan with exposed wires on the workroom floor (see Figure 4); and a dirty/rusted air vent and stained ceiling tiles in the men's restroom (see Figure 5). In addition, we identified a broken toilet, dirty walls, and a faucet with no cold water in the women's restroom (see Figure 6). We also observed a gate in front of the building that was pulling the brick wall apart toward the customer sidewalk (see Figure 7); and a handrail on the dock that was rusted at the base with its concrete chipping away (see Figure 8).

We recommend the **District Manager, Kansas-Missouri District**, address all building safety, security, and maintenance issues identified at the Saint Peters Main Post Office and the Maryville Gardens, Chouteau, and Marian Oldham Stations.

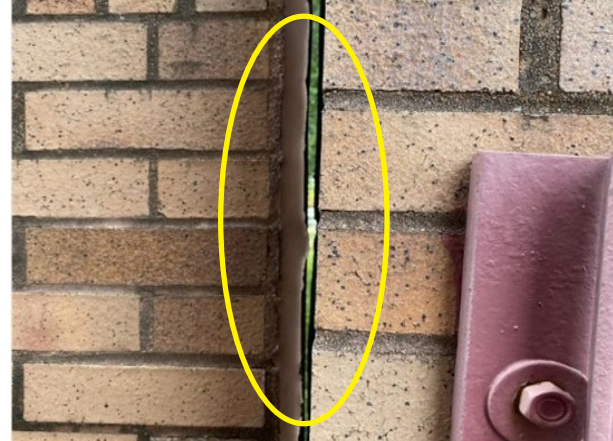
Figure 7. Inspection Gate Pulling Wall Apart

Management did not provide adequate oversight to ensure that they corrected property condition issues. Specifically, management at the Saint Peters MPO stated that they reported the issue with the gate to Facilities management; however, as of May 17, 2022, the issue had not been reported in the eFMS. Management stated that they were not aware of the other issues that we reported.

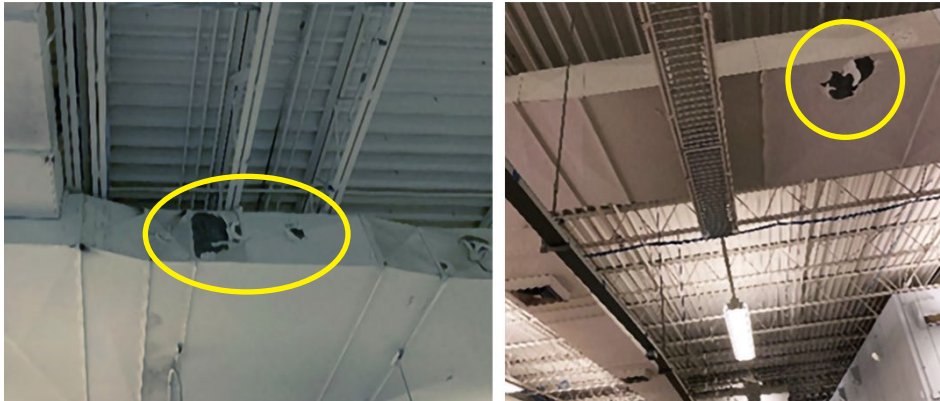
Figure 9. Peeling Paint Above Workroom Floor

At Maryville Gardens Station, we identified peeling paint along parts of the air vents in the workroom floor area (see [Figure 9](#)); two ceiling tiles in the customer lobby with signs of water damage and another tile that was missing (see [Figure 10](#)); dirty air vents (see [Figure 11](#)); and an inoperable urinal in the men's restroom (see [Figure 12](#)). In addition, 40 percent of the lights in the workroom floor area and in the customer lobby needed to be repaired or replaced

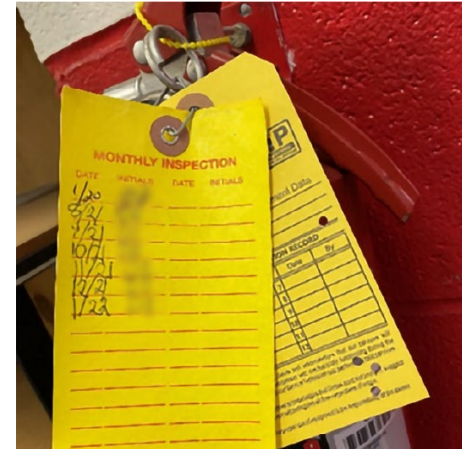
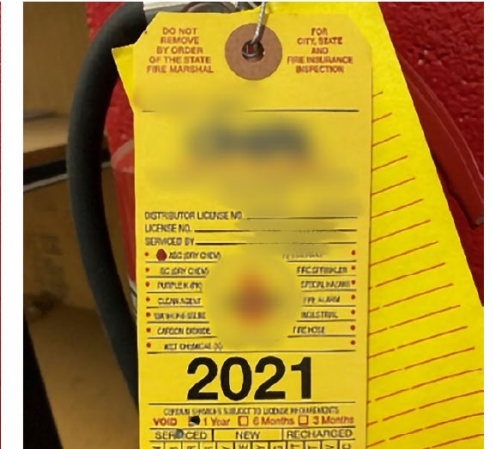
Figure 15. Examples of Expired Fire Extinguisher Inspections

(see Figure 13). We also identified a blocked internal Postal Inspection Service door (see Figure 14), portable fire extinguishers with outdated monthly and annual inspections (see Figure 15),²⁴ and a newly installed drinking fountain in the employee breakroom that was leaking. During our audit, unit staff completed repairs on the drinking fountain (see Figure 16).

²⁴ Occupational Safety and Health Administration (OSHA), 29 CFR 1910.157(e)(2) and 29 CFR 1910.157(e)(3) requires that fire extinguishers be inspected monthly and annually.

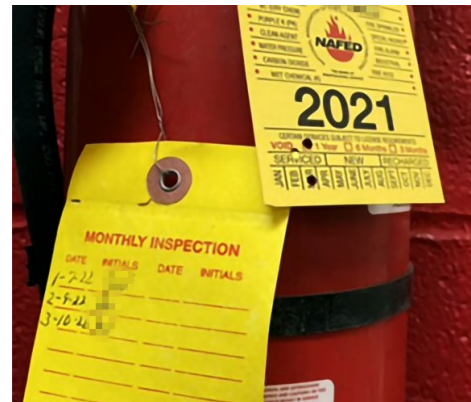
Figure 20. Example of Fire Extinguisher Missing Inspections

At the Marian Oldham Station, seven fire extinguishers were missing annual and monthly inspections (see Figure 20), a space heater was plugged into a surge protector rather than directly into the wall (see Figure 21), there were dirty vents in the customer lobby (see Figure 22), and one large pothole in the employee parking lot (see Figure 23).
