Mail Delivery, Customer Service, and Property Conditions Review – Select Units, Milwaukee, WI Region

AUDIT REPORT

Report Number 22-147-R23 | October 17, 2022

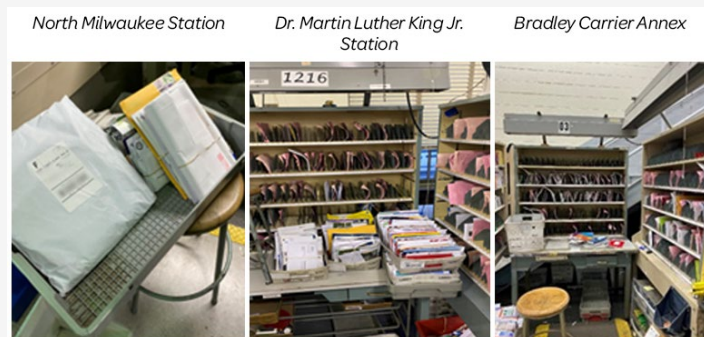
Figure 1. Examples of Delayed Mail in the Carrier Cases

On the morning of June 28, 2022, we identified about 19,254 pieces of delayed letter and flat mail (see Table 4 and Figure 1) at the North Milwaukee and Dr. Martin Luther King Jr. Stations and the Bradley Carrier Annex, which included about 19,208 letters and flats and 46 packages at 60 carrier cases (see Table 4). Management at the North Milwaukee and Dr. Martin Luther King Jr. Stations did not report

this delayed mail in DCV. Management at the Bradley Carrier Annex did not report any delayed mail in DCV, but did report 12,023 mailpieces as curtailed, which is noncommitted mail that the carrier does not have time to sort before their scheduled route leave time and is authorized to deliver the next day. See Figure 1 for examples of delayed mail found at the carrier cases.

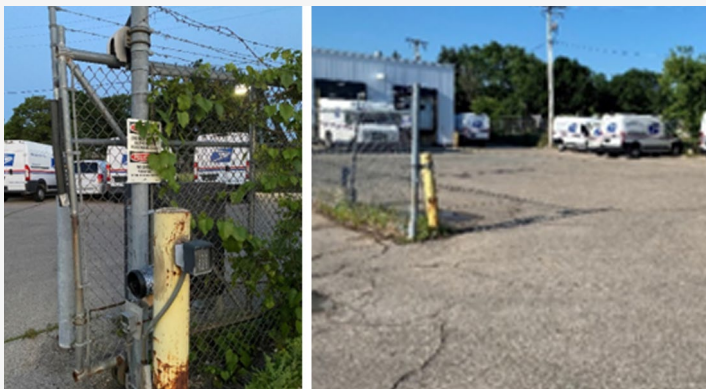
Figure 2. Inoperable Front Security Gate

- Several stained ceiling tiles in the workroom floor and PO Box area;
- A cracked and damaged sidewalk near the customer parking lot, which created a tripping hazard;
- A damaged gutter downspout in the carrier parking lot;
- Inoperable front and rear security gates (see Figure 2);
- Portable fire extinguishers with expired monthly and annual inspections;

During our audit, management took corrective actions by replacing the stained ceiling tiles; repairing the cracked sidewalk, damaged downspout, and rear security gate; completing monthly fire extinguisher inspections; and removing excess equipment that was blocking a carrier door.

We recommend the **Manager, Wisconsin District**, address all building safety, security, and maintenance issues identified at the North Milwaukee Station, Waukesha Main Post Office, Dr. Martin Luther King Jr. Station, and Bradley Carrier Annex.

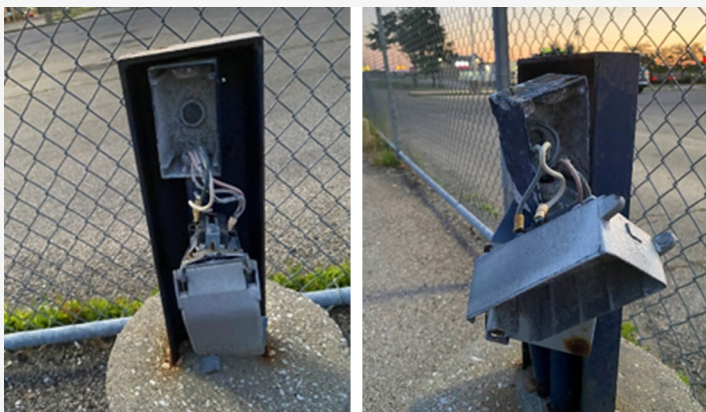
Figure 3. Damaged Exterior Outlets

- Damaged exterior electrical outlets with exposed wires (see Figure 3);
- Multiple electrical devices plugged into one extension cord (see Figure 4);
- Excess equipment blocking a carrier door; and
- Broken or missing safety mirrors over the carrier garage door (see Figure 5).

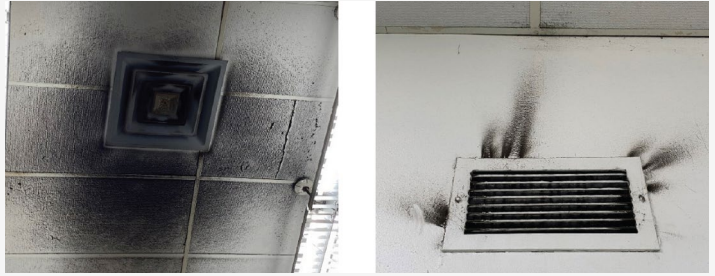
Figure 12. Dirty Air Vents and Ceiling Tiles

- Dirty air vents and ceiling tiles (see Figure 12);
- Fire extinguishers missing annual inspections since 2020 and monthly inspections since October 2021 (see Figure 13);
- A leaking sink faucet (when turned on) and dirty walls and floors in the women's restroom (see Figure 14);
- Potholes near the loading dock, which created a tripping hazard (see Figure 15); and
- No signage posted in the employee parking lot stating that vehicles may be subject to search, as required.

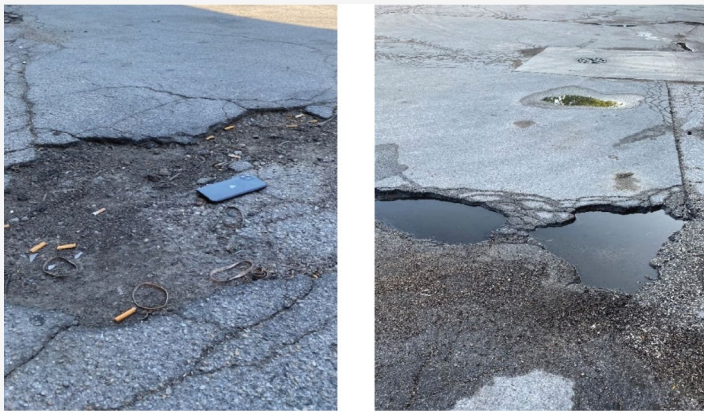
Figure 15. Potholes near the Loading Dock

Source: OIG photos taken June 28 and 29, 2022. Cell phone added to provide context of the size.

- Management at the North Milwaukee Station was in the process of addressing other repairs with higher urgency, such as a roof leak and a garage door that was stuck closed.
- The Postmaster at the Waukesha MPO said that he was not aware of the unmounted fire extinguisher, blocked electrical panel, blocked inspection service doors, and the dirty vent. The postmaster also stated that a roof leak repair done about two years ago caused the stained ceiling tiles; however, he did not request replacement tiles.
- Management at the Dr. Martin Luther King Jr. Station was more focused on mail delivery and was unfamiliar with eFMS.
- Management at the Bradley Carrier Annex stated that they were unaware of issues with the fire extinguishers, the women's restroom, and the missing sign in the employee parking lot. Management stated that they reported the potholes in eFMS on May 2, 2022.
