Unsecured Assets at the Washington Network Distribution Center

MANAGEMENT ALERT

Report Number 22-185-1-R23 | June 28, 2023

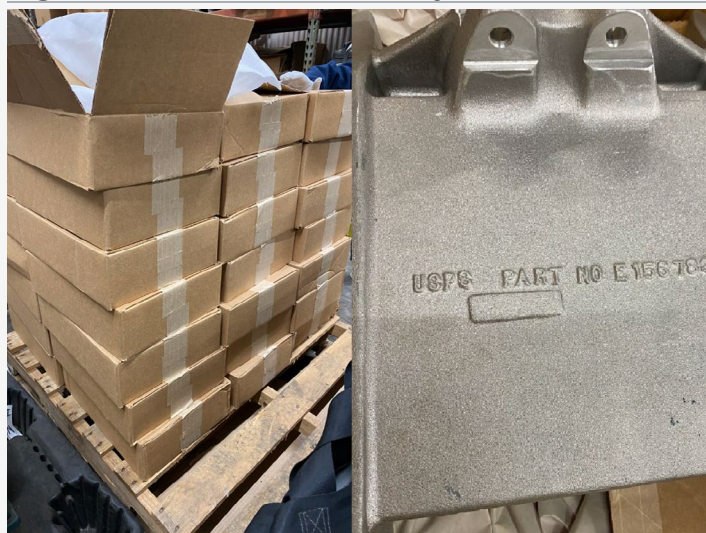
Figure 1. Index Level Assembly

Facility management had not completed any periodic reviews to identify which assets within the portable structure were inactive. Specifically, based on direct observations, we found some assets such as unused repair parts in its original packaging dating back to 2009. Additionally, management confirmed during interviews that these assets could be classified as inactive and consequently redistributed within the organization, recycled, or disposed.⁷ These assets included:

- Forty-one boxes of index level assembly, used as a part of the carriages in Parcel Sorting Machines (PSM) – designed to mechanically sort packages within a facility (see Figure 1).

We recommend **Vice President, Processing Operations, Eastern Region**, instruct the **Manager, Washington NDC**, to define and communicate who is responsible for the assets in the external portable structure and require staff to conduct periodic reviews of the assets to identify inactive items for appropriate disposition, in accordance with Handbook AS-701, *Asset Management*.

We recommend the **Vice President, Processing Operations, Eastern Region**, instruct the **Manager, Washington NDC**, to conduct a physical inventory of all assets located in the external portable structure and record assets in the appropriate inventory management systems.

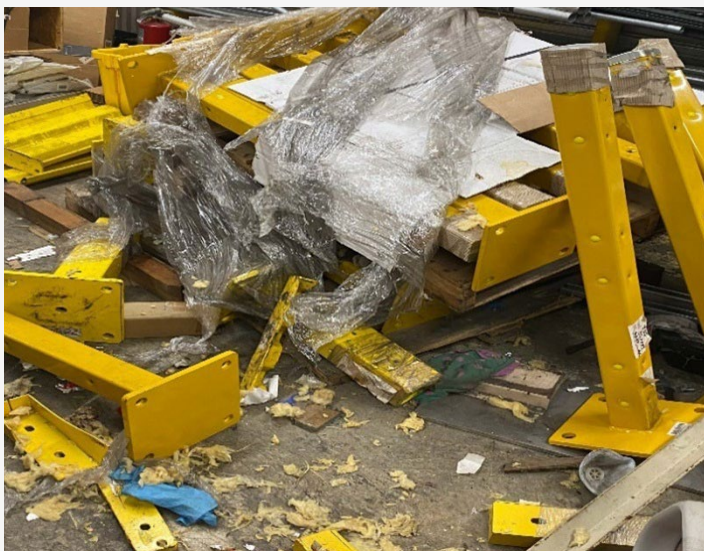
Figure 2. Bollards

- Sixteen bollards, used for barriers in front of buildings, in parking lots, or along sidewalks (see Figure 2).
- Fourteen chutes for Automated Parcel and Bundle Sorter machines – designed to sort bundles and small single mail pieces into a series of containers (see Figure 3).
- Eleven motors of various sizes, used as a part in the conveyor belts.
- Seven hampers of carriages, also used as a part in PSMs (see Figure 4).
- Seven drum pulleys of various sizes, used to drive conveyor belts.
- Five control reducers, used as a part in the conveyor belts.
- Three rollers, used to drive conveyor belts that sort mail.

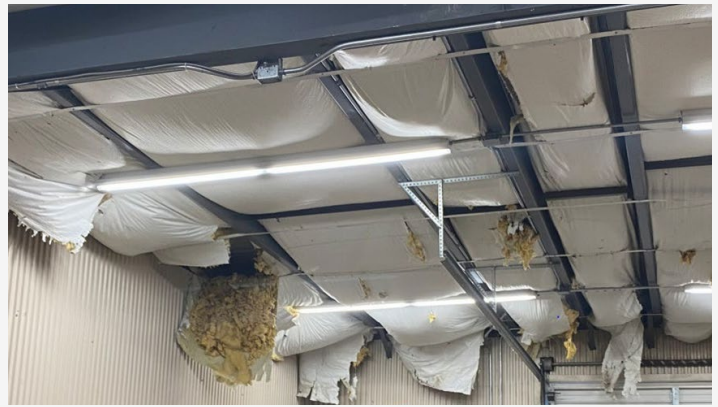
Figure 5. Damaged Ceiling

We found that the repair parts and equipment were stored in an environment which may impair or damage the service life of assets and can be unsafe for employees. Specifically, management did not maintain the external portable structure in accordance with applicable building safety and maintenance standards. We observed:

- Damaged ceiling with exposed insulation (see Figure 5).
- Rodent feces on Postal Service assets (see Figure 6).
- Dust, debris, and trip hazards (see Figure 7).
- Broken door closure (see Figure 8).
- Flammable materials, such as paint¹⁸ and sealant, which were not properly stored.

Regarding management's partial agreement with finding 2, as noted in the report, the external portable structure had visible issues with building safety and maintenance standards. The exposed ceiling and rodent feces observed may damage parts or equipment, which are critical to Postal Service operations. In addition, the improper storage of flammable materials may result in extensive damage to the structure or equipment in the event of a fire.

We recommend the **Vice President, Processing Operations, Eastern Region**, instruct the **Manager, Washington NDC**, to develop and implement an action plan to address all exterior portable structure safety and maintenance issues identified during our audit.
