# Mail Delivery, Customer Service, and Property Conditions Review – North Philadelphia Station, Philadelphia, PA

## AUDIT REPORT

Report Number 22-208-3-R23 | January 10, 2023

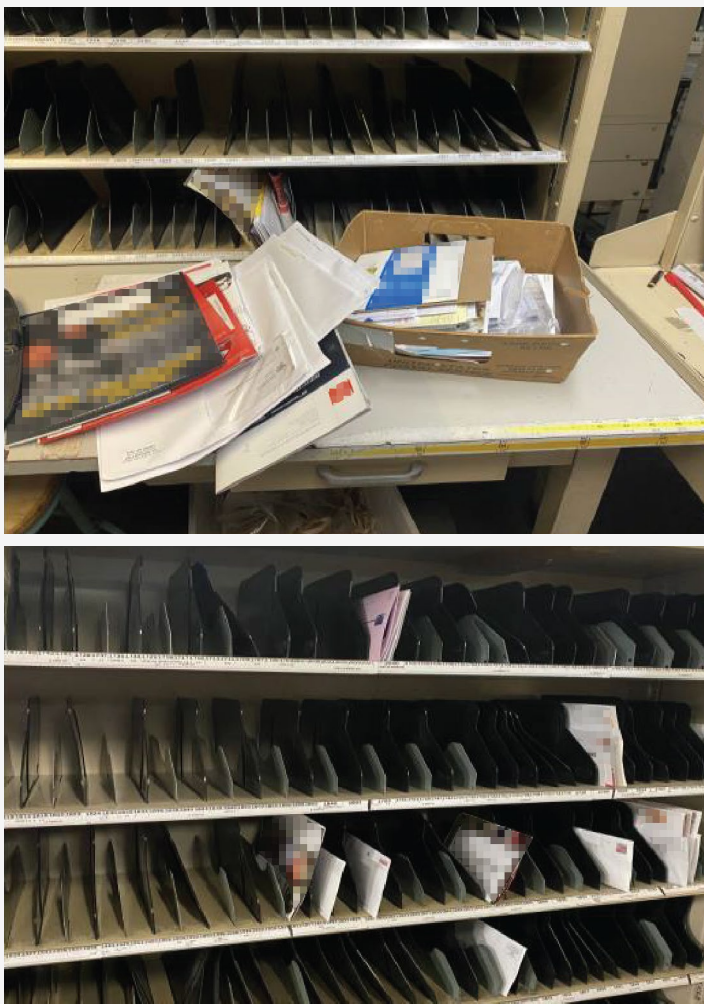
**Figure 1. Examples of Delayed Mail at Carrier Cases**

On the morning of October 25, 2022, we identified 5,283 delayed mailpieces at the unit. Specifically, we identified 3,398 letters, 1,817 flats, and 68 packages at 37 carrier cases and prepared for delivery on the workroom floor. In addition, this mail was not reported as undelivered in the Delivery Condition Visualization (DCV)<sup>9</sup> system. See Figures 1 and 2 for examples of delayed mail found at carrier cases and on the workroom floor.

Management stated that carriers brought back mail at the end of the day due to several contributing factors. Specifically:

- The unit did not have enough arrow keys for all carriers on routes that required them for delivery. The unit has 14 arrow keys to share among 49 carrier routes. This obstructs the delivery of mail because carriers use arrow keys to open mail receptacles.
- The unit did not have experienced delivery personnel. Specifically, 65 percent of the unit's staff have less than one year of experience and did not possess knowledge of the delivery routes. An increase in political mail volume worsened this situation.

Management should have ensured that all committed mail would be delivered and accurately accounted for and reported in DCV. Management should have prioritized the availability of arrow keys to ensure carriers could deliver the mail. In addition,

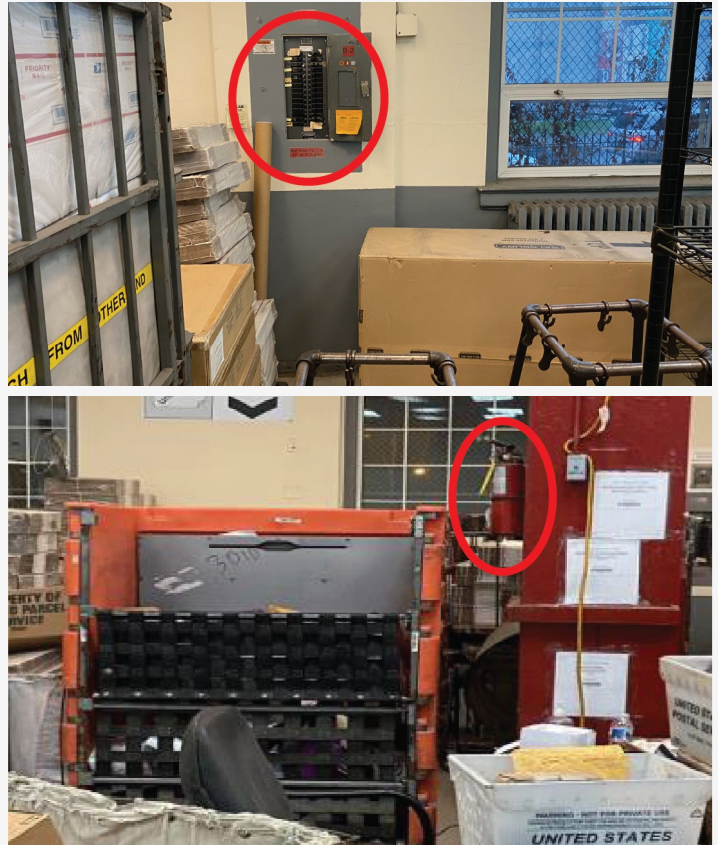
**Figure 4. Blocked Electrical Panel and Fire Extinguisher**

- A blocked electrical panel and fire extinguisher (see Figure 4).
- Three electrical outlets and one thermostat not securely mounted (see Figure 5).
- Damaged walls (see Figure 5).
- Light switches in the conference room with missing switch plates.
- All seven fire extinguishers were missing required monthly and annual inspections.
- No sign posted in the delivery unit employee parking lot stating that vehicles may be subject to search.
- Two leaking faucets, one inoperable toilet, and a closet overflowing with clutter and trash in the men's restroom.
- Inoperable toilets in the women's restroom.

Management did not take the necessary actions to ensure that facility conditions were corrected because they were not aware of the issues.

Management should have provided sufficient oversight of personnel responsible for maintaining facilities, reported safety and maintenance issues as they arose, and followed up for completion. The Postal Service is required to maintain a safe environment for employees and customers. In addition, the Occupational Safety and Health Administration (OSHA) requires employers to provide a safe and healthy workplace free of recognized hazards.<sup>21</sup>
