Office of Inspector General

AUD-SI-17-20

Management Assistance Report: Health and Safety Concerns Identified Related to Armored Vehicle Disposals

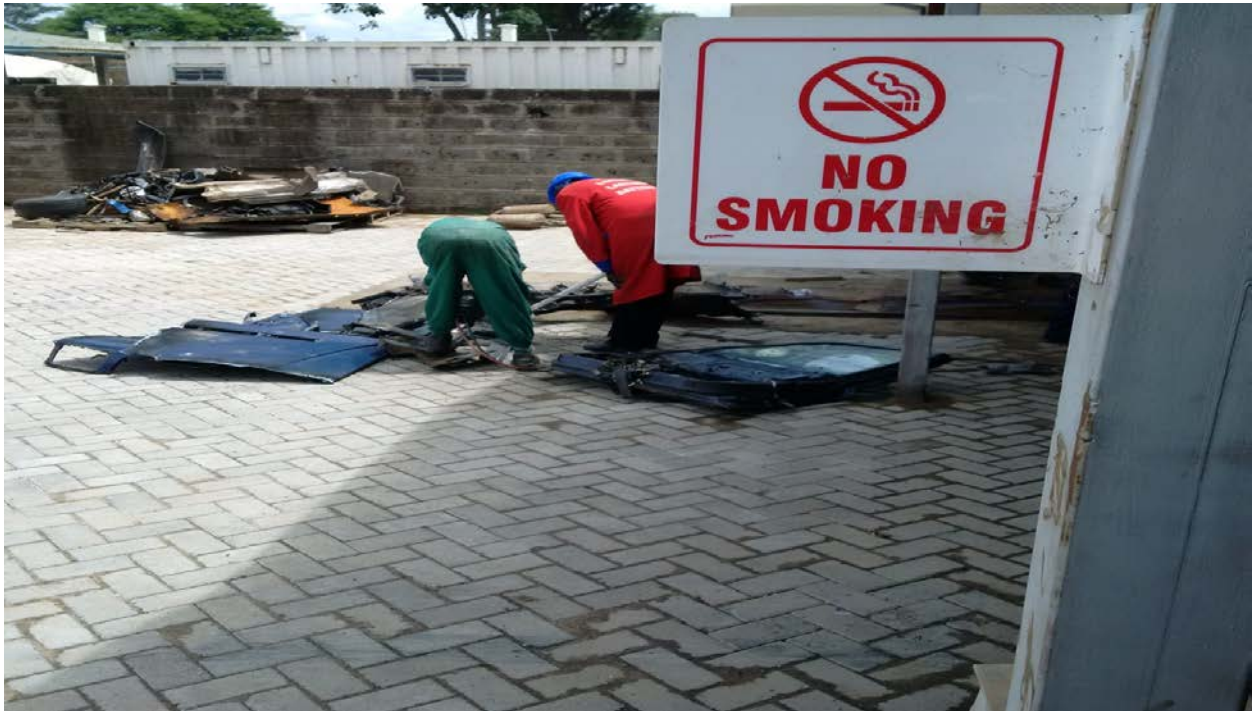
OIG observed the first armored vehicle disposal with the selected vendor, which occurred on April 20, 2016. The contractor arrived at the embassy warehouse with equipment to perform the disposal, including blow torches and unmarked cans of compressed gases. As the contractor began dismantling and cutting up the armored vehicle, OIG observed several apparent deviations from Occupational Safety and Health Administration standards. For example, OIG observed contractors cutting portions of an armored vehicle with blow torches in an area marked "No Smoking,"¹⁶ as shown in Figure 1. OIG also noted that some of the contractor personnel participating in the process, as well as Department personnel witnessing the process, did not have the required personal protective equipment, as shown in Figure 2. Occupational Safety and Health Administration standards state that appropriate eye and face protection must be used when exposed to eye or face hazards;¹⁷ the use of blow torches appears to constitute just such eye and face hazards, and therefore all persons within the vicinity of the disposal should have been equipped with eye and face protection.¹⁸

Figure 1. Workers disposing of an armored vehicle at Embassy Nairobi's warehouse using a blow torch in close proximity to a "No Smoking" sign.

¹⁶ In response to a draft of this report (see Appendix D), Embassy Nairobi commented that the "area in question had once been a working auto shop/garage that included the mission fuel station. The auto shop was closed and the fuel tanks drained (emptied) many years ago. There is no flammable material in the area and the "No Smoking" sign has now been removed."

Response: The area in question had once been a working auto shop/garage that included the mission fuel station. The auto shop was closed and the fuel tanks drained (emptied) many years ago. There is no flammable material in the area and the "No Smoking" sign has now been removed.

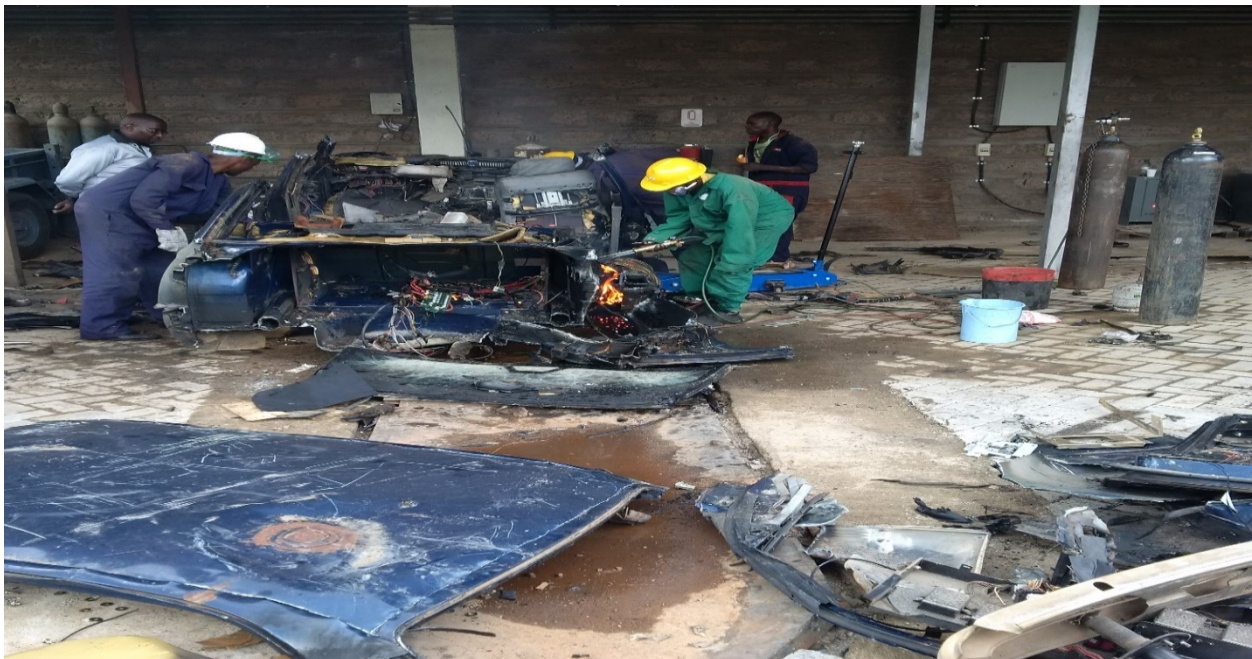
Figure 2. Contracted workers using a blow torch in an enclosed area; two contractors supervising the disposal lack the required personal protective equipment.

¹⁸ Embassy Nairobi also stated its written response that "the Mission has equipped the contractor with gloves and goggles and will ensure that all personnel in the area at the time destruction occurs are using them. Additional face protection as required has been ordered and will be distributed upon receipt."

Response: The Mission has equipped the contractor with gloves and goggles and will ensure that all personnel in the area at the time destruction occurs are using them. Additional face protection as required has been ordered and will be distributed upon receipt.

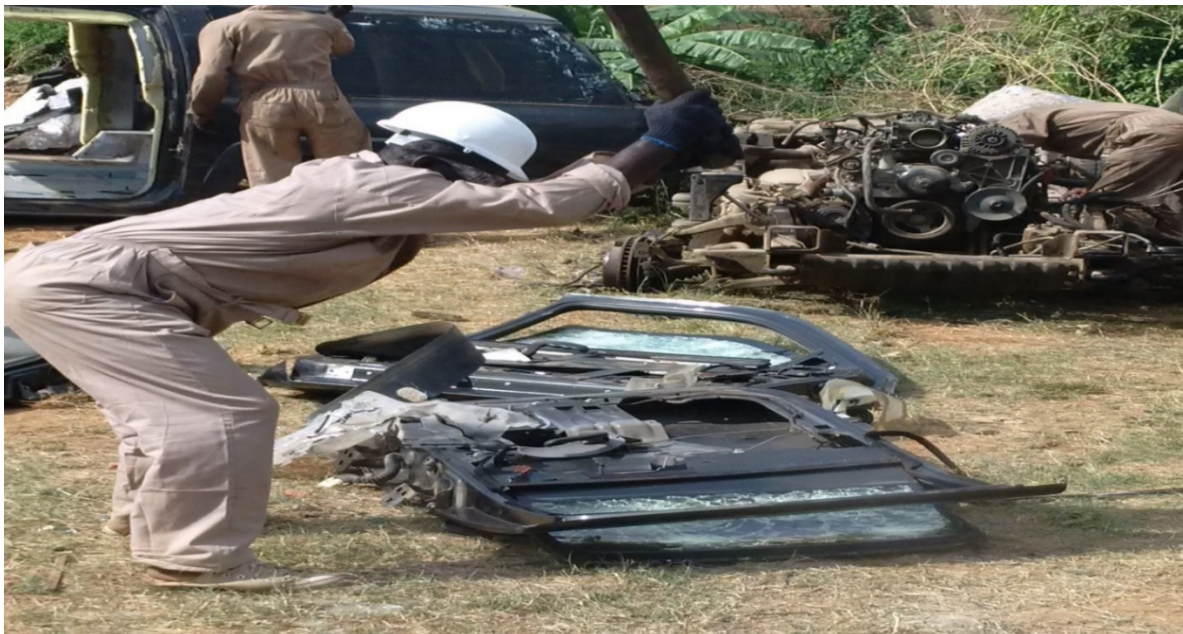
As the contractor began dismantling and crushing the armored vehicle, OIG observed several apparent deviations from Occupational Safety and Health Administration Standards. For example, OIG observed that several contractor employees participating in the disposal process, as well as Department employees supervising and witnessing the process, lacked adequate personal protective equipment. Some contractors were wearing flip flops, and one contractor employee, who was attempting to smash ballistic glass with a hammer, was wearing sneakers that only partially covered the sole of his foot, as shown in Figures 3 and 4. Occupational Safety and Health Administration standards state that protective footwear must be worn when working in areas where foot injuries are possible due to objects piercing the sole, such as broken glass.¹⁹

Figure 3. A contractor without proper protective footwear smashing ballistic glass.

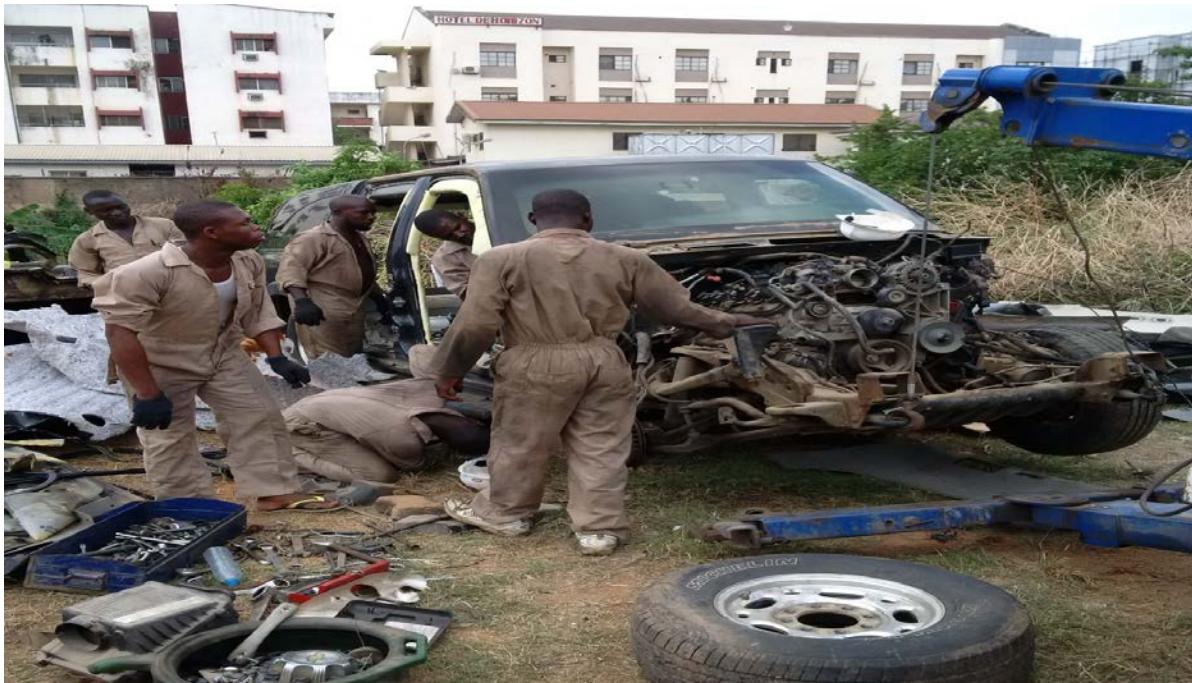
OIG also observed several contractors working underneath an armored vehicle, while other contractors were inside the vehicle, which was being suspended by a metal chain from a tow truck. As shown in Figure 4, these workers did not have personal protective equipment—such as face, head, or eye protection—while performing the disposal process.

Figure 4. Contractors working in flip flops, without personal protective equipment, and under the vehicle while other men are in the vehicle, which is being suspended by a metal chain from a tow truck.

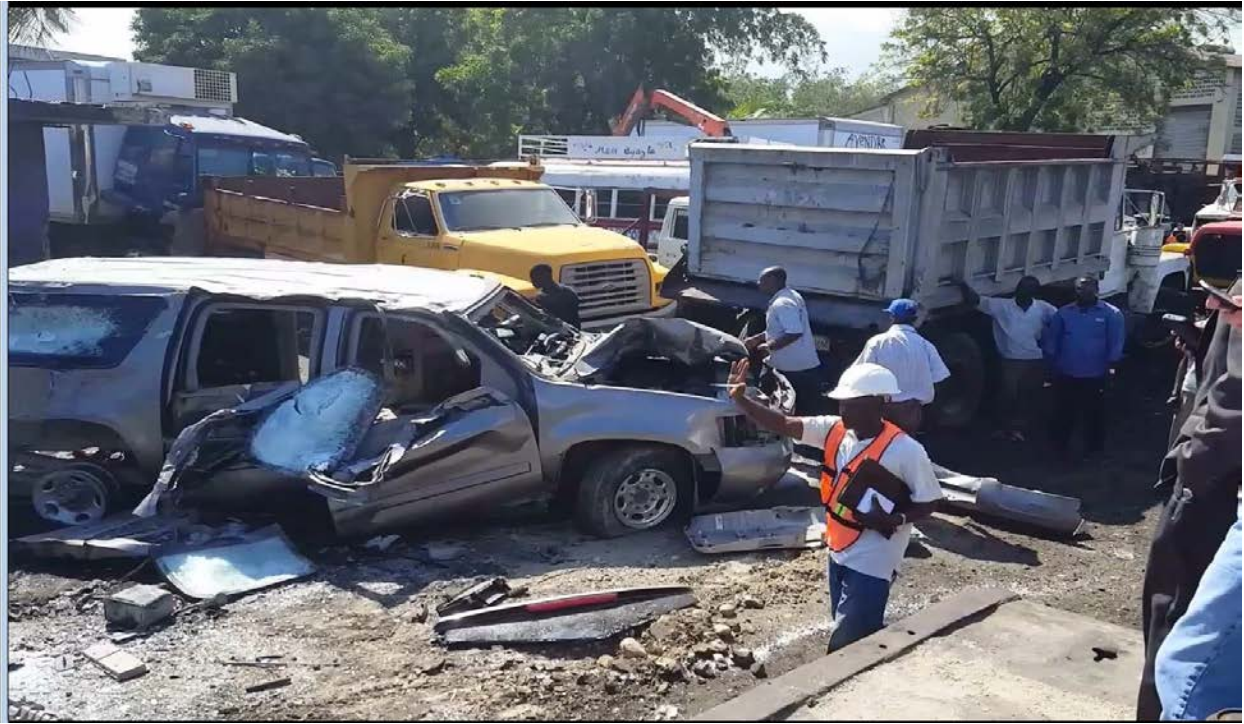
Embassy Port-au-Prince contracted with a local junkyard to conduct its armored vehicle disposals. On February 24, 2016, OIG observed an armored vehicle disposal at the junkyard, during which the contractor attempted to destroy an armored vehicle by hitting it repeatedly with a front-end loader. As shown in Figures 5, 6, and 7, OIG observed the process with a crowd of onlookers (including Department personnel) standing nearby, within 5 to 10 feet, and most onlookers had no personal protective equipment.²⁰

Figure 5. On-lookers without complete personal protective equipment, such as protective eyewear, viewing the disposal in close vicinity to the area where the front-end loader was hitting the vehicle.

²⁰ In response to a draft of this report (see Appendix C), Embassy Port-au-Prince commented that “for all future in-country disposals of armored vehicles via destruction, Post will ensure that contractor and Mission personnel performing or observing the destruction use personal protective equipment; that the destruction is performed in a controlled area with potential onlookers kept at a safe distance; that a purchase order or contract between the Mission and the contractor is established which includes Department of State Acquisition Regulation (DOSAR) clause 652-236-70 covering accident prevention; and that the contractor adheres to the provisions of that clause.”

For all future in-country disposals of armored vehicles via destruction, Post will ensure that contractor and Mission personnel performing or observing the destruction use personal protective equipment; that the destruction is performed in a controlled area with potential onlookers kept at a safe distance; that a purchase order or contract between the Mission and the contractor is established which includes Department of State Acquisition Regulation (DOSAR) clause 652-236-70 covering accident prevention; and that the contractor adheres to the provisions of that clause.

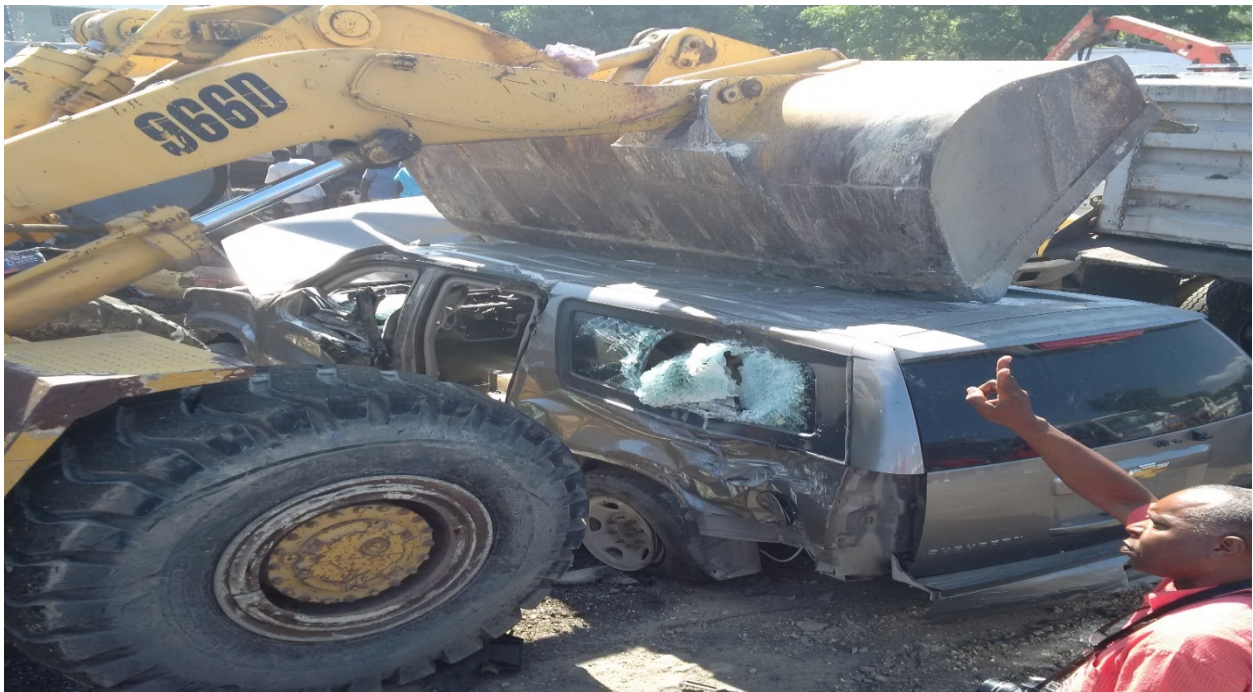
Figure 6. A front-end loader attempting to smash the vehicle while a Department employee who is providing instruction to the contractor stands nearby without personal protective equipment.

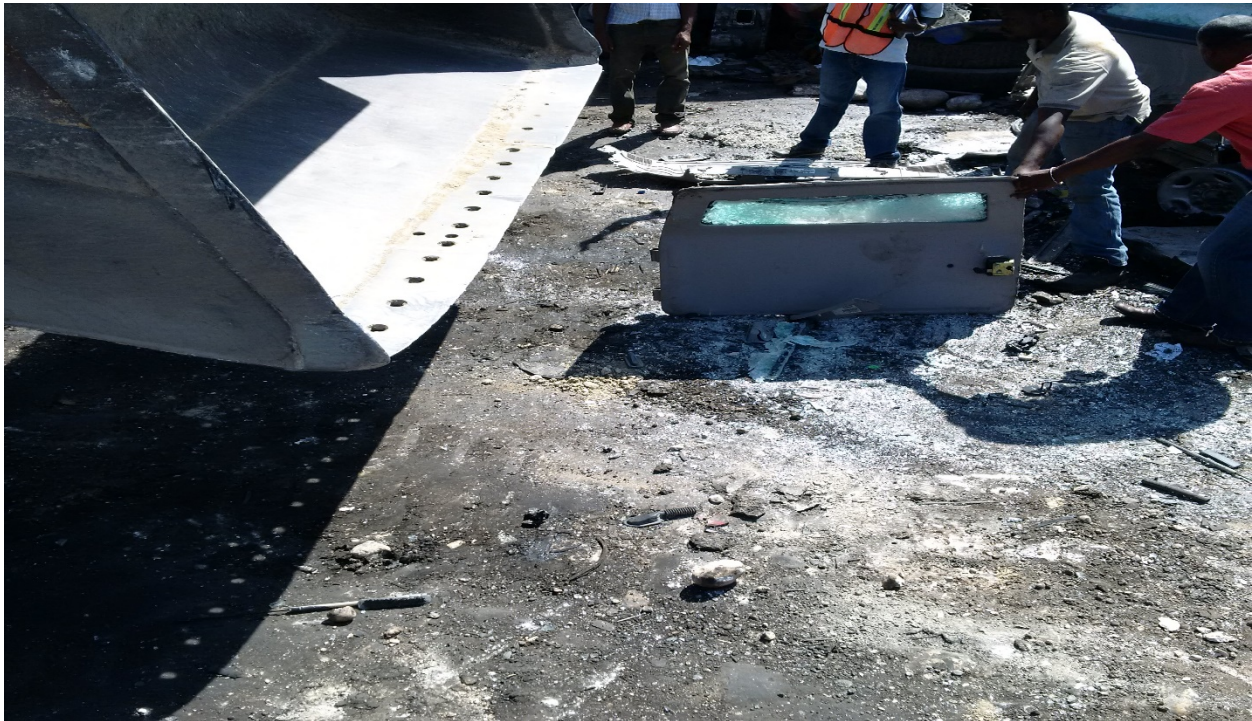
Figure 7. Contractor personnel, with no personal protective equipment, holding an armored door while the front-end loader attempts to smash it.
