Memorandum from the Office of the Inspector General

**REQUEST FOR MANAGEMENT DECISION – EVALUATION 2016-15359 – ACTIONS
TAKEN TO ADDRESS RISKS RELATED TO COAL PLANT DUCTWORK**

ACTIONS TAKEN TO ADDRESS RISKS RELATED TO COAL PLANT DUCTWORK

Evaluation 2016-15359
July 28, 2016

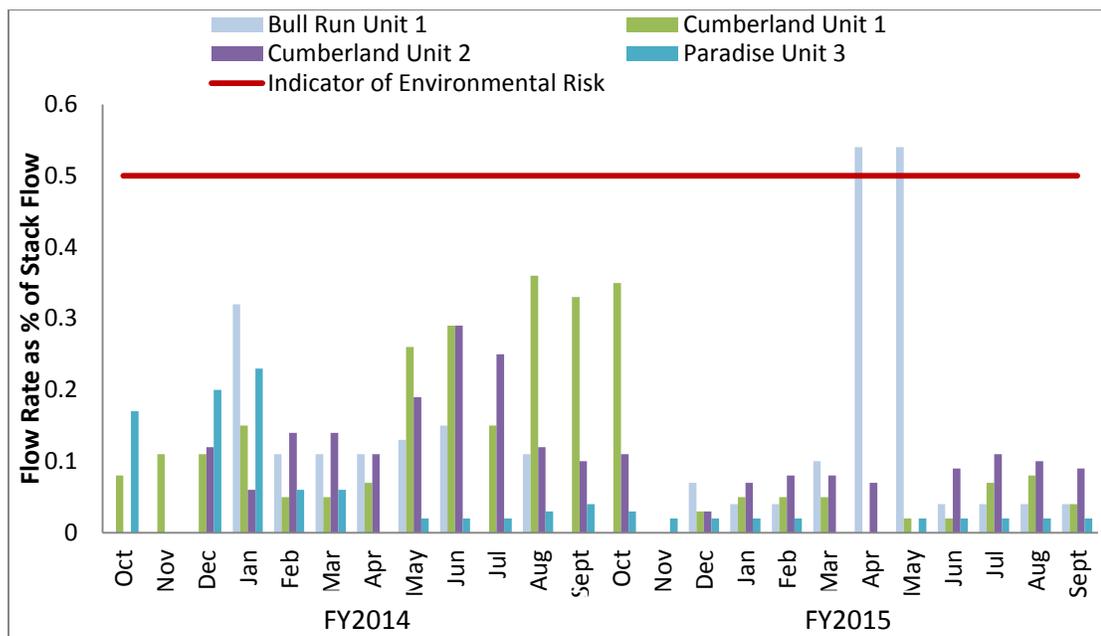
Figure 1: Flow Rates of Leaks at TVA Coal Plants¹⁰ FYs 2014 and 2015

Overall, TVA has completed repairs to address environmental risks associated with flue gas ductwork. TVA's Guidance established 0.5 percent flow rate as an indicator of potential pervasiveness, which we considered a signal of environmental risk. As shown in Figure 1, in April and May 2015, Bull Run's cumulative ductwork leaks on a unit exceeded 0.5 percent flow rate. Bull Run took actions to address the problem by replacing two expansion joints in May 2015.

¹⁰ Monthly Environmental Duct Leak Summary reports showed no ductwork leaks at Kingston during our scope.

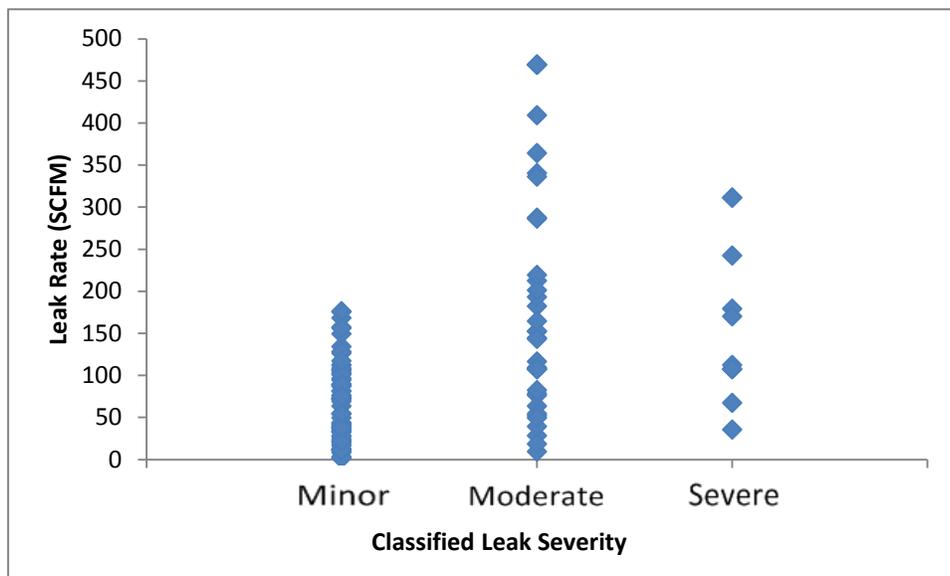
Figure 2: Leak Rates (SCFM) Versus Classified Severity

In discussions with TVA, we were informed that the intent of the SPP is primarily to resolve environmental concerns associated with ductwork leaks. Given the intent of the SPP, we examined the relationship between leak severity classifications made by the ductwork inspectors and the actual calculated leak rates. We reviewed the ductwork inspectors' reports and identified a total of 133 new leaks,¹¹ 2 at Paradise, 29 at Bull Run, and 102 at Cumberland. We analyzed the correlation between leak severity (as classified by ductwork inspectors) and leak rate (as reported on the Monthly Environmental Duct Leak Summaries). We determined that a weak correlation exists between classified leak severity and leak rate. As shown in Figure 2, after removing outliers,¹² we determined maximum leak rate values were highest for moderate leaks. Additionally, the average leak rates were 67, 180, and 164 standard cubic feet per minute (SCFM) for minor, moderate, and severe leaks, respectively.

Based on the above analysis, the SPP may not provide the best method for determining leak severity. Since classified leak severity determines repair prioritization and has a weak correlation with flow rate, the most environmentally
