OFFICE OF INSPECTOR GENERAL

AUDIT OF USAID/WEST BANK AND GAZA CONSTRUCTION PROGRAMS

AUDIT REPORT NO. 8-294-16-001-P
FEBRUARY 22, 2016

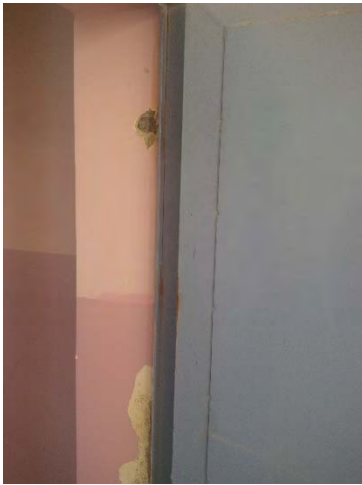
Photo 1

1. The paint is not adhering to walls in several locations (photo 1, 3, 4, 6, 10, 11, 13).
2. Metal works are rusting (photo 1, 5, 14).
3. The plaster is cracking at the masonry to column connections (photo 2, 12).
4. There are broken and missing drain grates (photo 3, 12).
5. A downspout is missing (photo 4).
6. Plaster is cracking on walls and at the parapet (photo 4, 6, 7, 9, 10).
7. There is no flashing at the parapet walls (photo 6, 7, 8, 9, 10).
8. The plaster and caulk is cracking at windows (photo 14).
9. Furniture is stored on roof (photo 8).

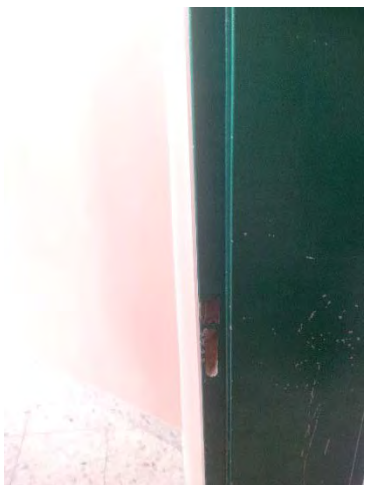
Photo 1

1. Missing door strikes (photo 1)
2. Missing and bent anchor bolts (photo 2)
3. Paint not adhering to walls (photos 3, 5, 6, 16, 17)
4. Improper installation of flashing at parapet walls (photos 4, 5, 6, 7, 10, 11, 12, 13, 14, 15)
5. Plaster cracking at parapet (photos 7, 8)
6. Missing roof drain grate (photo 12)

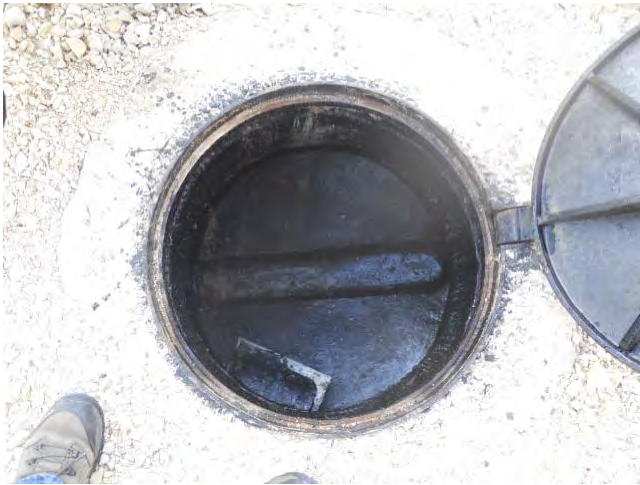
Photo 1

This work included supply and installation of 787 m of pipe, manholes and inlets. Work also included repair of pavement from excavation (see photos 1-2).

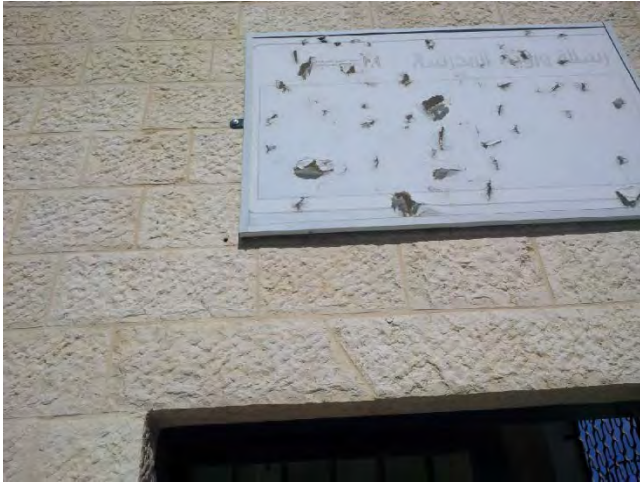
Photo 1

1. Paint on signage is faded to not visible (photo 1, 2).
2. Paint peeling from walls (photos 3, 4).
3. Moisture is causing damage to external plaster (photos 5, 7, 19).
4. Plaster is cracking between columns and block walls (photos 6, 12).
5. Electrical panel is marked "Danger" but does not have a lock-out mechanism (photo 8).
6. Joint filler is detaching at expansion joint (photo 11).
7. Expansion joint cover is bending and warping (photos 9, 10, 11).
8. Moisture is causing damage to internal plaster and paint throughout the building (photos 5, 12, 13, 14, 15).
9. Flashing is improperly installed (photos 16, 17, 18, 20).
