INSPECTOR GENERAL

JUNE 2, 2017

U.S.-Controlled and -Occupied Military Facilities Inspection – Camp Lemonnier, Djibouti

Our objective was to inspect U.S. military-occupied facilities at Camp Lemonnier, Djibouti, to verify compliance with DoD health and safety policies and standards regarding electrical and fire protection systems.

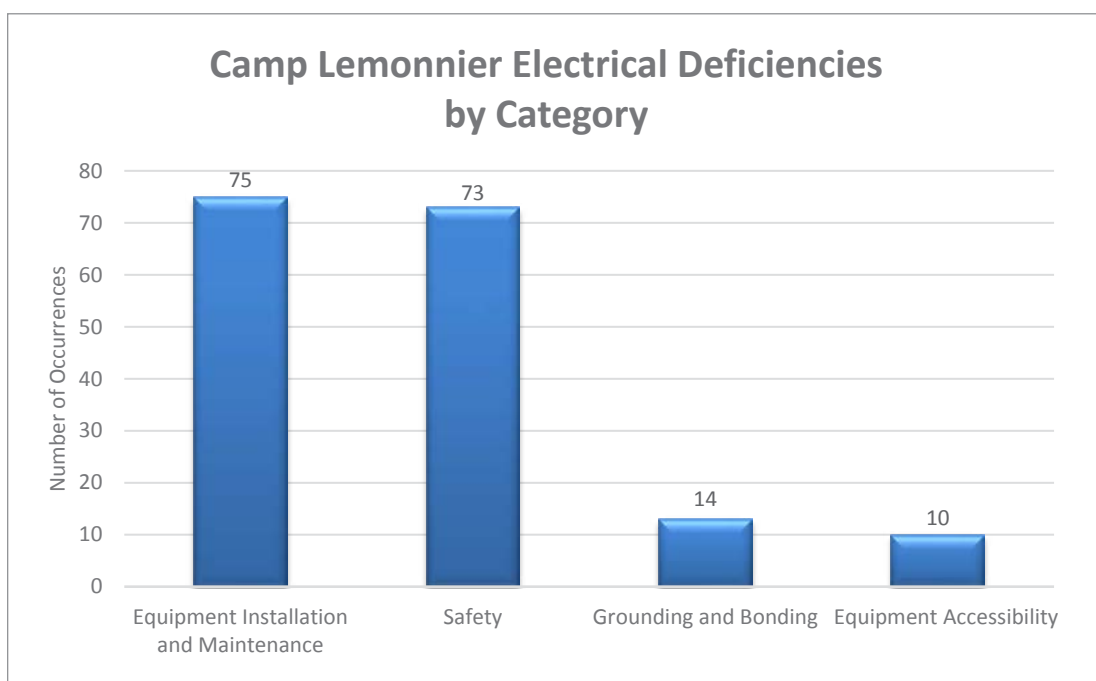
Figure 1. Electrical Deficiencies

We documented 172 deficiencies related to electrical systems (see Figure 1). The deficiencies were related to equipment installation and maintenance, safety, grounding and bonding, and equipment accessibility. All of these deficiencies pose a risk of shock, electrocution, or fire.

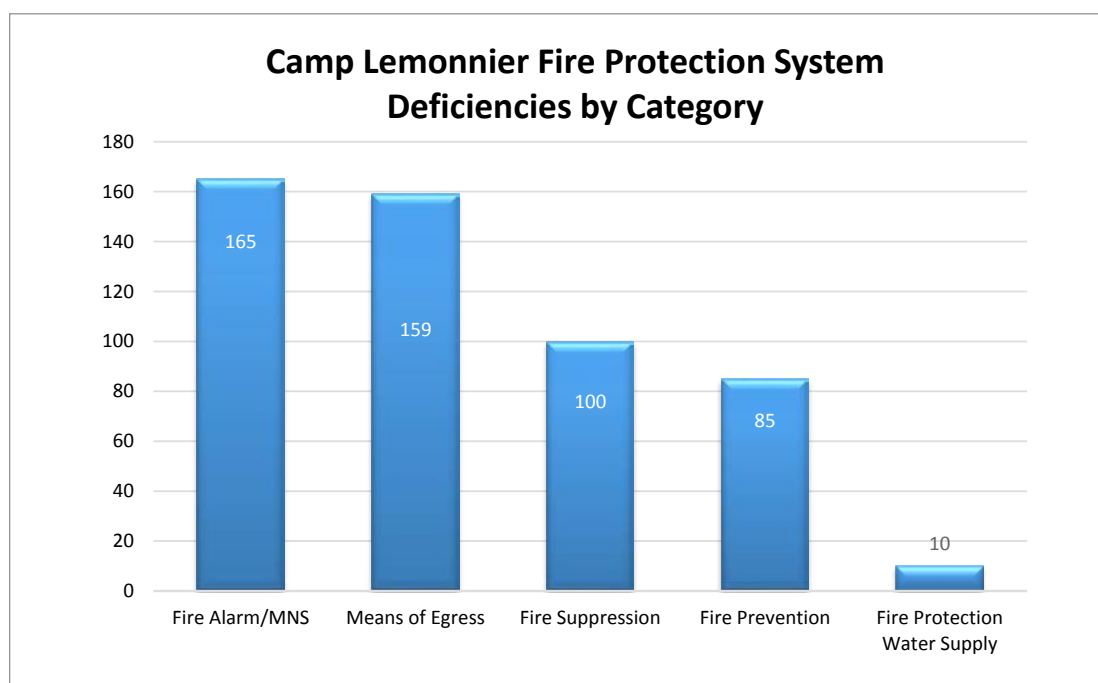
Figure 6. Fire Protection Deficiencies

We documented 519 fire protection deficiencies. The deficiencies found were related to fire alarm or mass notification, means of egress, fire suppression, fire prevention, and fire protection water supply. These deficiencies increase the risk of fire, injury, or death.
