OIG

AUD-MERO-17-44

June 2017

Management Assistance Report: Building Deficiencies Identified at U.S. Embassy Kabul, Afghanistan Need Prompt Attention

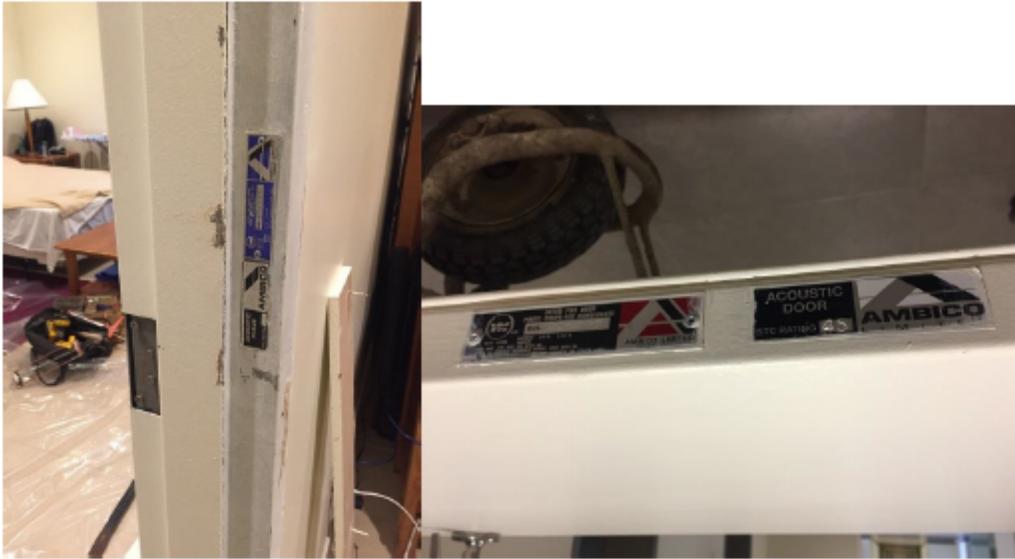
OBO Response, May 2017: OBO does not concur with this recommendation. As noted in OBO's response to Recommendation 12, the AHJ determined the elevator and efficiency suite doors did not require replacement. The efficiency suite doors were recently discovered to have had their fire door labels obscured by moldings.

OIG Recommendation 13: OIG recommends that the Bureau of Overseas Buildings Operations implement actions to replace and correct all elevator lobby doors and efficiency suite connector doors in the New Office Annex and Staff Diplomatic Apartment-1 found not to conform to the contract requirements or National Fire Protection Association standards.
