# INSPECTOR GENERAL

(U) Evaluation of Army Pre-Positioned Equipment Issued in Response to Ukraine and the NATO Defense Forces

#### (U) February 27, 2023

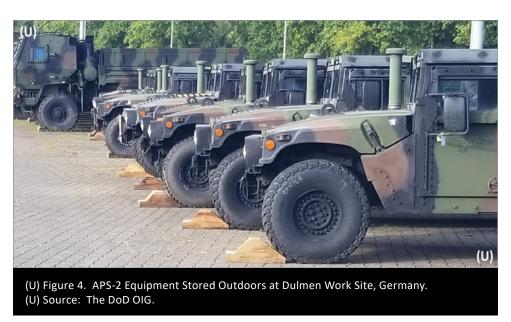
(U) The 405 AFSB could not exercise APS equipment during storage, as required in TM 38-470 and in equipment technical manuals, because their facilities do not have exercise tracks. According to TM 38-470, equipment exercise must be integrated into the cyclic maintenance program for APS equipment to the fullest extent possible. TM 38-470 states that the primary purpose of equipment exercise is to determine the degree of functionality of equipment, prevent its accelerated deterioration, and maintain the equipment's operational capability. It states that combat vehicles in storage require exercise every 36 months in a controlled humidity environment, and every 18 months if stored outdoors. Tactical vehicles in storage require exercise every 48 months in a controlled humidity environment, and every 24 months, if stored outdoors.

- (U) The lack of 405 AFSB exercise tracks contributed to the 405 AFSB issuing equipment to the 1 ABCT that was non-FMC. An AFSBn-Mannheim official stated that there was no exercise track at either Dulmen Work Site or Coleman Work Site to carry out this vehicle exercise requirement. We physically observed that neither site has an exercise track.
