AUD-MERO-18-32

April 2018

Management Assistance Report: Improper Installation of Key Components of U.S. Embassy Kabul, Afghanistan's Fire Alarm System Needs Prompt Attention

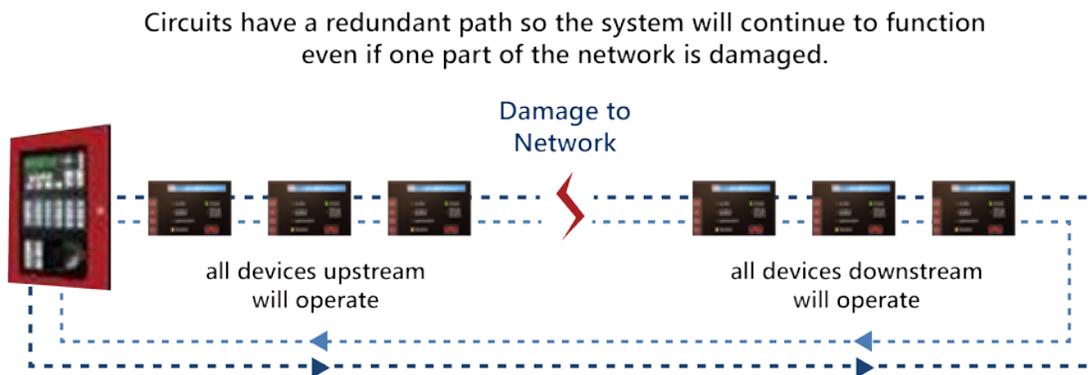
Figure 1: Redundant Path Required by NFPA 72

one of the cables is damaged. That is, these redundant paths allow the system to continue to function even if one part of the network is damaged. Figure 1 shows an example of a redundant path consistent with NFPA 72 requirements.

OIG found the pathways between fire alarm control panels at Embassy Kabul do not have a separate redundant path, as required by NFPA 72, to provide survivability in case of damage or failure to one part of the network. According to PAE, a secondary path was installed. However, rather than being routed separately, the existing fiber optic cables run in a parallel path. Because the fiber optic cables run in the same direction and are bundled together in the same conduit, damage to one part of the network can render sections of the network inoperable. This routing is contrary to NFPA 72 standards. OBO officials acknowledged that a redundant path has not been installed throughout the embassy compound but stated that, because the fiber optic cable network is part of a larger project involving the construction of multiple buildings and facilities, there is no requirement to install such a redundant path until the end of the entire construction project. OIG notes, however, that Caddell began construction on the embassy compound in 2011 and construction is not due to be completed until March 2019. In fact, many of the fire alarm control panels that would have been included in the redundant path are located in buildings that have been in use since 2011. As a result, OBO has postponed compliance with NFPA 72 standards for 8 years while the embassy is under construction. Further, OBO officials have acknowledged that additional proposed modifications to Caddell's contract could further delay completion of construction beyond March 2019.

Recommendation 1: OIG recommends that the Bureau of Overseas Buildings Operations' Office of Fire Protection, in coordination with Embassy Kabul, take immediate action to establish a separate redundant path for the fire alarm system that will allow operational capability to continue in the event of damage to one part of the network, in accordance with National Fire Protection Association requirements.
