INSPECTOR GENERAL

AUGUST 16, 2018

Hotline Allegations Regarding the Acceptance and Testing of the MQ-9 Reaper Aircraft

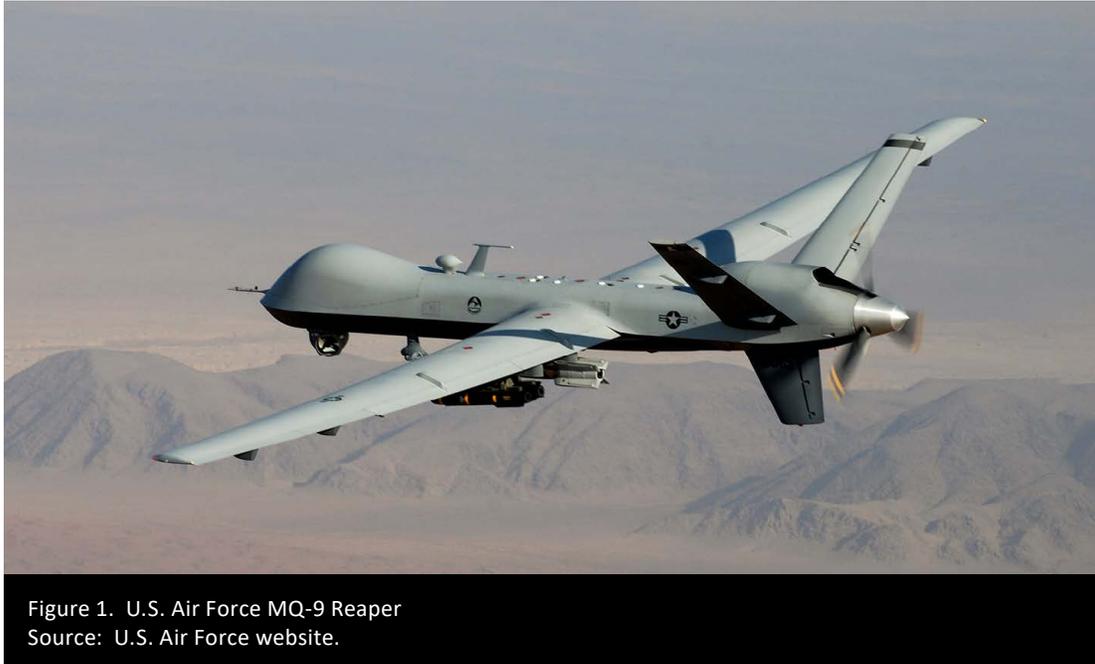
Figure 1. U.S. Air Force MQ-9 Reaper
Source: U.S. Air Force website.

Figure 1 shows a picture of the Air Force MQ-9 Reaper.

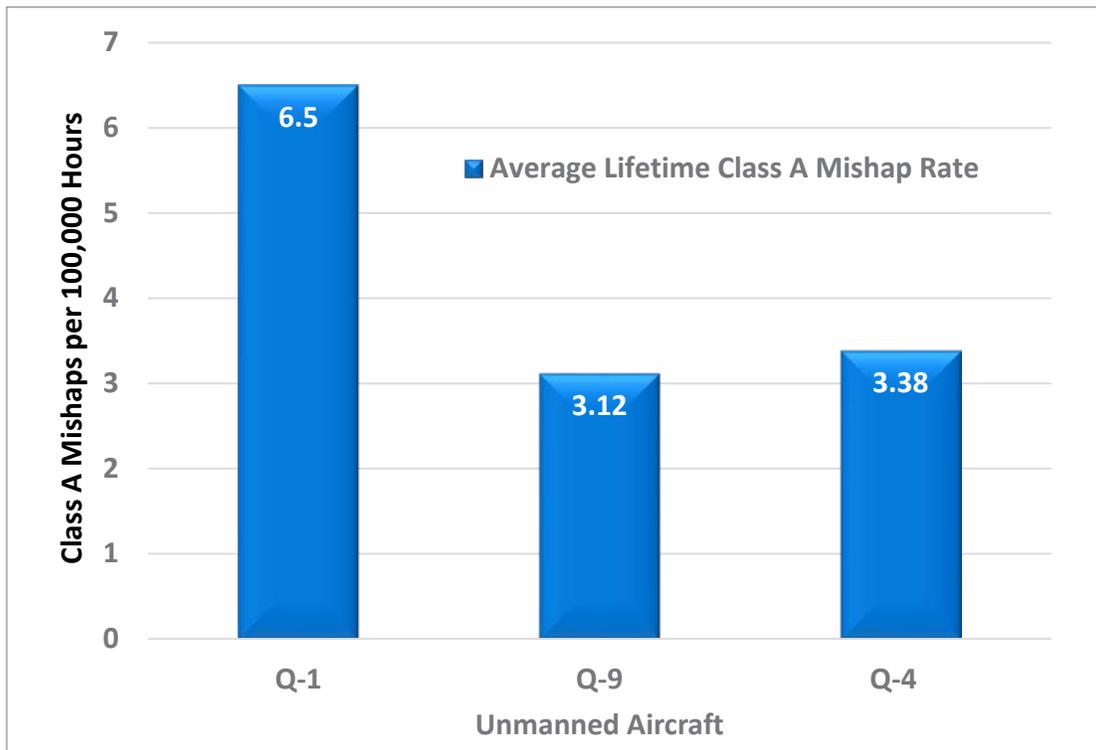
Figure 2. Group 5 Unmanned Aircraft – Lifetime Class A Mishap Rates (As of November 6, 2017)

Source: U.S. Air Force Safety Center data.

Figure 2 depicts the average lifetime Class A mishap rates for the three unmanned aircraft vehicles.
