# INSPECTOR GENERAL

## Audit of the Department of the Navy Actions Taken to Improve Safety and Reduce Physiological Events

## *Audit of the Department of the Navy Actions Taken to Improve Safety and Reduce Physiological Events*

**November 4, 2020**

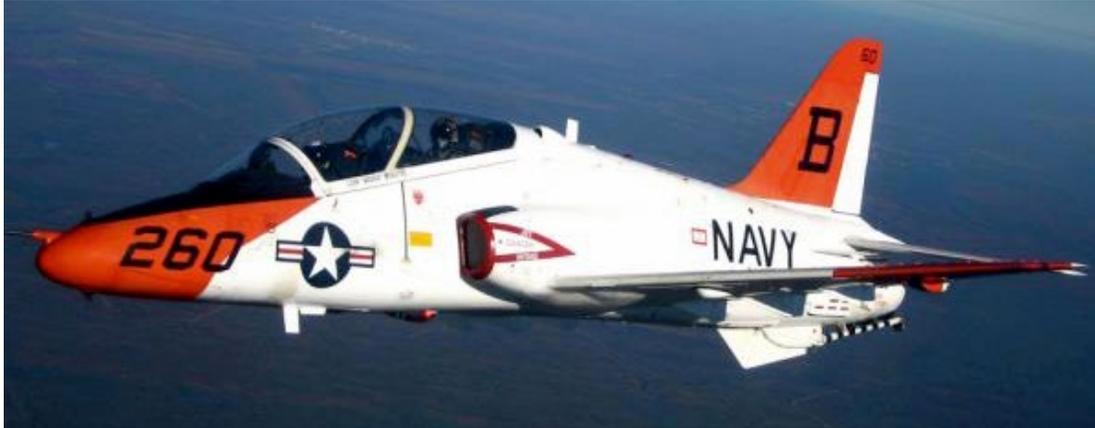
Figure 1. T-45C Goshawk  
Source: Defense Visual Information Distribution Service.

The Goshawk is a two-seat, carrier-capable, jet trainer whose mission is to provide intermediate and advanced training to Navy and Marine Corps pilots. Figure 1 shows the Goshawk.

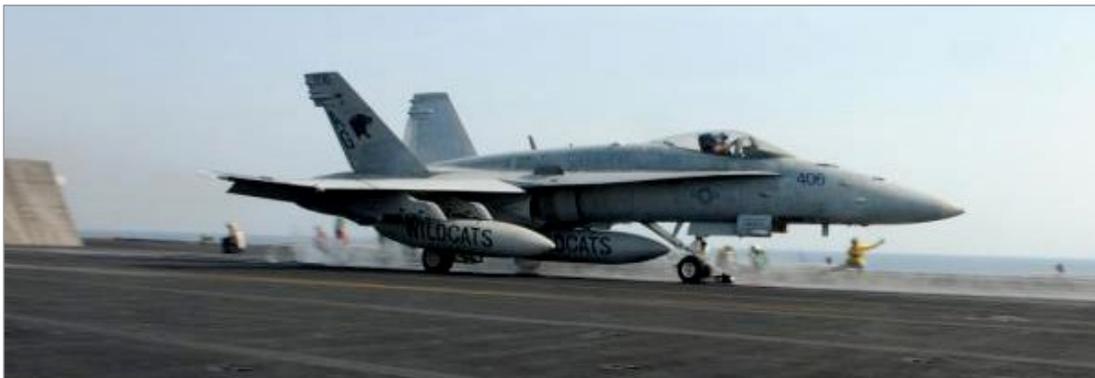
Figure 2. F/A-18 Legacy Hornet C Model  
Source: Defense Visual Information Distribution Service.

The Legacy Hornet is an all-weather fighter and attack aircraft that is used for fighter escort, fleet air defense, force protection, and close and deep air support. The Legacy Hornet has single-seat (F/A-18 A and C) and two-seat (F/A-18 B and D) models. Figure 2 shows a Legacy Hornet C model.

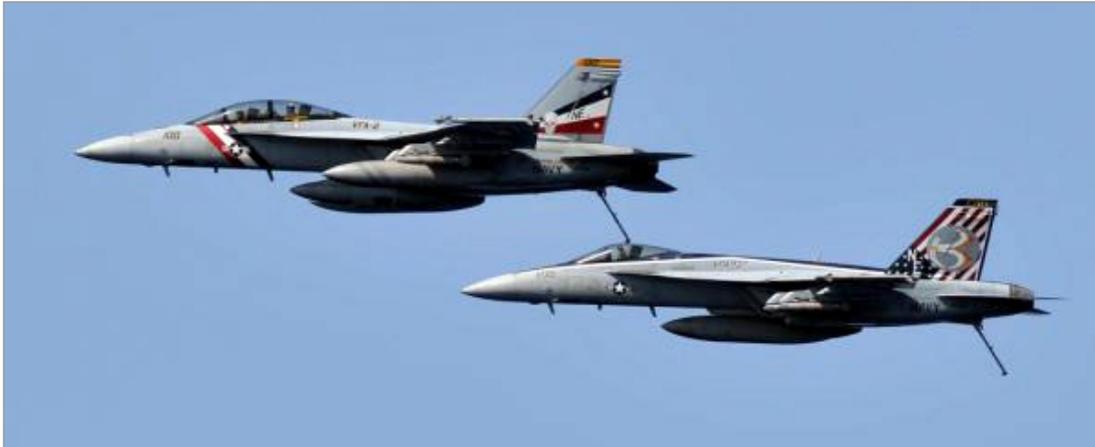
Figure 3. F/A-18 Super Hornet E Model (bottom) and F Model (top)  
Source: Defense Visual Information Distribution Service.

The Super Hornet is a fighter and attack aircraft that provides escort and fleet air defense as well as offensive capabilities. The aircraft can target enemy fighter aircraft and attack ground and surface targets. The Super Hornet has increased maneuverability, range, and payloads compared to the Legacy Hornet. The Super Hornet has single-seat (F/A-18 E) and two-seat (F/A-18 F) models. Figure 3 shows a Super Hornet E model and F model.

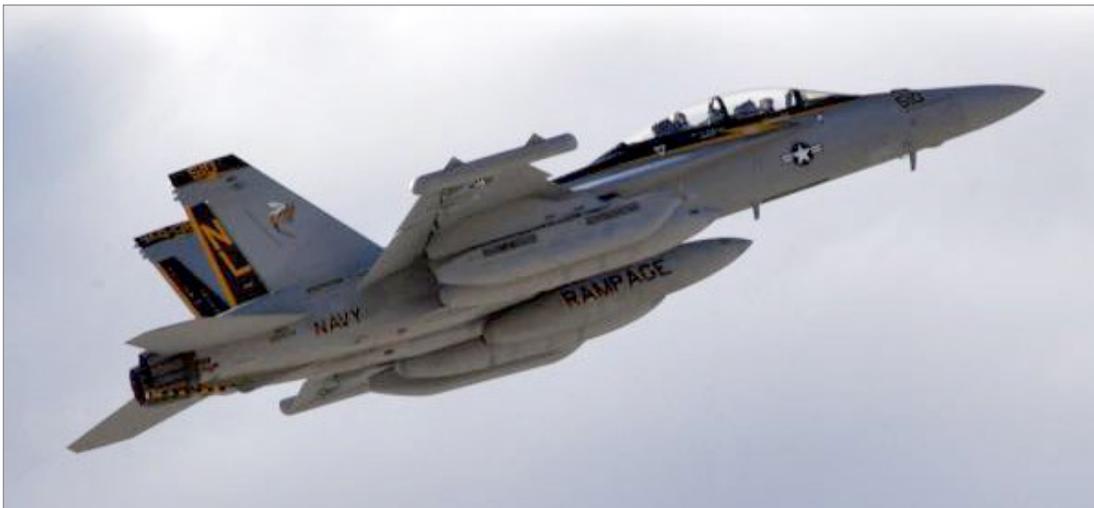
Figure 4. EA-18G Growler  
Source: Defense Visual Information Distribution Service.

The Growler is a variant of the Super Hornet with a sophisticated electronic warfare suite. The two-seat, electronic attack aircraft integrates electronic attack technology, including jamming pods, communication countermeasures, radar, and satellite communications. Figure 4 shows a Growler.

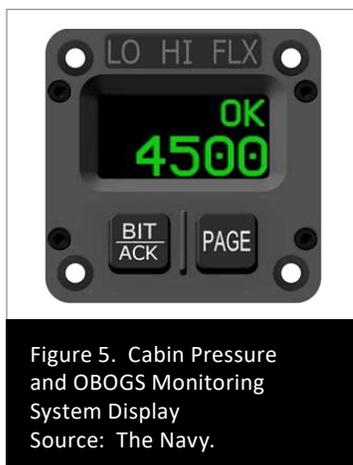
Figure 5. Cabin Pressure and OBOGS Monitoring System Display  
Source: The Navy.

In addition to the technical changes, the DON plans to upgrade a Goshawk OBOGS component and install a Cabin Pressure and OBOGS Monitoring System on Legacy Hornets, Super Hornets, and Growlers. Aircrew Systems (PMA-202) plans to perform system validation and verification testing of the new Goshawk OBOGS component in second quarter FY 2021, which will enable control over OBOGS oxygen levels. The DON plans to upgrade the current analog cabin pressure gauge in Legacy Hornets, Super Hornets, and Growlers to a Cabin Pressure and OBOGS Monitoring System. The new Cabin Pressure and OBOGS Monitoring System will record and display aircraft cabin pressure and record OBOGS information. The data from the new system will be available for download after a flight. According to a Hornets and Growlers (PMA-265) official, once the DON completes the validation process to approve the new system, the aircraft maintenance personnel will install the new system in the Hornets and Growlers. As of August 2020, Hornets and Growlers (PMA-265) was planning to award a contract to install the Cabin Pressure and OBOGS monitoring System by December 31, 2020, and start installation in second quarter FY 2021. Figure 5 shows a Cabin Pressure and OBOGS Monitoring System display.

and Growlers (PMA-265) official, it will take several years for the DON to install the new Cabin Pressure and OBOGS Monitoring System on all Legacy Hornets, Super Hornets, and Growlers because the aircraft cabin has to be modified for the installation. Therefore, the DON will continue to require aircrew members to carry slam sticks during flight.

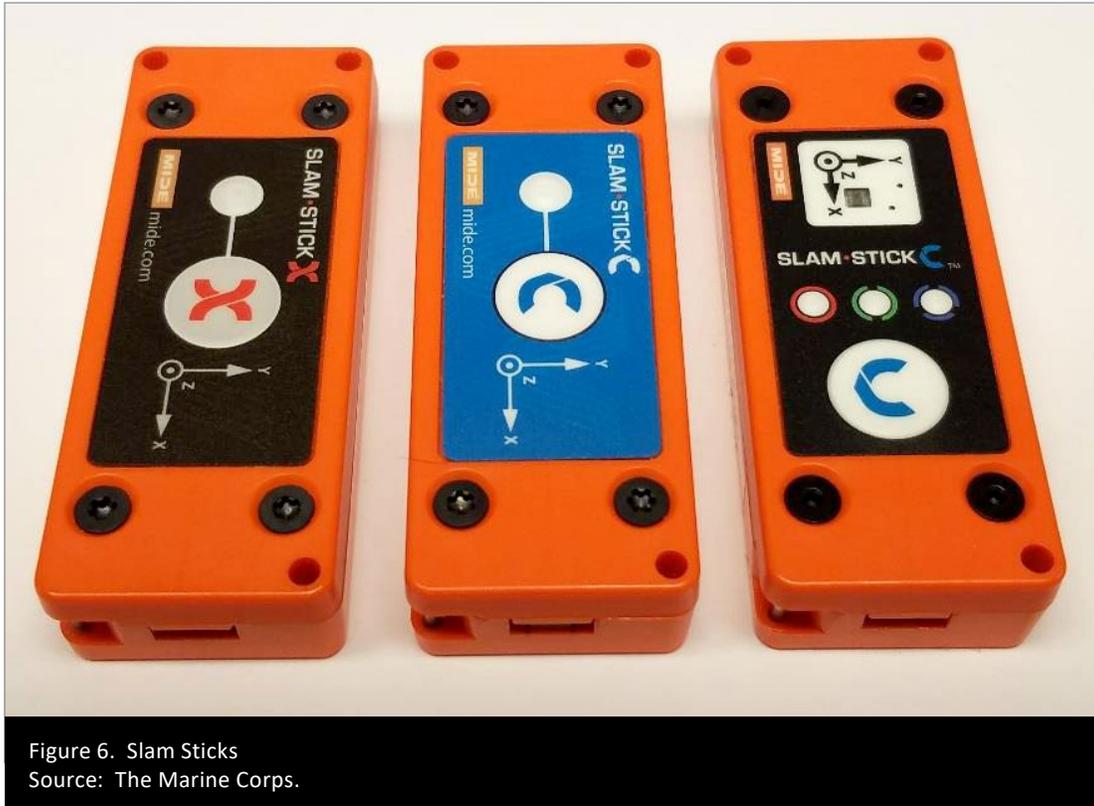
Figure 6. Slam Sticks  
Source: The Marine Corps.

Because the analog cabin pressure gauge in Legacy Hornets, Super Hornets, and Growlers did not record data on the changes in cabin pressure throughout a flight, in October 2017 the DON began having pilots carry a portable device to record cabin pressure data.<sup>24</sup> The portable device was called a slam stick and was about the size of a universal serial bus (USB) drive (see Figure 6). At the conclusion of the flight, the pilot downloaded the data from the slam stick, which the DON used to determine the health and performance of the aircraft. According to a Hornets

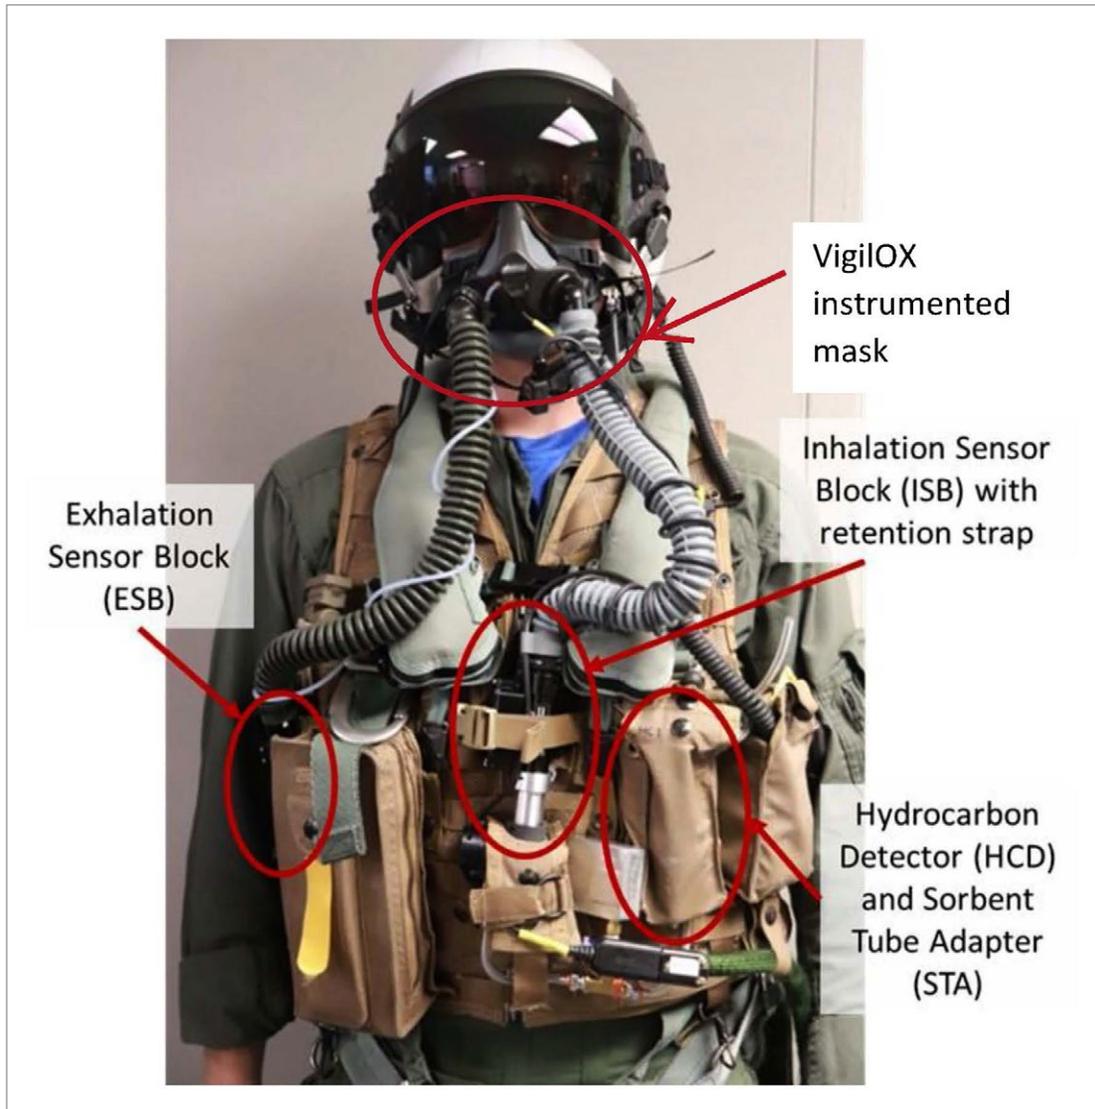
Figure 8. VigilOX Testing Equipment with Hydrocarbon Detector and Sorbent Tube Adapter

In addition, Training (PMA-273), Hornets and Growlers (PMA-265), Aircrew Systems (PMA-202), and the Navy PEAT tasked Test and Evaluation Squadron (VX-23) to conduct tests on Goshawks, Legacy Hornets, Super Hornets, and Growlers to help determine potential causes of PEs. From April 2017 through December 2019, Test and Evaluation Squadron (VX-23) conducted 143 flights and 66 ground tests for Goshawks. In addition, from August 2016 through December 2019, Test and Evaluation Squadron (VX-23) conducted 97 flights and 70 ground tests for Legacy Hornets, Super Hornets, and Growlers. Specifically, Test and Evaluation Squadron (VX-23) collected data to evaluate OBOGS pressure from engine to aircrew member using a VigilOX instrumented mask, hydrocarbon detector, and sorbent tube adapter.<sup>28</sup> The RCCA teams used the physiological monitoring data that Test and Evaluation Squadron (VX-23) collected to rule out potential causes of PEs. See Figure 8 for the aircrew member physiological monitoring testing equipment that Test and Evaluation Squadron (VX-23) used to perform tests on Goshawk, Legacy Hornet, Super Hornet, and Growler aircrew members.

<sup>28</sup> The VigilOX is an instrumented mask that records several air parameters, such as air flow, air pressure, and temperature of the air flow and cabin. The sorbent tube adapter is a man-mounted air sensor that is on the aircrew members' vest, and the hydrocarbon detector is a self-contained volatile organic compound detector for air.
