REVIEW OF VIOLENCE PREVENTION AT THE PASCHAL SHERMAN INDIAN SCHOOL

Subject: Inspection Report – Review of Violence Prevention at the Paschal Sherman
Indian School
Report No. C-IS-BIE-0029-2014

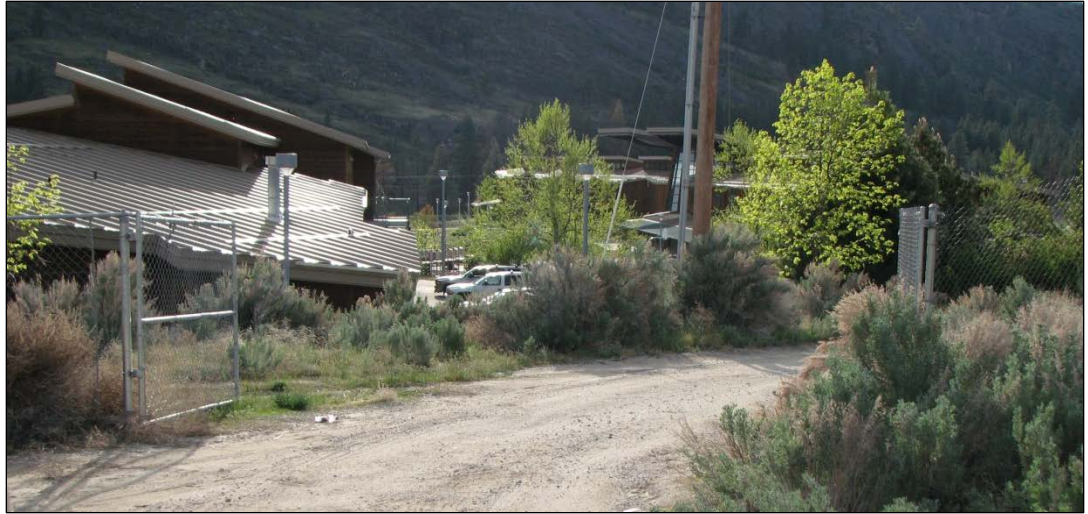
When we arrived on campus on May 1, 2014, we entered the main academic building through an exterior classroom door that was propped open. Once inside, the teacher directed us to the main lobby to sign in. Before arriving at the main lobby, however, we were not challenged by any other staff we encountered in the building. In addition, although the school had a security fence surrounding the entire campus, we observed, and school officials confirmed, that several of the gates were always open. For example, a gate located at the back of the school by the dormitory remained open to allow access to the open area behind the campus (see Figure 1). In addition, gates located between the school ground and the Tribe's adjacent property were also always left open (see Figure 2). Further, a large section of the school's fence was severely damaged. School officials indicated they were in the process of fixing the fence and installing a gate at that location (see Figure 3).

Figure 1. Open gate near the dormitory. Source: OIG

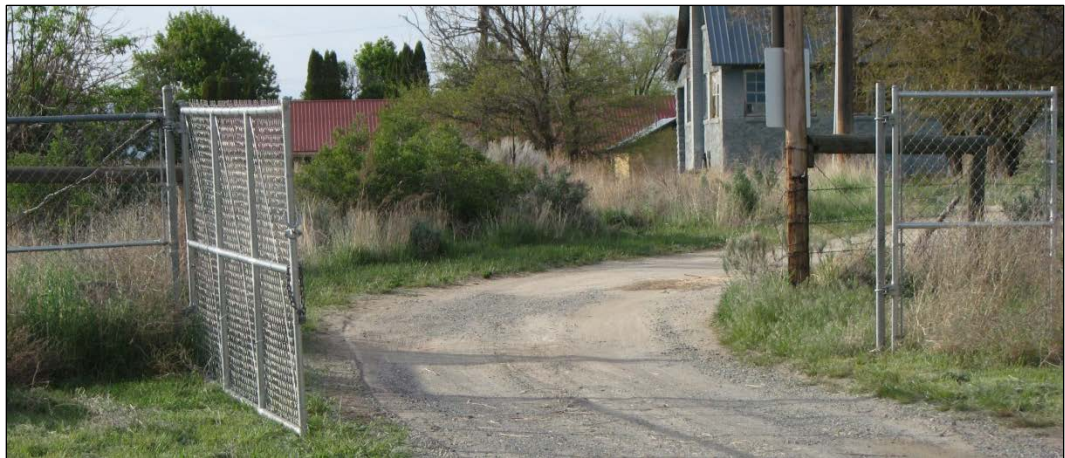
Figure 2. Open gate between the school campus and adjacent tribal property. Source: OIG

Finally, the school did not adequately control campus visitors. For example, a funeral was held at the tribal Long House, on the property adjacent to the school, on the day of our visit. Because the gate remained open between the two properties, several former students attending the funeral walked over to the school. The former students, many of them still children and difficult to distinguish from current students, roamed the halls and interrupted classes. The former students did not stop by the office to sign in, so school personnel remained unaware of how many such “visitors” roamed the facility during our visit. While we understand that cultural sensitivities play a role in Indian Country, and that schools often serve as centers of activity, safety measures are needed to protect students and staff. If an actual emergency occurred, such as a fire, school officials could not have ensured that all individuals safely evacuated the facility, especially because they had no way to know the number of individuals present.

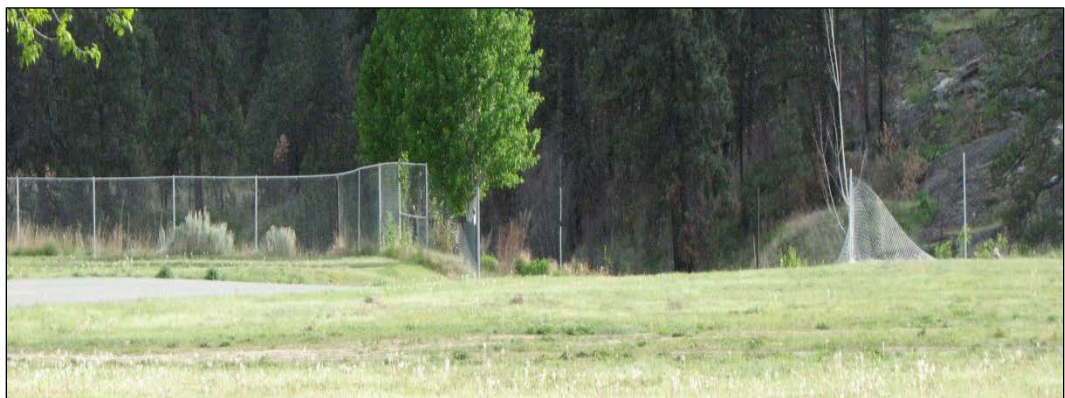
Figure 3. Damaged fencing on the school campus. Source: OIG

2. Repair the damaged section of fencing; and
3. Evaluate the 18 safety measures in Appendix 6 and determine the correct combination of safety measures for the campus necessary to ensure the safety of staff and students from internal and external threats. Once determined, work to put the selected safety measures in place.
